ACCIDENT ON THE
LINE OF THE
READING COMPANY

WESTON-MANVILLE, N. J.

AUGUST 31, 1940

INVESTIGATION NO. 2444

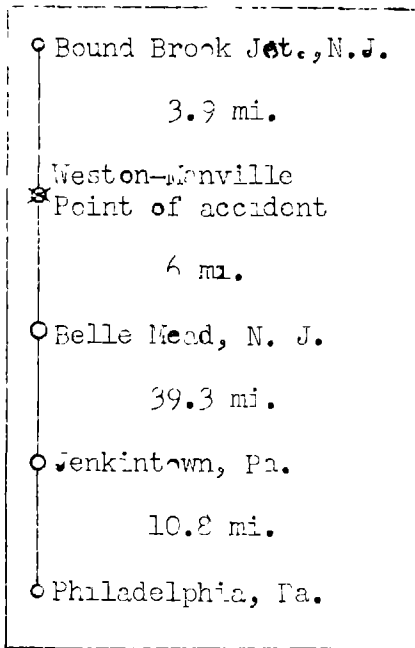
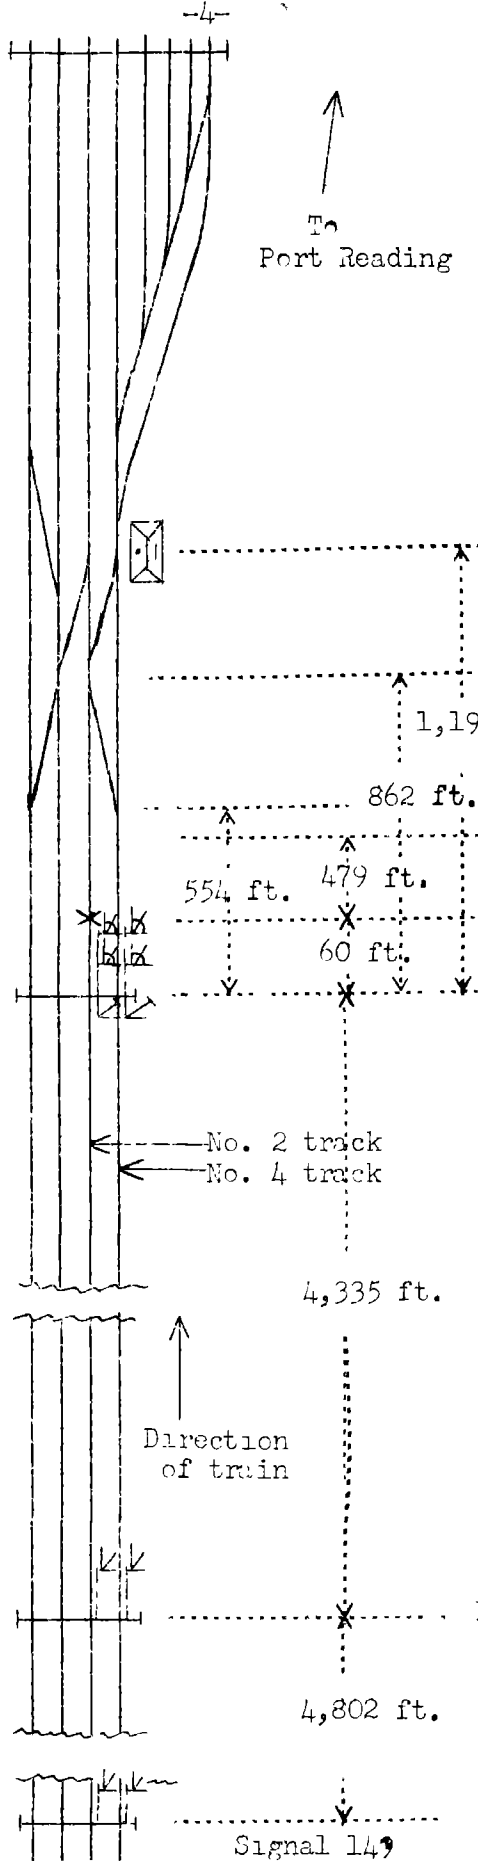
The interlocking machine is a Model 14, power type, and consists of 33 working levers; it is equipped with approach-locking on all routes and electric-locking for all switches and derails. Time releases on approach circuits are set for 2-minute operation. All movements through the interlocking are controlled by signal indication. Distant signals and home signals governing eastward movements on tracks Nos. 2 and 4 are located on signal bridges 5,527 feet and 1,192 feet, respectively, west of the interlocking tower. The distant signals are of the automatic, single-arm semaphore type. The home signals are of the semi-automatic, 3-arm, upper quadrant, semaphore type. The involved aspects, indications, and names of the distant and home signals on track No. 2 are as follows:

Main-track derails of the Wharton type are located on tracks Nos. 2 and 4 at points 60 feet east of the eastward home-signal bridge. The west switch of the cross-over from track No. 4 to track No. 2 is located 554 feet east of the home-signal bridge.
