WASHINGTON, D.C. 20594

REAR-END COLLISION OF AMTRAK PASSENGER TRAIN 94, THE COLONIAL AND CONSOLIDATED RAIL CORPORATION FREIGHT TRAIN ENS-121, ON THE NORTHEAST CORRIDOR CHASE, MARYLAND JANUARY 4, 1987

NTSB/RAR-88/01

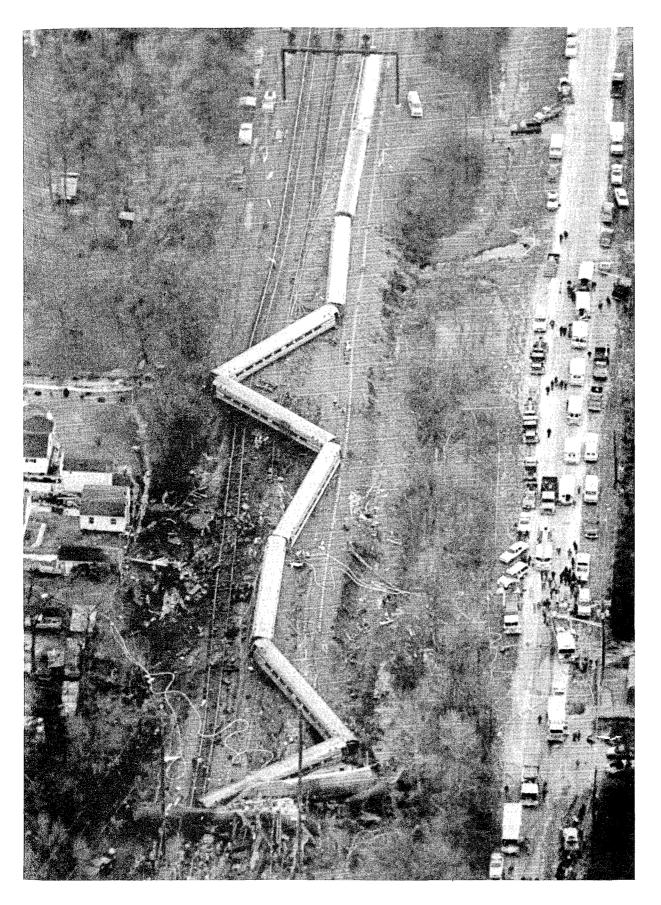
Figure 3. Aerial view of the accident site.

The forward cab and superstructure of the lead Amtrak locomotive unit was crushed downward and inward to the underframe. Separated from the trucks, the remains of the car body came to rest west of the tracks about 400 feet north of the collision point. The trailing Amtrak unit remained in line with the track, although separated from its trucks, and came to rest leaning about 45° to the right at a point about 45° feet north of the collision point (see figure 3).

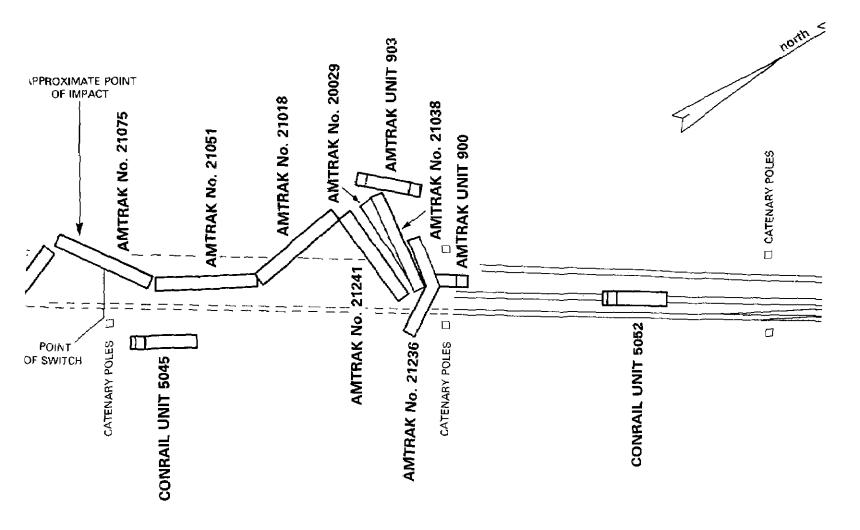
"GUNPOW" INTERLOCKING WRECKAGE DISTRIBUTION PLAN CHASE, MARYLAND

The rear Conrail unit was virtually disintegrated with parts scattered across the tracks and property east of the tracks. The largest piece of wreckage came to rest about 150 feet northeast of the collision point. The rear of the middle Conrail unit was crushed by the rear unit. Uncoupled from the lead unit, it was propelled forward on track 2 for about 700 feet. Only the rear truck of this unit derailed. The lead Conrail unit sustained relatively superficial damage, although driven forward about 900 feet, it was the only piece of equipment in the two trains that was not derailed.

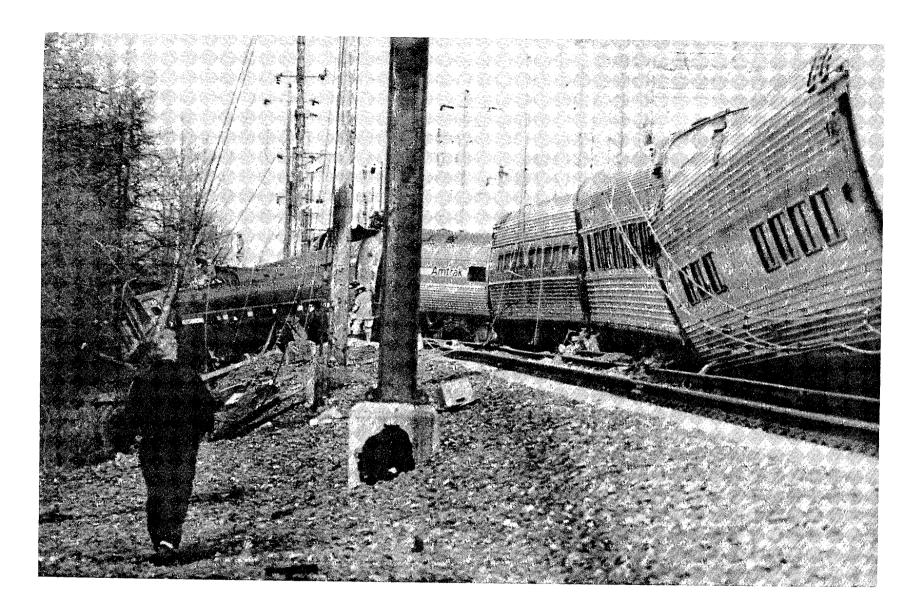
The head car of the passenger train, an unoccupied food service car, came to rest behind the trailing Amtrak locomotive. After passing over the food service car, the second car came to rest on its side on top of the rear of the trailing Amtrak locomotive unit. It was more or less perpendicular to the track, badly deformed and bent or crimped downward in the middle at an angle of about 30° (see figure 4). The third car stopped diagonally to the track, leaning to one side, on top of the crushed food service car. One end was crushed between the second and fourth cars. The fourth car stopped diagonally to the track, upright and with the car body essentially intact. The 5th through 12th cars remained coupled and upright, although the 5th, 7th, 8th, and 9th cars had jackknifed and stopped diagonally to the track. The other derailed cars remained in line with the track (see figure 5).

Figure 5. View from west side of the tracks facing north and showing derailed passenger cars of train 94. The car at the extreme right was the rear car of the train, and the car ahead of it was the second car from ther ear. The piles in the middle held up the catenary wires. Fallen catenary and high-voltage transmission lines are on both sides of the poles.

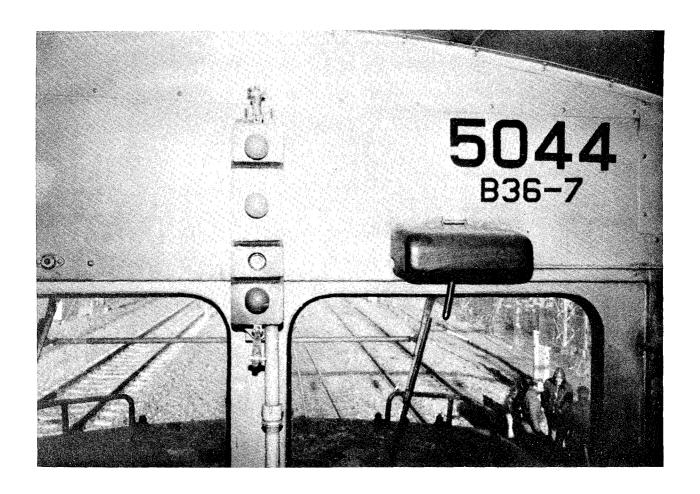
The four-aspect cab signal of unit 5044 was of the same configuration as the Amtrak AEM-7 locomotives; it was mounted in the middle of the forward cab bulkhead at the top of the windshield. The hinged cover had two sets of aspect ports set at oblique angles so that one could be viewed from each side of the cab. The top port was the "clear" aspect, the next two below were the "approach medium" aspect, the next below was the "approach" aspect, and the bottom port was the "restricting" aspect. There were screw-in receptacles in the signal box for four small white bulbs--one for each aspect. An examination of the signal box after the accident revealed that the bulb for the "approach" aspect was missing (see figure 13). All the other aspects had operative bulbs that were properly inserted.

Figure 13. Cab signal of Conrail unit 5044 with the cover removed; the bulb for the "approach" aspect is missing.

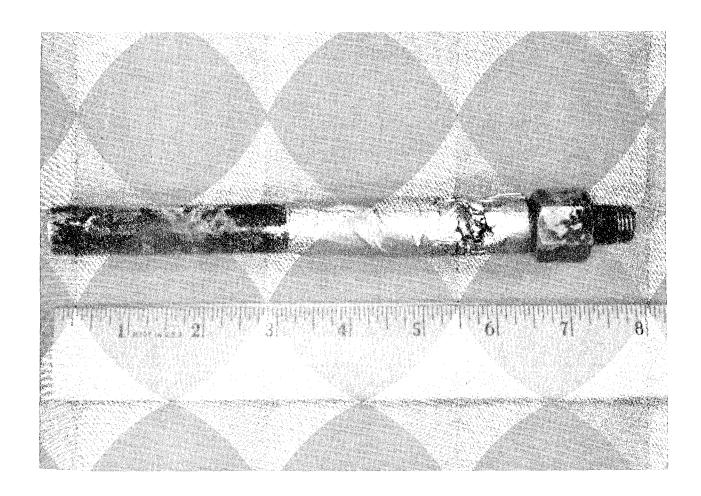
The 6 1/2-inch cab signal whistle was mounted in the airbrake control stand and could be accessed by unsnapping six latches that held the back cover in place. Following the accident, investigators removed the cover from the airbrake control stand of unit 5044 and found the port of the whistle wrapped tightly with duct tape (see figure 14). In this

Figure 14. The cab signal whistle removed from Conrail 5044 with the port covered by duct tape.

condition, no sound could be heard over the sound of the idling engine of an adjacent locomotive. When the tape was slit at the port, the whistle emitted sound at a normal 95- to 105-decibel level.

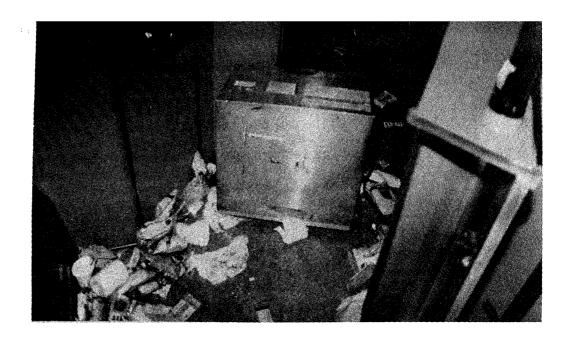
The train crewmembers related that most of the passengers remained calm and there was little panic, although the aisles of most of the coaches were blocked by fallen luggage. In the food service cars, unsecured microwave and convection ovens and other articles in the pantry sections were thrown to the floor and blocked movement through the cars (see figure 15).

Figure 15. Microwave oven and other pantry material blocking the aisle of the rear car of train 94, the food service car.

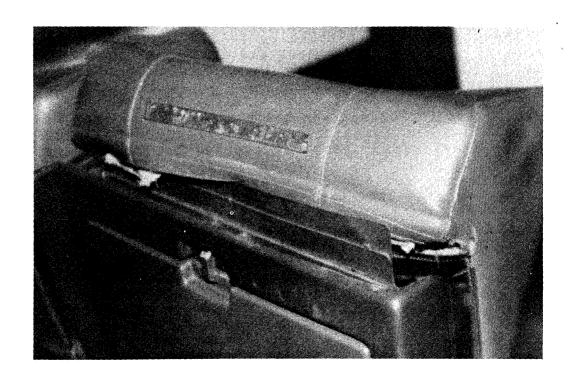
Passengers throughout the train reported that they had been struck by fallen luggage. Others stated they were injured when thrown into sheet metal seatbacks exposed by dislodged cushions (see figures 16 and 17). A number of seats had been dislodged altogether in the seventh car (see figure 18). Postaccident inspections revealed that the emergency windows in the 11th car, a rebuilt Heritage-class coach, could not be pulled inward as designed because the inside framing around them was too wide. Of the 45 passengers who were interviewed or who responded to questionnaires, 20 reproted they were struck by luggage falling from overhead racks; additionally, 8 of the 45 passengers reported they had difficulty in evacuating because of fallen luggage in the aisles.

Figure 16. Edges of sheetmetal seatback frames exposed by displacement of the cushions.

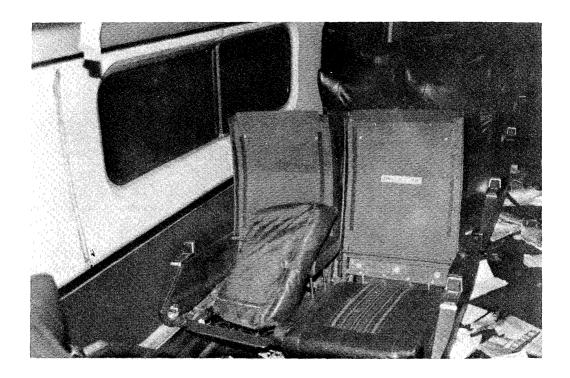
Figure 17. Missing seatback cushions and exposed sheetmetal seatback frames in a coach.

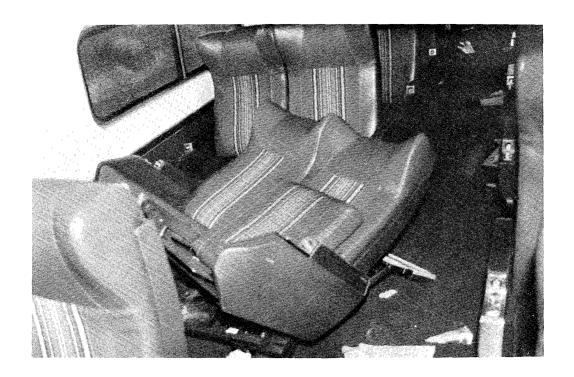
Figure 18. Seats separated from pedestals in the seventh car of train 94.

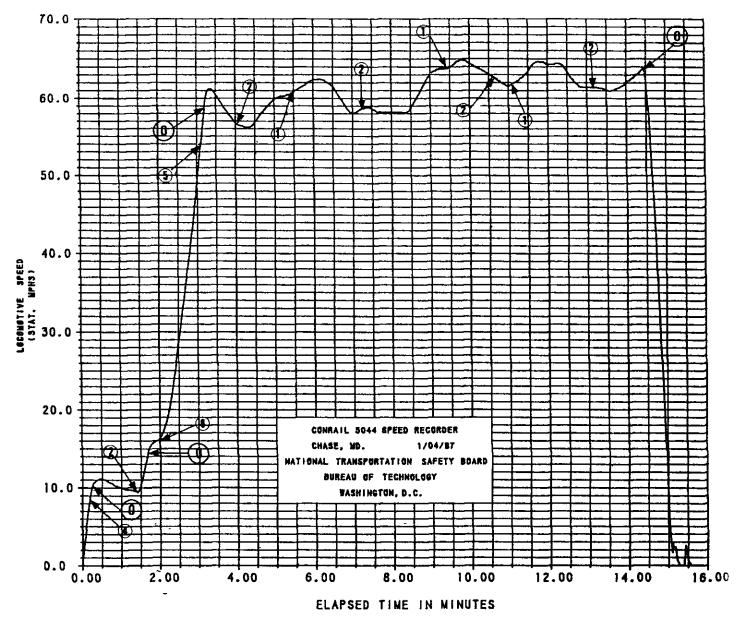
Figure 20: Speed data from the event recorder on Conrail locomotive 5044, the lead unit of train ENS-121, as reproduced in enhanced graphic form. The locations of changes in the throttle setting have been plotted on the graph. Throttle settings are 0 (idle) through 8 (fully open).

The data from the lead unit's recorder indicated that 15 minutes 15 seconds passed between the time train ENS-121 left the vicinity of Bay View yard office and the time it stopped at Gunpow. The times 1:15:15 and 1:30:30 were used as reference points for the start and stop times. At 1:17:15, 2 minutes after the start, the throttle was opened to the eighth or full throttle position; at the time, the train was moving at about 15.5 mph. At 1:18:20 and 52 mph, the throttle was reduced from the eighth to the fifth position, and 10 seconds later, at 57 mph, the was reduced to idle. Acceleration ceased deceleration began at about 60 mph; at about 56 mph, the throttle was opened to the second position.
