RAILROAD ACCIDENT REPORT

RICHMOND, FREDERICKSBURG AND
POTOMAC RAILROAD COMPANY

TRAIN NO. 10/76
DERAILMENT WITH THREE
FATALITIES AND NUMEROUS
PERSONAL INJURIES
FRANCONIA, VIRGINIA
JANUARY 27, 1970

NATIONAL TRANSPORTATION SAFETY BOARD
Washington, D. C. 20591
REPORT NUMBER NTSB-RAR-71-1

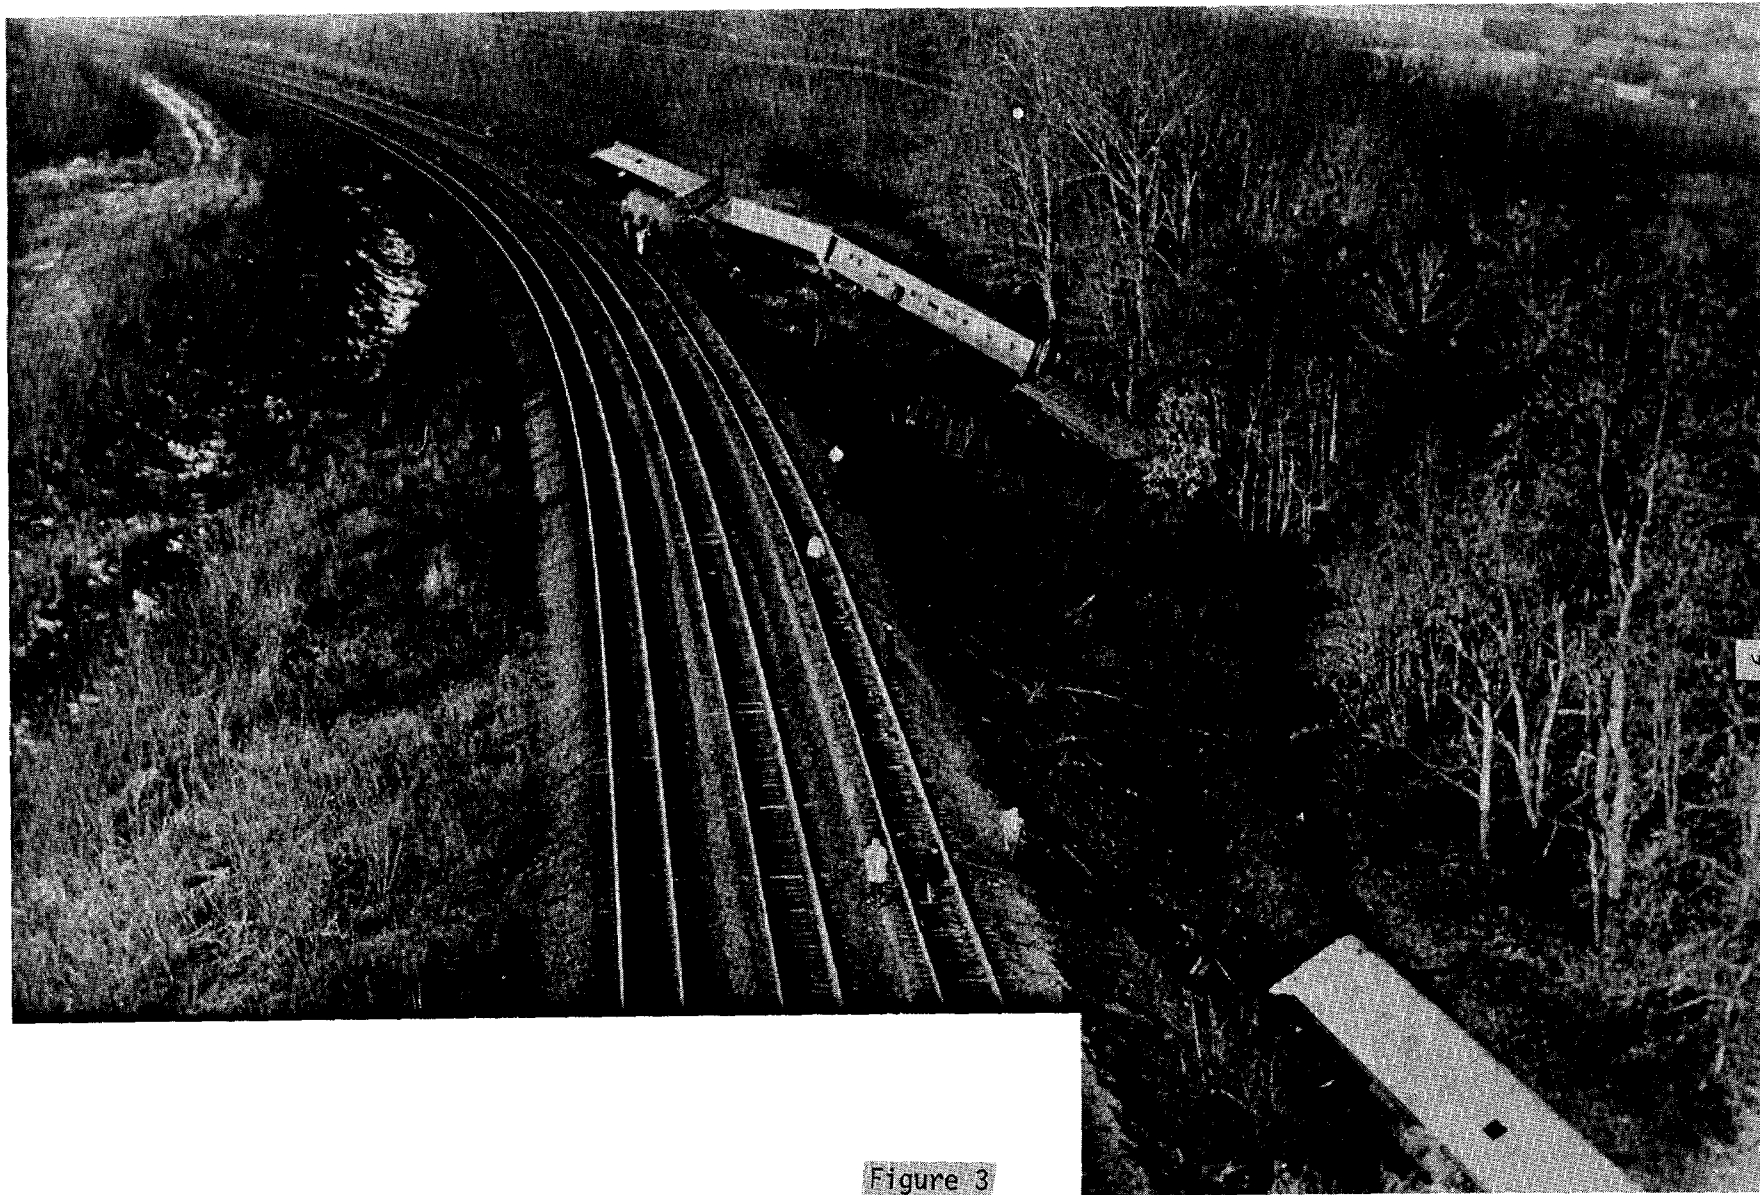
The track was then torn up for approximately 200 feet in the general derailment area. In the area where the cars plunged over the embankment, a joint in the west rail separated because of broken bolts. Figure 3 on page 9 depicts the track damage in the derailment area.

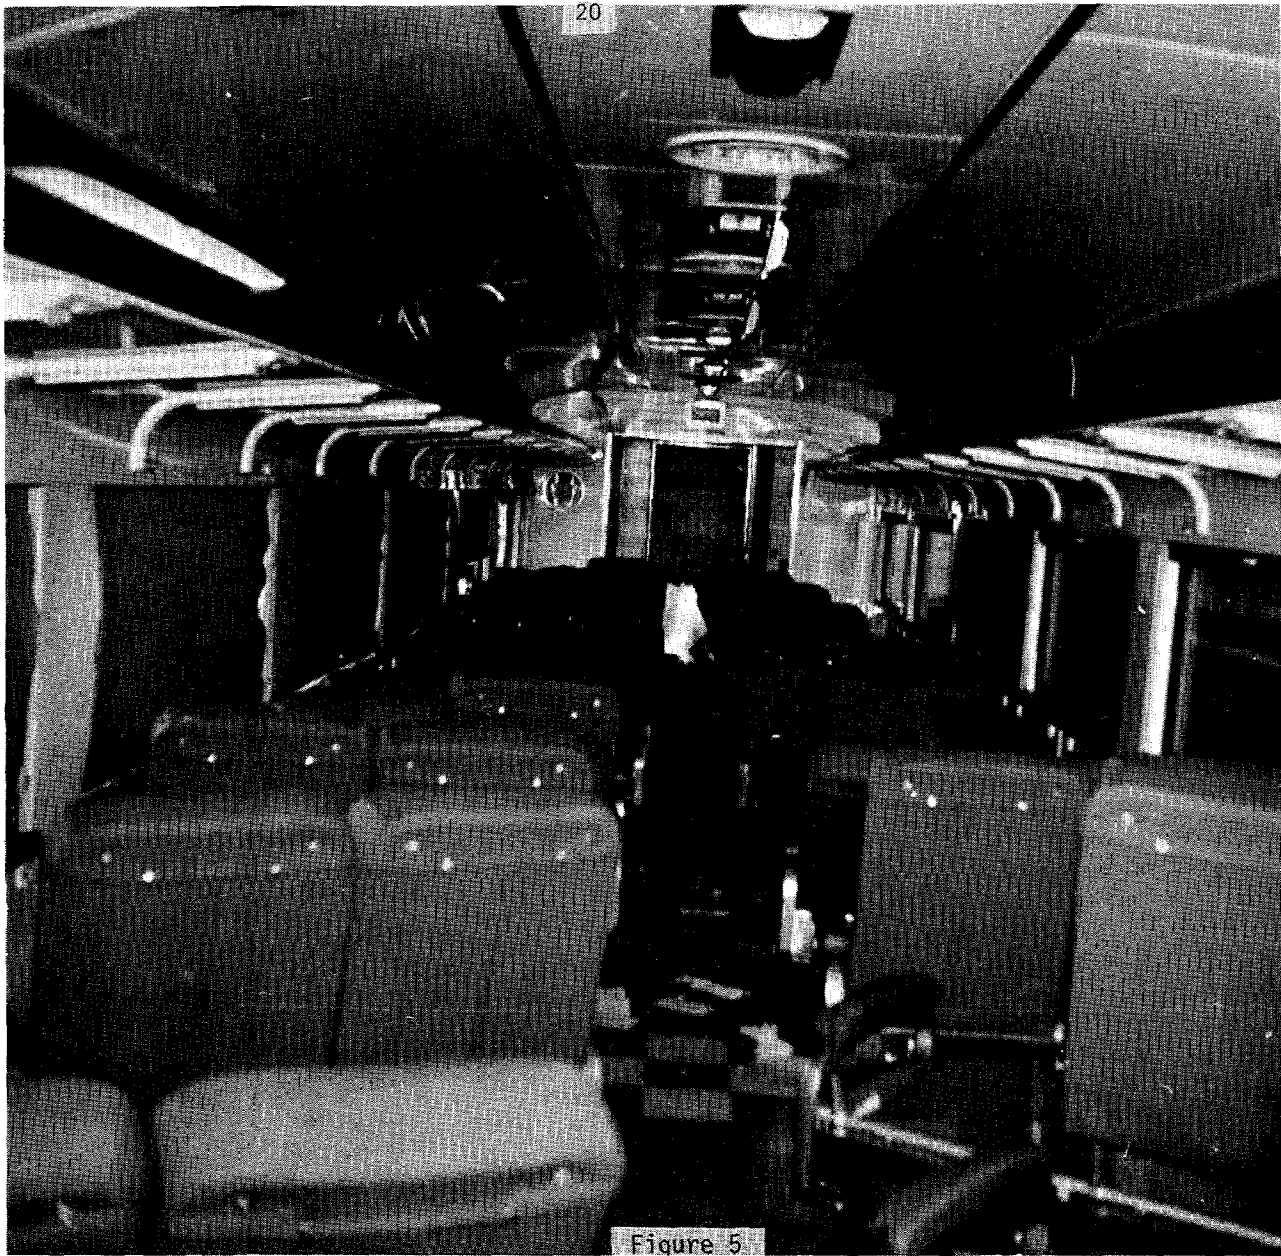
The sixth car incurred considerable structural damage on the west side, including several large indentations in the roof. Creosote marks indicated that some of this damage resulted from striking a telephone pole or uninstalled crossties. There were also dirt and debris lodged in the roof, indicating that the car had completely overturned onto its west side. The six large windows accommodating the main seating area of the coach were broken out on the west side of the car. The west side uncoupling levers on both ends of the sixth car were bent and inoperative and the car incurred considerable underside damage. However, the structure was essentially intact, except for the lost retention capability of the large windows. Figure 4 on page 19 shows the west side of the sixth car after the car was rerailed. Figure 5 on page 20 shows the interior of this car.

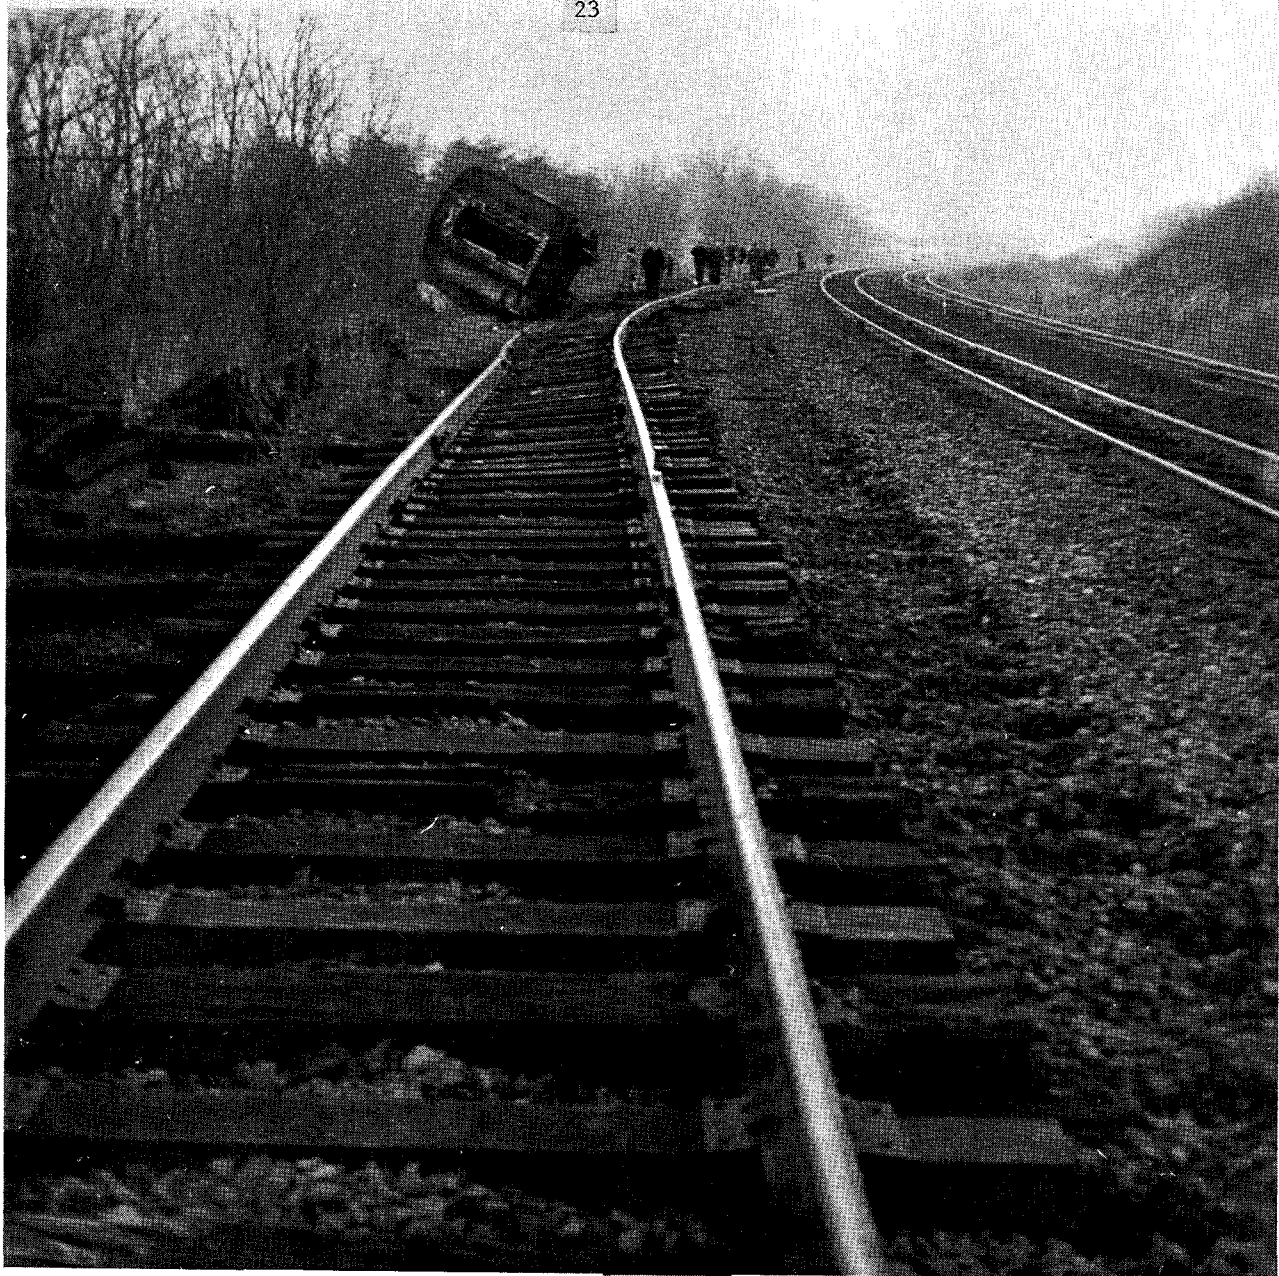
No. 3 track was the only one damaged by the derailment. The damage extended over 4,260 feet, commencing at a location 156 feet south of the first derailed flange mark. The first 200 feet of damage consisted of the track being moved westward on the roadbed. The movement over this area varied proportionately from zero to approximately 4 feet. The track was basically intact through this initial 200 feet. Figure 6 on page 23 shows the track movement.

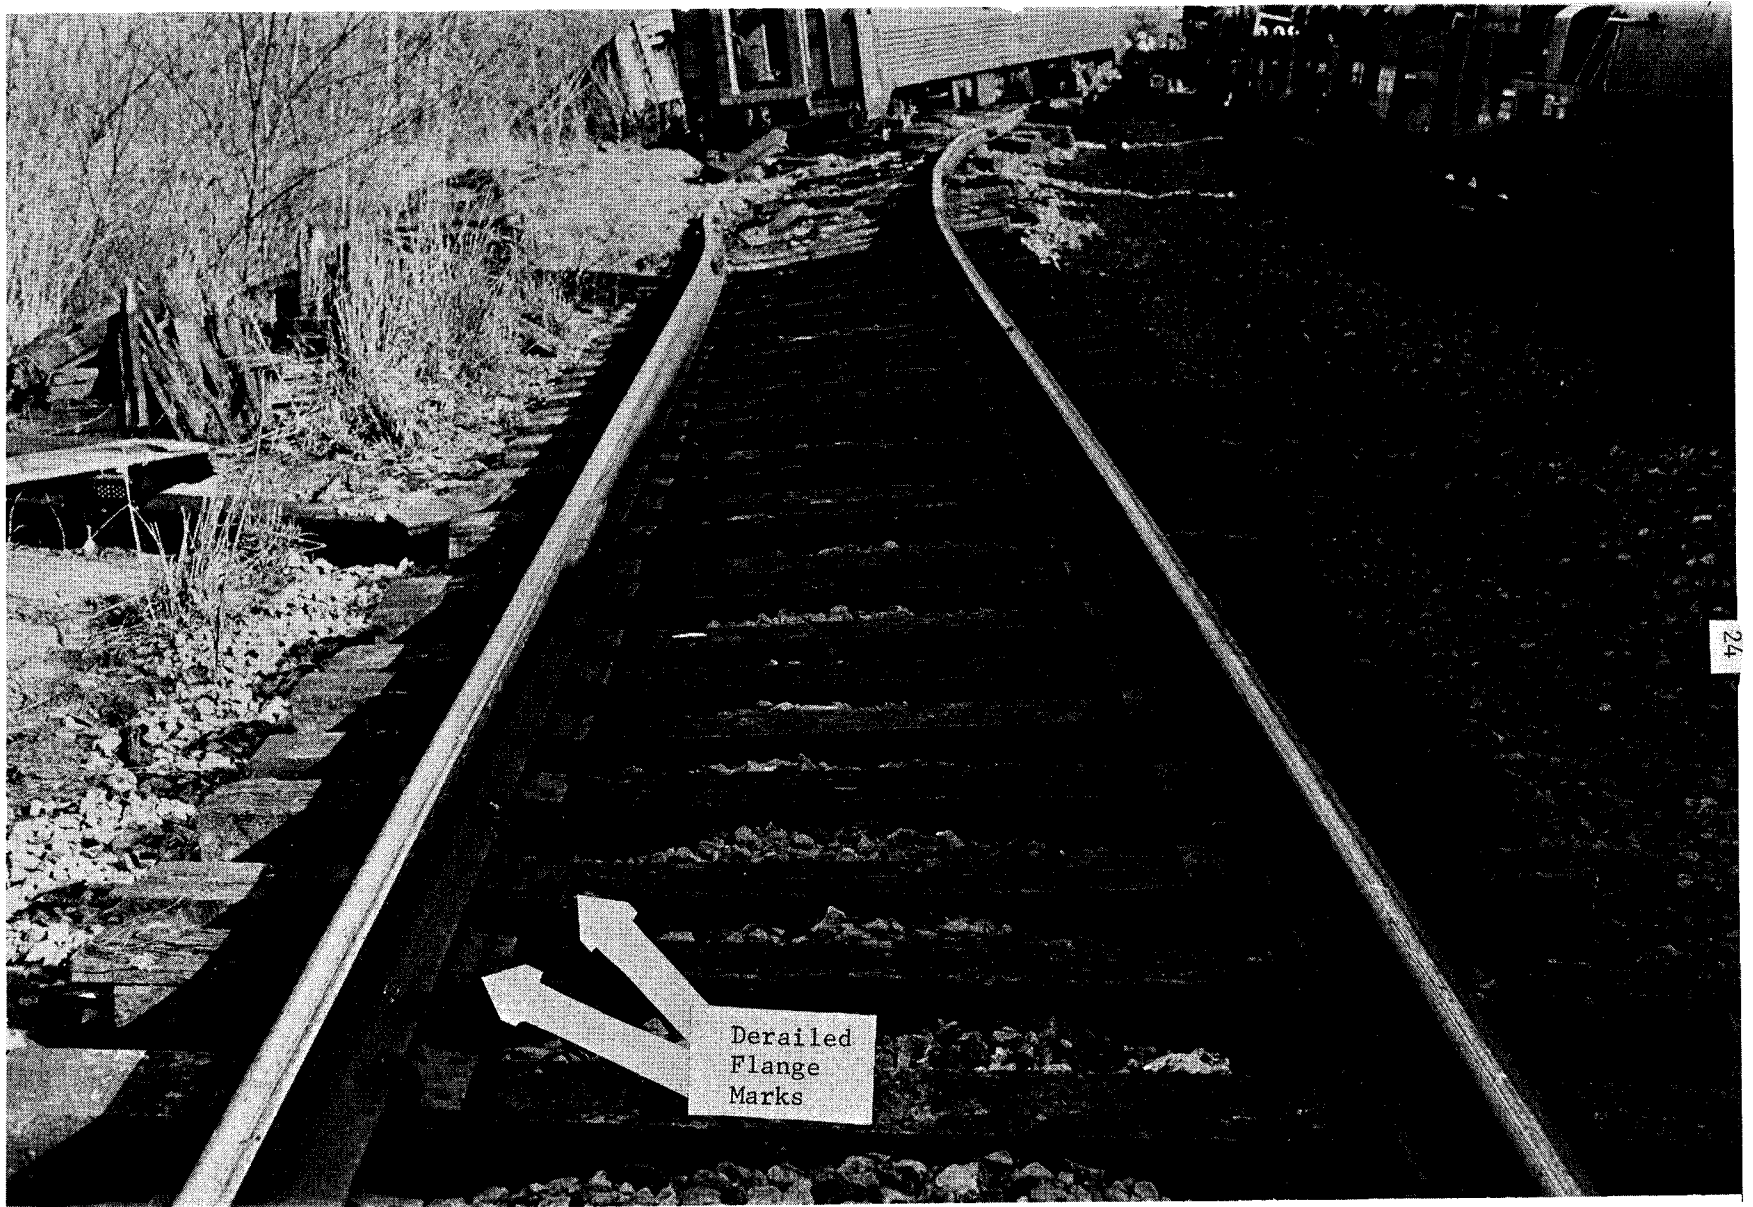
The first unusual marks found on the track structure in the direction of movement were located 5,457 feet north of Franconia. These flange marks were inside of the west rail as shown in Figure 7 on page 24. One wheel flange was following the west rail, riding the edge of the tie plates, while a second wheel was riding the crossties and progressing toward the center of the track. Indications of this movement continued into the general derailment area. North of the general derailment, flange marks on the crossties were noted inside and outside of the west rail, as would be expected by the derailed position of the third through fifth cars.
