INTERSTATE COMMERCE COMMISSION

REPORT OF THE DIRECTOR OF THE BUREAU OF SAFETY CONCERNING AN
ACCIDENT ON THE RICHMOND, FREDERICKSBURG & POTOMAC RAIL-
ROAD NEAR CHERRY HILL, VA., ON DECEMBER 6, 1933.

January 19, 1934.

Inv. No. 1873
 Richmond, Fredericksburg & Potomac
 Cherry Hill, Va.,
 Dec. 6, 1933

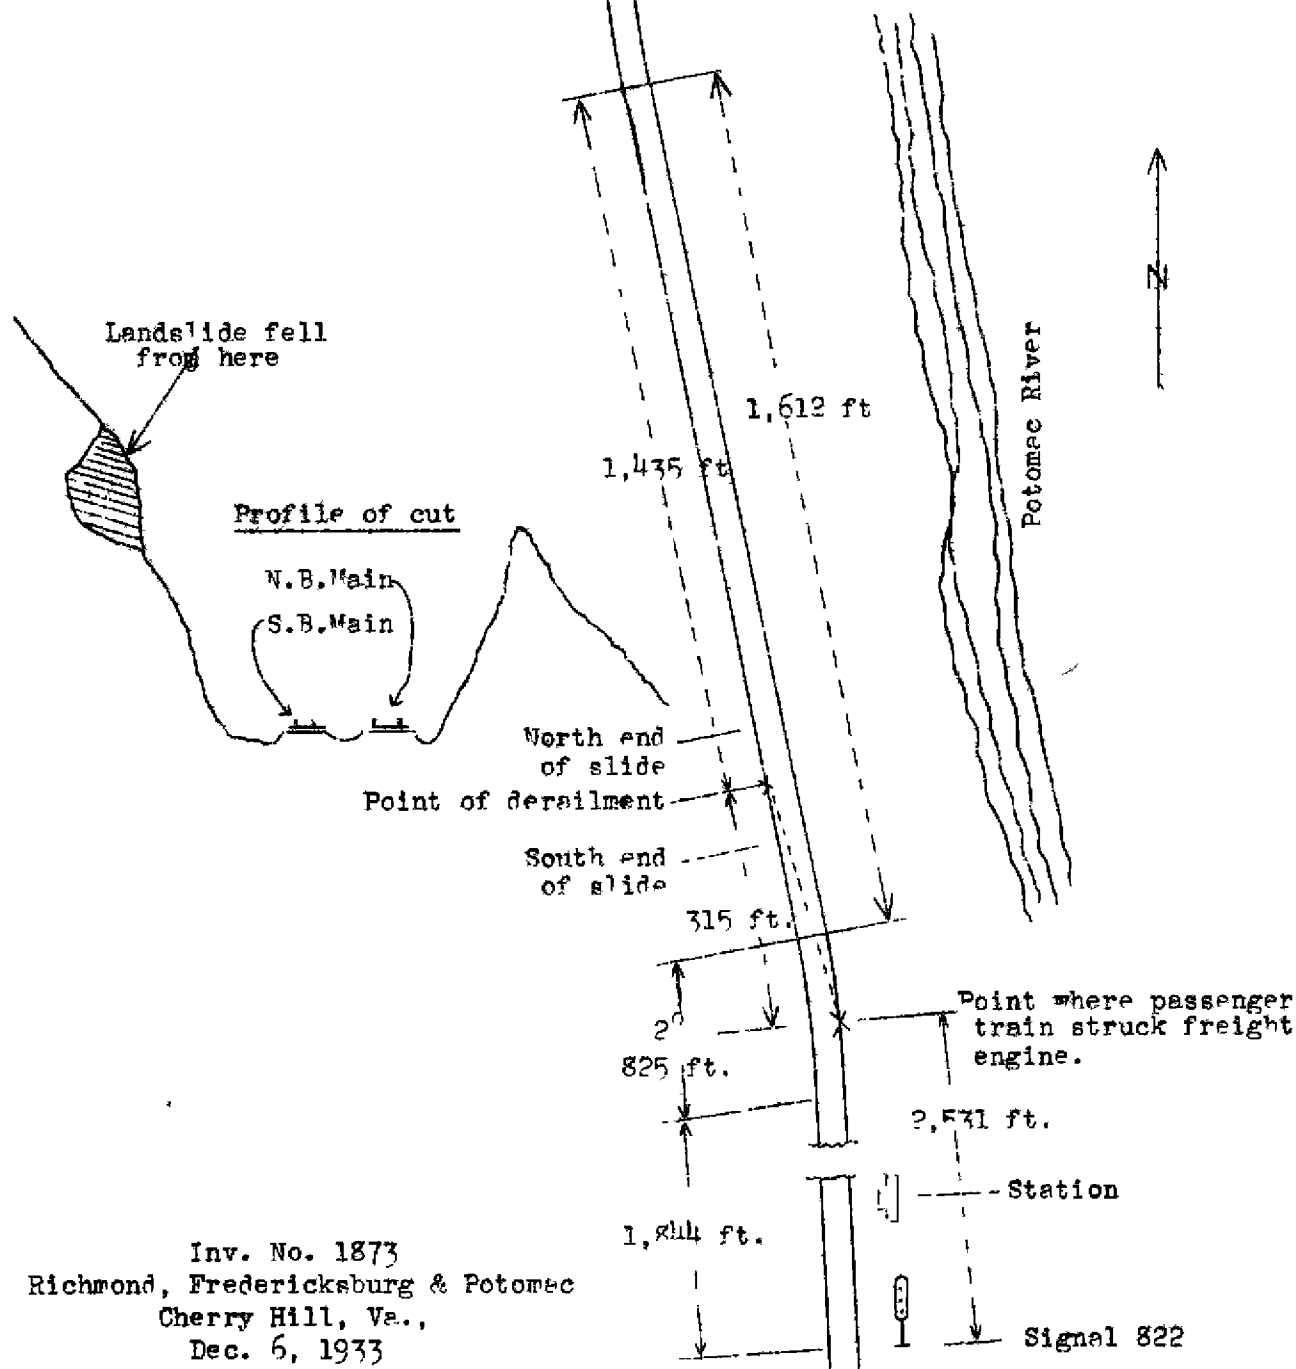
The automatic block signals are of the color-light type; south-bound signal 837 is located 4,853 feet north of the initial point of derailment, while north-bound signal 822 is located 2,845 feet south of that point.

Engine 403, together with its tender, the water car, the first 11 freight cars, and the forward truck of the twelfth car were derailed. Engine 403 was leaning to the east with its tender and the water car behind it; the first 10 cars were empty gondolas and 8 of them were piled up behind the engine and tender and completely blocked the cut. When the derailed equipment of extra 403 was struck by train No. 192 the force of the impact apparently drove engine 403 and its tender backward a distance of about 30 feet and tore the boiler from the frame, this engine being very badly damaged. Engine 306 was hurled over the east bank of the cut and stopped on its left side, partly reversed and headed toward the river east of the right of way, while its tender was standing on and leaning against engine 403. Four of the empty express cars were derailed, the first car overriding the wreckage and stopping diagonally across the front end of engine 403, with the forward end of the car alongside the west bank of the cut; the second car followed engine 306 up the east bank, with the next two cars behind it, but in line with the tracks. The landslide which caused the derailment of the freight train consisted of approximately 375 cubic yards of material from near the top of the west bank of the cut, most of it lodging

between the toe of the slope and the ends of the ties of the south-bound track and pushing that track out of line toward the east a maximum of about 12 inches. The employees killed were the engineman and fireman of train No. 192, while the employees injured were the engineman, fireman and head brakeman of extra 403.
