INVESTIGATION NO. 3225

RICHMOND, FREDERICKSBURG AND POTOMAC  
RAILROAD COMPANY

REPORT IN RE ACCIDENT

AT MILFORD, VA., ON

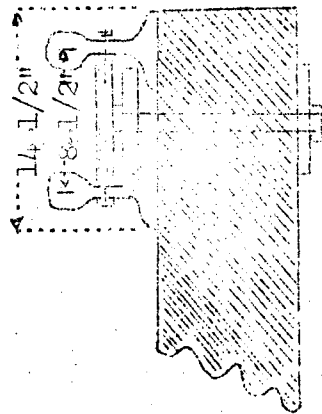
Sketch showing construction of stringer

Examination after the accident disclosed that No. 46 had struck an obstruction on the track. The obstruction consisted of two parallel pieces of 130-pound rail, about 30 feet in length, bolted together with 8 one-inch bolts distributed evenly. The rails were spaced 8-1/2 inches between rail-centers with pipe sleeves over the bolts. A triangular section of the web, 18 inches in length, was cut away from each end of each rail and the head was bent downward to the base to form a ramp at each end. This pair of rails weighed approximately 2,600 pounds. These rails were broken into several pieces, most of which were recovered. The largest piece, consisting of 17 feet 3 inches of each rail, was found between the northward main track and the siding and about 50 feet north of the point of derailment. The north end was embedded in the ballast under the west ends of the ties of the siding. The south end was near the northward main track. The second largest piece, consisting of one rail 9 feet 10 inches in length, was found 28 feet east of the northward main track and about 350 feet north of the point of derailment. A third piece, consisting of one rail 9 feet in length, was found on the northward main track and about 820 feet north of the point of derailment. Smaller pieces of the rail were found at various locations throughout a distance of about 900 feet north of the point of derailment.

pipe that connected the water mains to the water column. The rails involved in the accident were used as a stringer over the trench and outside the east rail of the northward main track to support the track structure. A similar stringer was used outside the west rail of this track. The stringer outside the east rail was placed on the tops of the ties and was clamped to the ties with eighteen clamps. Each clamp consisted of two 1-inch steel plates, 14-1/2 inches by 7 inches, one of which was placed under the ties and the other between the two rails on the upper side of the base, and they were bolted together with two 1-inch by 12-1/2-inch bolts. The pipe line was laid in the trench, then the trench was filled on January 7. On the day of the accident a force consisting of a foreman and four workmen were engaged in removing the stringers from the ties. The stringer on the west side of the track was unclamped and removed. Then the clamps were removed from the stringer on the east side of the track. The south end of the stringer was near the water-column foundation, and this stringer was moved northward on the ties a distance of about 10 feet to clear the foundation. This movement was effected by prying with bars against the spacer bolts. When No. 46 was about 3,000 feet south of the point where the derailment occurred, the workmen attempted to pry the stringer off the ends of the ties. The level of the ballast between the northward main track and the siding was about 12 inches below the tops of the ties in the northward main track. The north end of the stringer was pried eastward off the ties to the ballast, but the stringer became lodged against the ties near its center. In this position, the south end was above and near the east-running rail, and was in position to be struck by the pilot, the pedestal binder-bolts on the trailer truck, and the train-control-receiver housing on the tender. These blows moved the south end of the stringer northward and westward into position where it was struck by the right front wheel of the first car, then driven under the truck, which was derailed.
