REPORT NO. 3550
THE RIVER TERMINAL RAILWAY COMPANY
IN RE ACCIDENT
AT CLEVELAND, OHIO, ON
NOVEMBER 30, 1953

Date: November 30, 1953

Kind of accident: Head-end collision

Report No. 3550
 The River Terminal Railway
 Cleveland, Ohio
 November 30, 1953

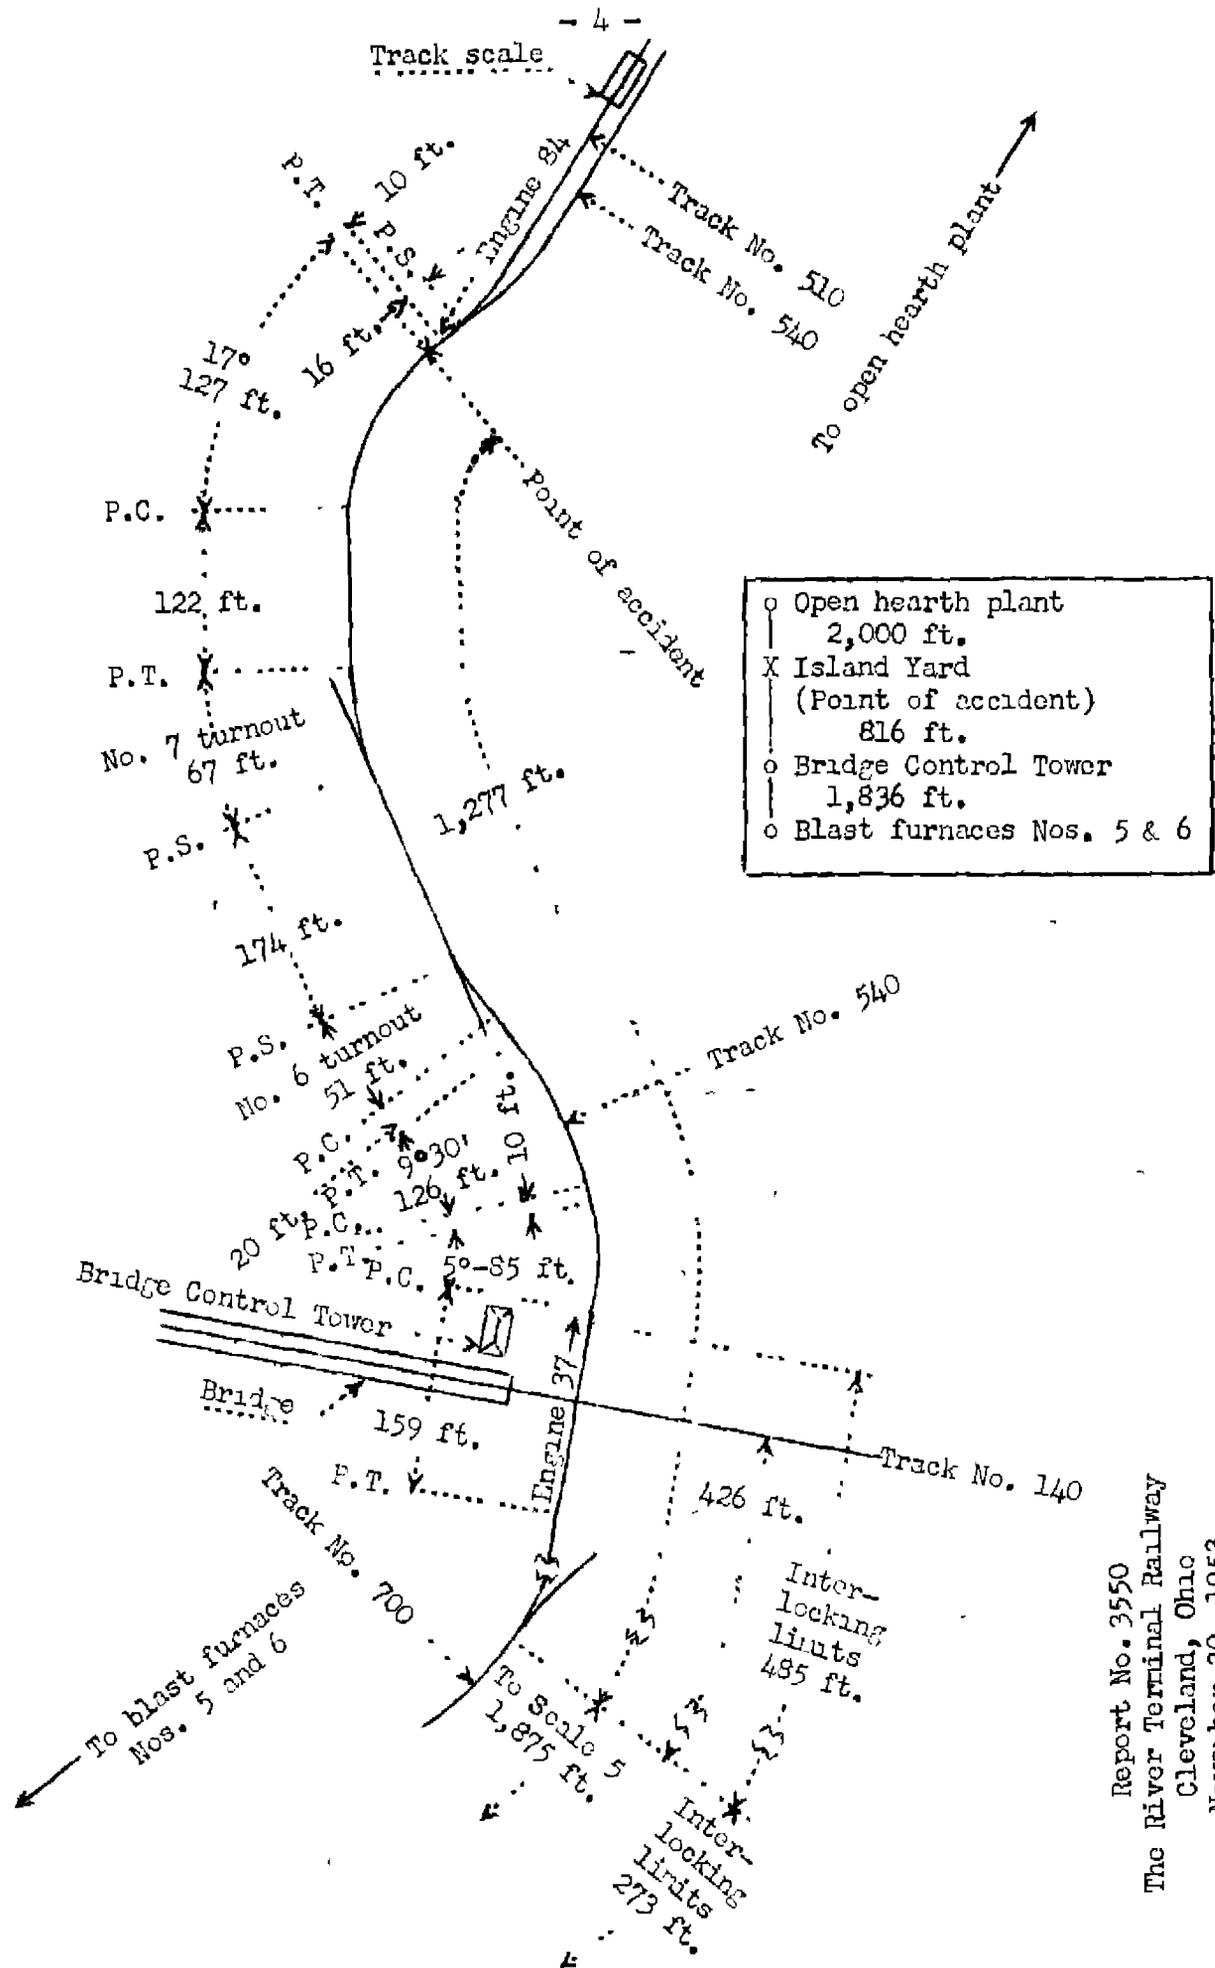
| X | Island Yard | (Point of accident) |

This accident occurred in the Island Yard of the River Terminal Railway at Cleveland, Ohio. This carrier performs switching and transfer service for steel plants of the Republic Steel Company located within the city. Train and engine movements are governed by operating rules of the carrier. The yard of blast furnaces Nos. 5 and 6, Island Yard, and the yard of an open hearth steel plant, together with connecting trackage, are located on the east side of the Cuyahoga River. A track scale designated as Scale No. 5 is located on a yard track at a point approximately 500 feet north of the gate of the plant of blast furnaces Nos. 5 and 6. A running track designated as track No. 700 connects the north ends of yard tracks in the vicinity of this plant immediately north of Scale No. 5 and extends northward and is parallel to the east bank of the river. A running track designated as track No. 540 diverges from track No. 700 at a power-operated switch located 1,875 feet north of Scale No. 5. Track No. 700 extends in a northeasterly direction from this point, and track No. 540 extends northward via Island Yard to the yard of the open hearth steel plant. The accident occurred on track No. 540 at a point 1,277 feet north of the south switch. In Island Yard a track scale is located on track No. 510. The south switch of this track is located in track No. 510 immediately north of the point of accident. From the south on track No. 540 there are, in succession, a tangent 159 feet in length, a 5° curve to the left 85 feet, a tangent 10 feet, a 9°30' curve to the left 126 feet, a tangent 20 feet, a No. 6 turnout to the right 51 feet, a tangent 174 feet, a No. 7 turnout to the right 57 feet, a tangent 122 feet, and a 17° curve to the right 127 feet to the point of accident and 10 feet northward. The grade for north-bound movements on track No. 540 is, successively, 2.22 percent ascending a distance of 293 feet, 1.05 percent ascending 71 feet, 0.42 percent descending 100 feet, 1.34 percent descending 214 feet, 1.18 percent descending 283 feet, 0.59 percent ascending 105 feet, 1.07 percent ascending 115 feet, and 1.63 percent ascending 33 feet to the point of accident and 152 feet beyond.
