INVESTIGATION NO. 2469
THE SEABOARD AIR LINE RAILWAY COMPANY
AND
THE ATLANTIC COAST LINE RAILROAD COMPANY
REPORT IN RE ACCIDENT
AT ZEPHYRHILLS, FLA., ON
DECEMBER 19, 1940

February 13, 1941

Accident at Zephyrhills, Fla., on December 19, 1940, caused by
failure of Atlantic Coast Line train to obey interlocking
signal indications.

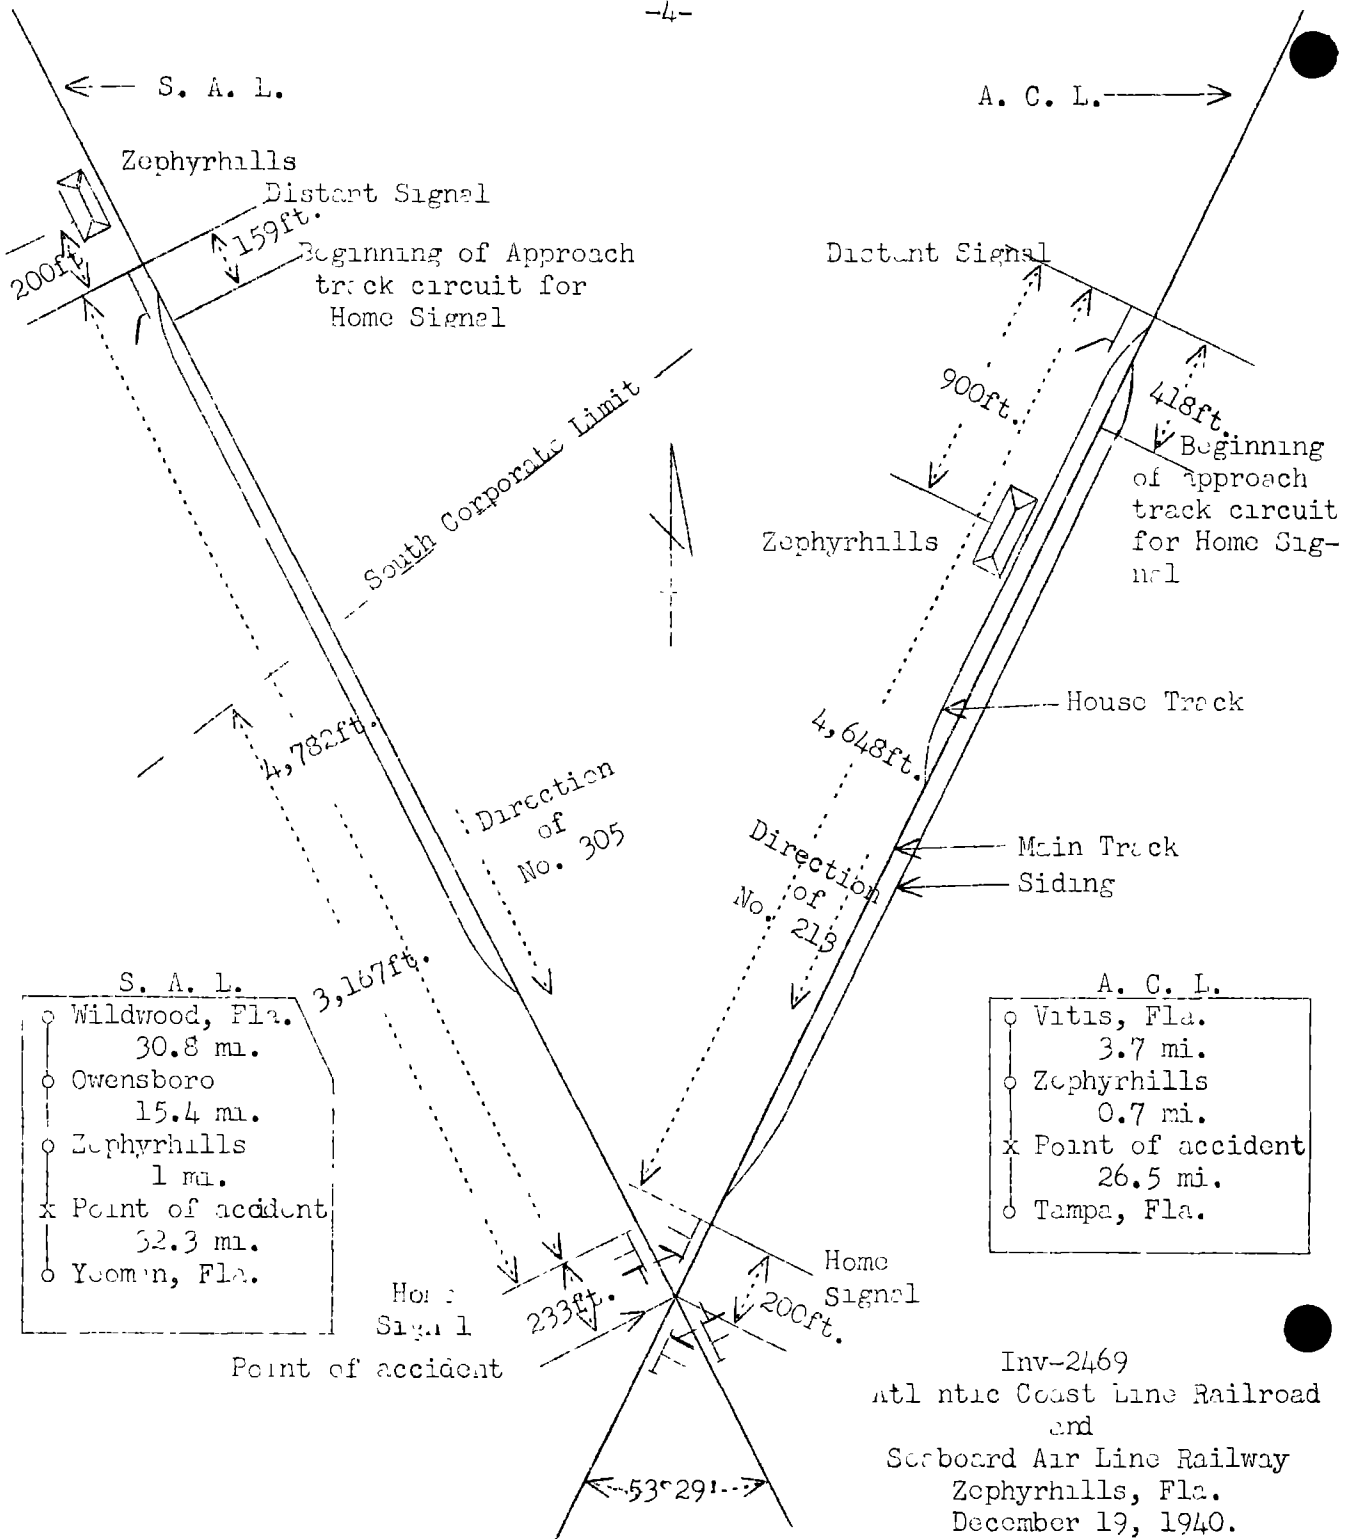
Inv-2469
Atlantic Coast Line Railroad
and
Seaboard Air Line Railway
Zephyrhills, Fla.
December 19, 1940.

The accident occurred at the intersection of the Seaboard Air Line Railway and the Atlantic Coast Line Railroad, herein-after referred to, respectively, as the S. A. L. and the A. C. L. Zephyrhills is located on that part of the North Florida Division of the S. A. L. designated as the Wildwood Sub-Division which extends between Wildwood and Yeoman, Fla., a distance of 79.5 miles, and on that part of the Ocala District of the A. C. L. which extends between Vitis and Tampa, Fla., a distance of 30.9 miles. Both are single-track lines. On the S. A. L. trains are operated by timetable, train orders and a manual block system for first-class trains or trains carrying passengers following first-class trains or trains carrying passengers. On the A. C. L. trains are operated by timetable and train orders; there is no block system in use. On both railroads time-table directions are north and south; however, according to compass directions, the S. A. L. track extends from northwest to southeast and the A.C.L. track extends from northeast to southwest; these tracks intersect at an angle of $33^{\circ}23'$. The crossing is located approximately 5,215 feet south of the S. A. L. station and 3,948 feet south of the A. C. L. station.

Movements over the crossing are governed by an automatic interlocking. The home signals are of the 2-position, 2-arm, upper quadrant, semaphore type, approach lighted; the bottom arms are fixed. The distant signals are of the 1-arm, semaphore type; they are inoperative and are fixed in a 45-degree position; they are not lighted but are equipped with yellow reflex lenses. The distant and the home signals governing southward movements on the S. A. L. are located 5,015 feet and 233 feet, respectively, north of the crossing. The day aspects and the indications of these signals are as follows:

The distant and the home signals governing southward movements on the A. C. L. are located 4,848 feet and 200 feet, respectively, north of the crossing. The day aspects and the indications of these signals are as follows:

Each home signal normally displays a stop indication and clears automatically upon the approach of a train. Track circuits in approach of the home signals are provided on each line. On the S. A. L. the approach circuit for southward movements extends from a point 4,323 feet north of the southward home signal, and on the A. C. L. from a point 4,250 feet north of the southward home signal. The interlocking is so arranged that when an approaching train on either line enters its respective approach track circuit, provided there is no conflicting train movement on the other line and the tracks within the home-signal limits on both lines are unoccupied, the home signal automatically displays an indication for movement of the train over the crossing. The first train to enter its approach circuit establishes priority over a train on the other line and the home signal on the opposing line remains at stop until the first train has completed its movement through the interlocking. The circuits are so arranged that if two trains enter their approach circuits simultaneously all home signals remain in stop position.
