INTERSTATE COMMERCE COMMISSION
WASHINGTON

REPORT OF THE DIRECTOR
BUREAU OF SAFETY

ACCIDENT ON THE
SEABOARD AIR LINE RAILWAY

DECEMBER 7, 1937.

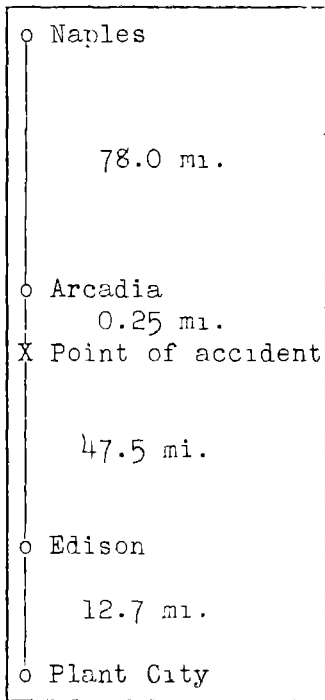
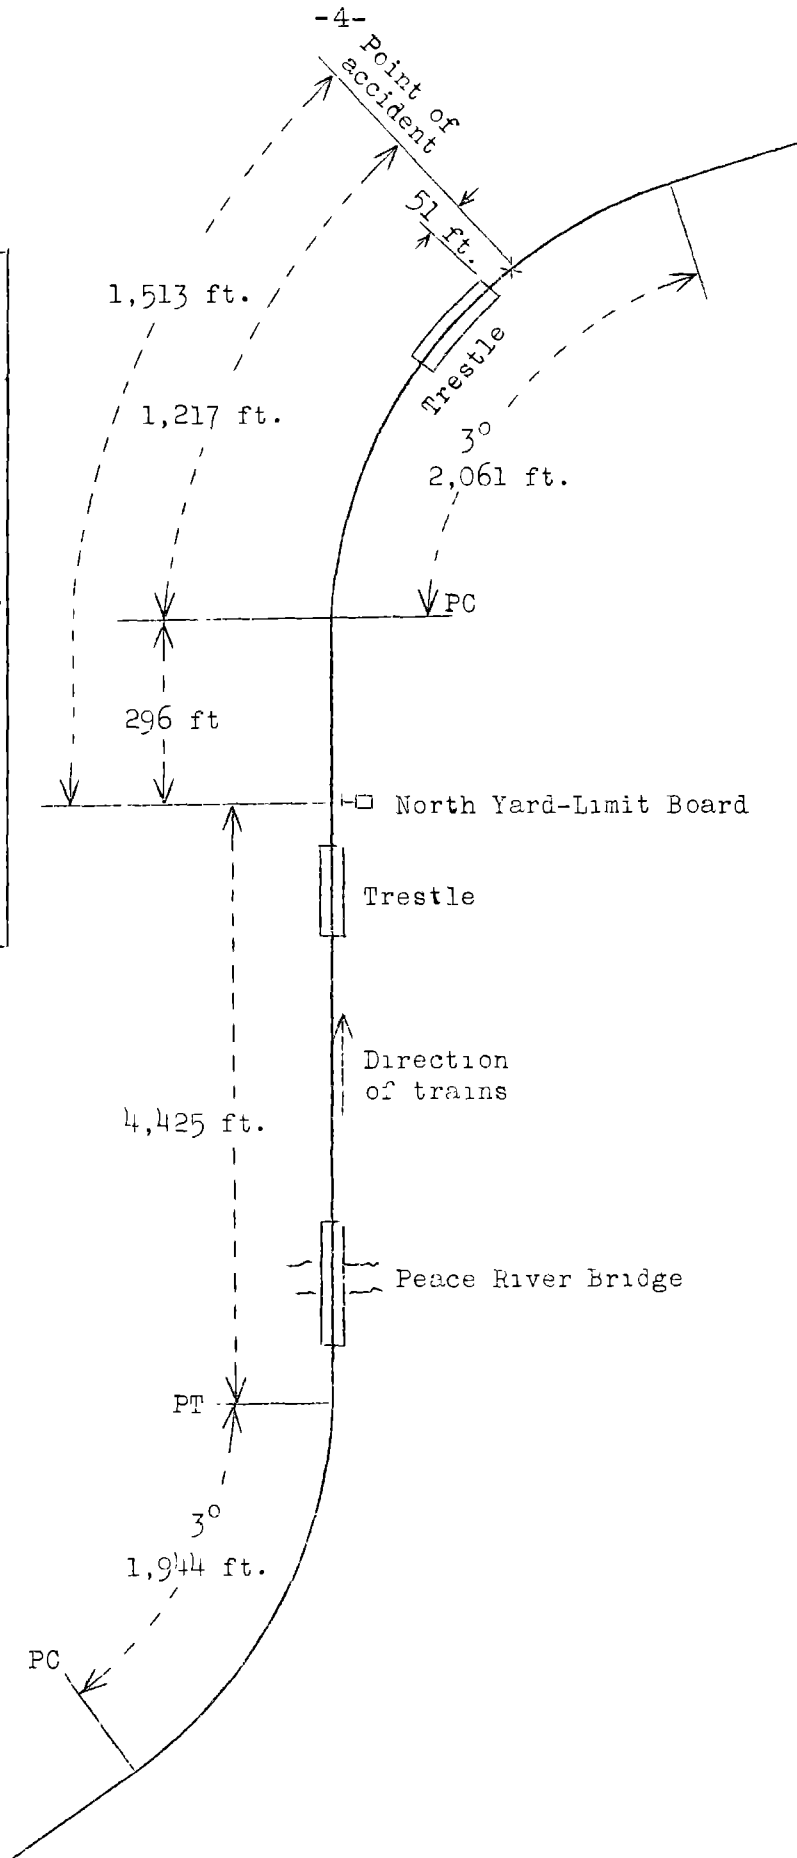
Inv No. 2233
 Seaboard Air Line Ry
 Arcadia, Florida
 Dec 7, 1937

Engine 930 partly telescoped the caboose of Extra 540, and the caboose, engine and tender turned over to the east of the track and lay on their left sides about 12 or 14 feet from the track and parallel to it. The first car in Extra 930 stopped on its left side to the east of, and at about right angles to, the track. The forward truck of the second car was derailed. The employees killed were the engineman and fireman of Extra 930.

The evidence is to the effect that Extra 540 had been standing with the caboose 1,513 feet inside the yard limits for about 20 minutes when it was struck by Extra 930. Rule 93 in part, reads as follows:
