INVESTIGATION NO. 3226  
SEABOARD AIR LINE RAILROAD COMPANY  
REPORT IN RE ACCIDENT  
AT BAY LAKE, FLA., ON  
JANUARY 11, 1949

Railroad: Seaboard Air Line  
Date: January 11, 1949  
Location: Bay Lake, Fla.  
Kind of accident: Derailment  
Train involved: Passenger  
Train number: 46  
Engine numbers: Diesel-electric units 3010,  
3103 and 3017  
Consist: 16 cars  
Speed: 75 m. p. h.  
Operation: Signal indications  
Track: Single, tangent, level  
Weather: Clear  
Time: 6.11 p. m.  
Casualties: 1 killed; 76 injured  
Cause: False flange resulting from  
slid-flat driving wheel

Accident at Bay Lake, Fla., on January 11, 1949, caused  
by a false flange resulting from a slid-flat  
driving wheel.

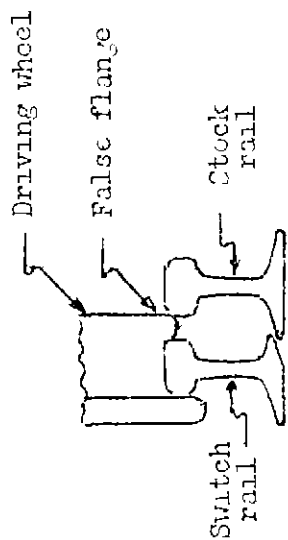
Cross section of switch rail and stock rail  
12 feet from point-of-switch

Examination after the accident disclosed that the inside spikes holding the west stock rail, the closed-point side, had been partially pulled, the tieplates had been forced outward on the ties, and the stock rail had been canted and forced outward. The switch was lined for main-track movement and locked. The gap between the switch point and the stock rail was about 1-1/2 inches. At a point about 12 feet south of the west switch point, where the distance between the gage sides of the switch rail and the stock rail was 3-3/4 inches, the gage side of the stock rail was scraped to a depth of 3/8-inch below the top of the rail. This scraping mark continued to a point about 44 feet northward, where one wheel had dropped to the tops of the ties inside the west rail. The wheel continued on the ties inside the west rail to a point about 85 feet north of the switch, where the joint bars were torn loose and where the general derailment occurred.
