INTERSTATE COMMERCE COMMISSION

REPORT OF THE DIRECTOR OF THE BUREAU OF SAFETY IN RE
INVESTIGATION OF AN ACCIDENT WHICH OCCURRED ON
THE SEABOARD AIR LINE RAILWAY AT SCOTT, FLA.,
ON DECEMBER 11, 1931.

February 3, 1932.

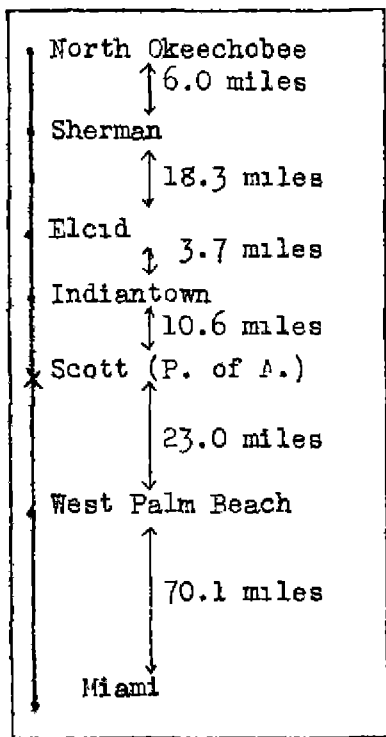
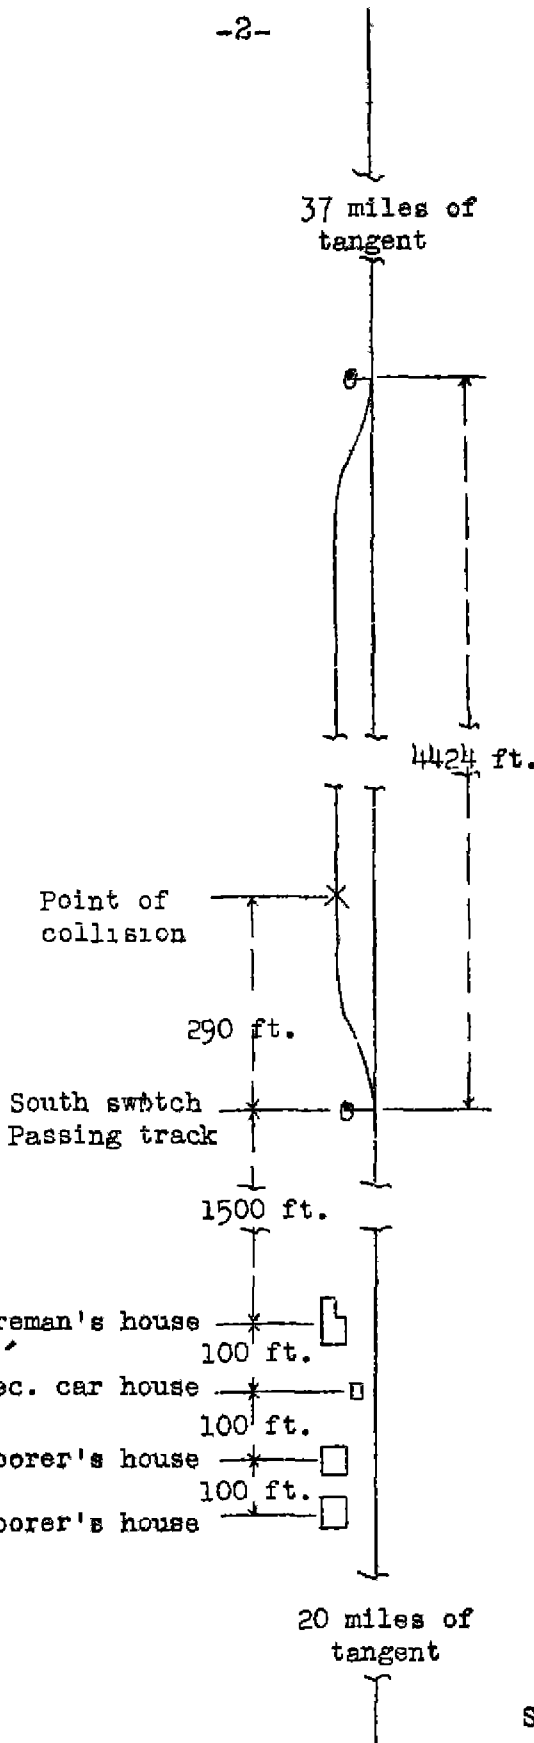
Inv. No. 1743
 Seaboard Air Line Ry.,
 Scott, Fla.,
 Dec. 11, 1931.

This accident occurred on the West Palm Beach Subdivision of the North Florida Division, extending between Miami and North Okeechobee, Fla., a distance of 131.7 miles, in the vicinity of the point of accident this is a single-track line over which trains are operated by time-table and train orders, no block-signal system being in use. The accident occurred on the passing track at Scott, at a point about 290 feet north of the south switch, this is a facing-point switch for north-bound trains and leads off the main track through a No. 10 turnout to the west, the passing track being 4,424 feet in length. Approaching from either direction the track is tangent for 20 miles or more, while the grade for several miles in each direction is practically level. The view is unobstructed.

The switch stand is of the Weir intermediate type, located on the west side of the track, equipped with switch lamp and banners; normal night indications are green, with the white, diagonal, pointed-end banner displayed, when the switch is closed, while the switch lamp shows red, with the red, horizontal, double-disk banner displayed, when the switch is open. At the time of the accident, however, the switch lamp was not burning.
