INVESTIGATION NO. 2926
SEABOARD AIR LINE RAILWAY COMPANY
REPORT IN RE ACCIDENT
AT SOUTH ABERDEEN, N. C., ON
AUGUST 25, 1945

Railroad: Seaboard Air Line

Location: South Aberdeen, N. C.

Kind of accident: Side collision

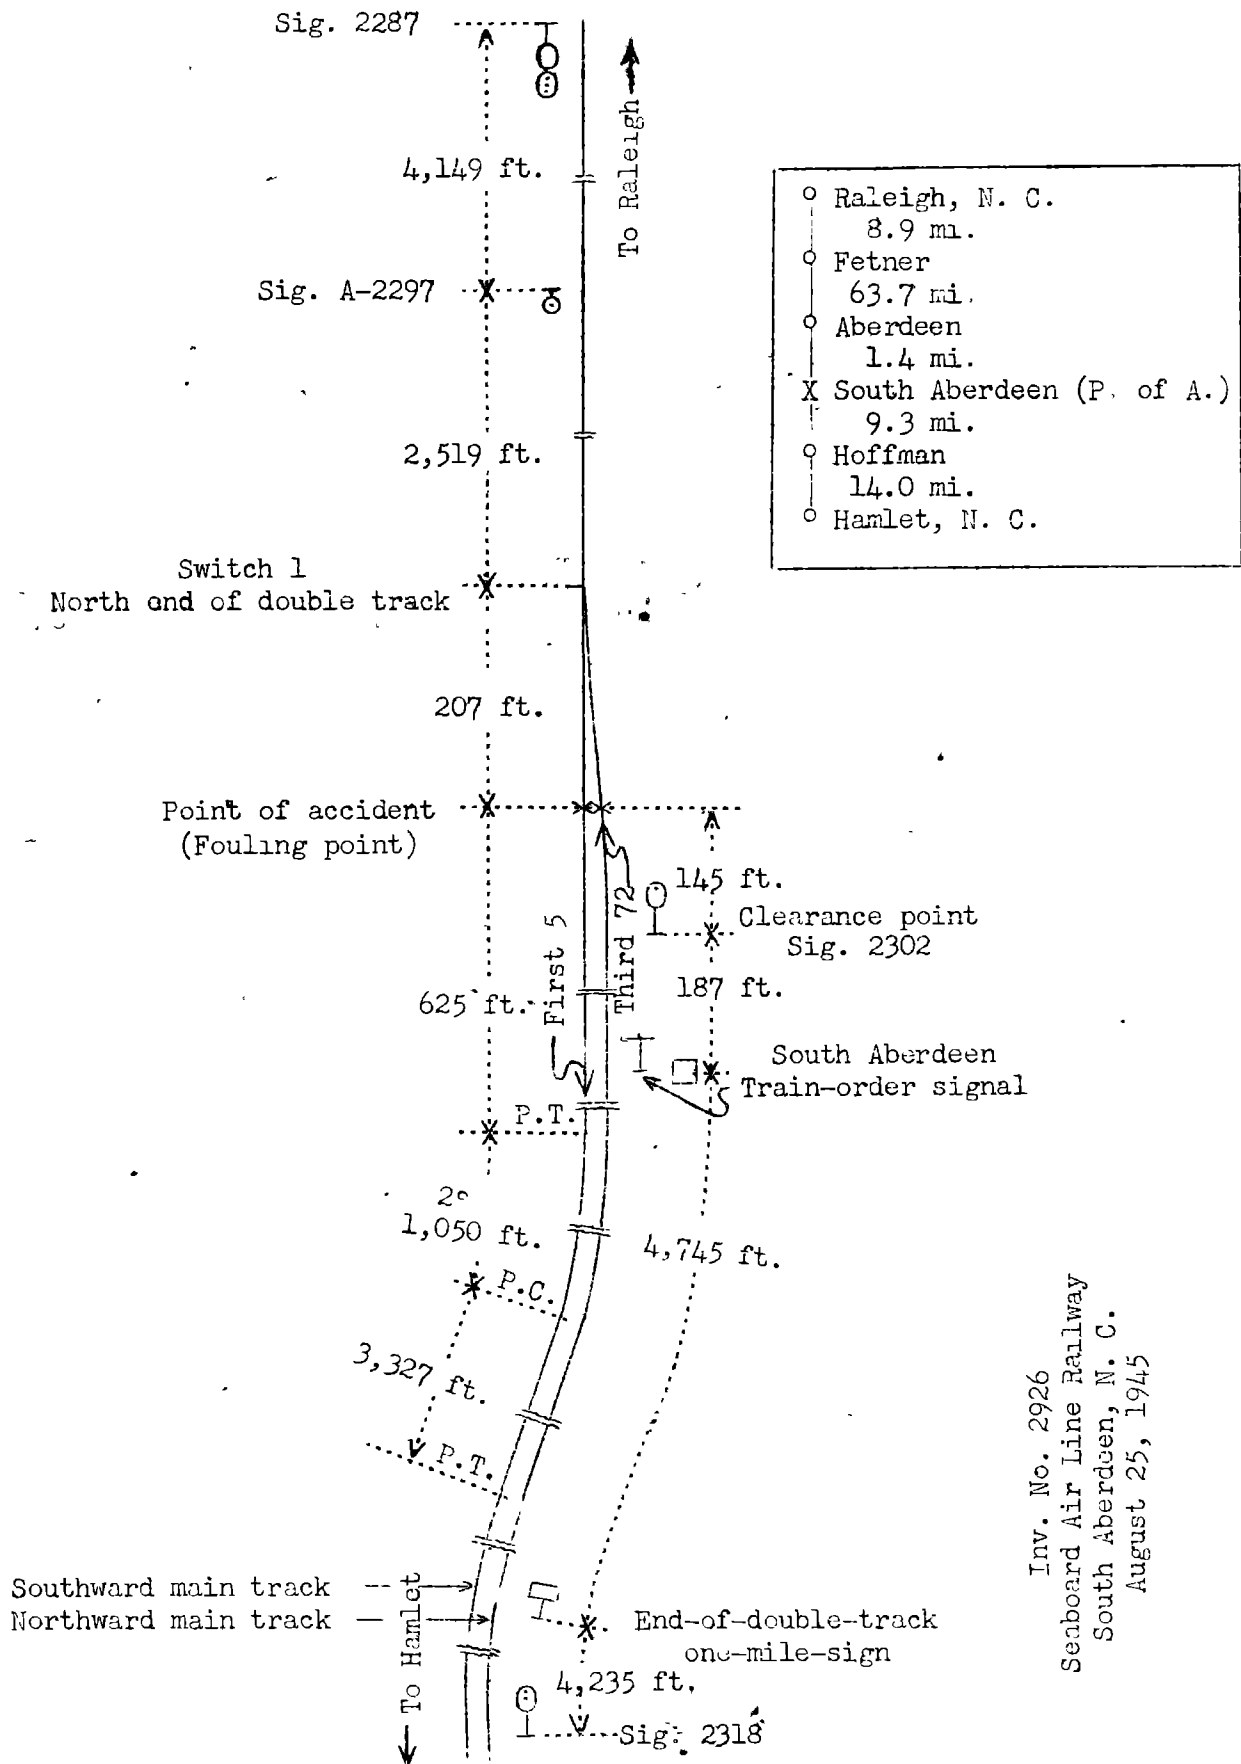
Inv. No. 2926
 Seaboard Air Line Railway
 South Aberdeen, N. C.
 August 25, 1945

The force of the impact separated the seventh car of First 5 from the eighth, the ninth car from the tenth and the tenth car from the eleventh. The rear truck of the seventh car and the eighth to the eleventh cars, inclusive, of First 5 and the engine of Third 72 were derailed. The eighth, ninth and tenth cars of First 5 stopped on their right sides on the west side of the southward main track, and were badly damaged. The remainder of the derailed equipment stopped practically upright and in line with the track, and this equipment was considerably damaged.

It is found that this accident was caused by failure properly to control the speed of Third 72 approaching the end of double track and in accordance with signal indications.
