INVESTIGATION NO. 3051
SEABOARD AIR LINE RAILROAD COMPANY
REPORT IN RE ACCIDENT
AT SUFFOLK, VA., ON
DECEMBER 22, 1946

Kind of accident: Rear-end collision

Inv. No. 3051
Seaboard Air Line Railroad
Suffolk, Va.
December 22, 1946

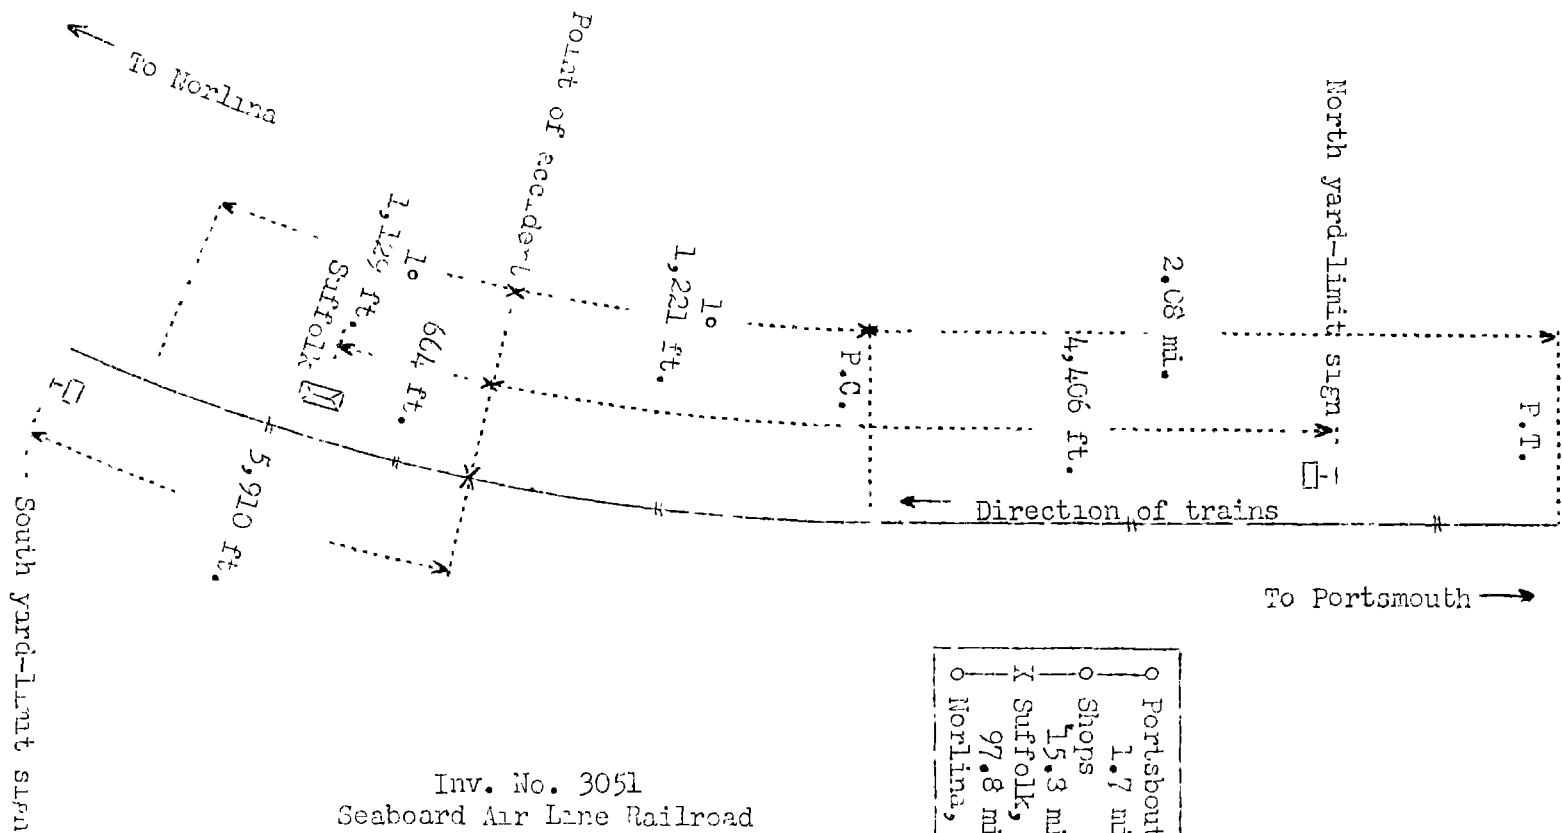
This accident occurred on that part of the Virginia Division extending between Portsmouth, Va., and Norlina, N. C., 115.3 miles, a single-track line, over which trains are operated by timetable and train orders, and a manual-block system for following first-class trains and trains carrying passengers. The accident occurred within yard limits on the main track at Suffolk, 17.5 miles south of Portsmouth, at a point 4,406 feet south of the north yard-limit sign, 664 feet north of the station and 5,910 feet north of the south yard-limit sign. From the north there is a tangent 2.08 miles in length, which is followed by a 1° curve to the right 1,221 feet to the point of accident and 1,129 feet southward. The grade for south-bound trains varies between 0.2 percent and 0.6 percent ascending throughout a distance of 3,180 feet, then it is, successively, 0.1 percent descending 505 feet, 0.2 percent descending 1,000 feet and 0.3 percent descending 681 feet to the point of accident and 324 feet southward.
