NATIONAL TRANSPORTATION SAFETY BOARD

RAILROAD/HIGHWAY ACCIDENT REPORT

SEABOARD COAST LINE/AMTRAK
PASSENGER TRAIN/PICKUP TRUCK COLLISION
PLANT CITY, FLORIDA
OCTOBER 2, 1977

Adopted: December 8, 1978

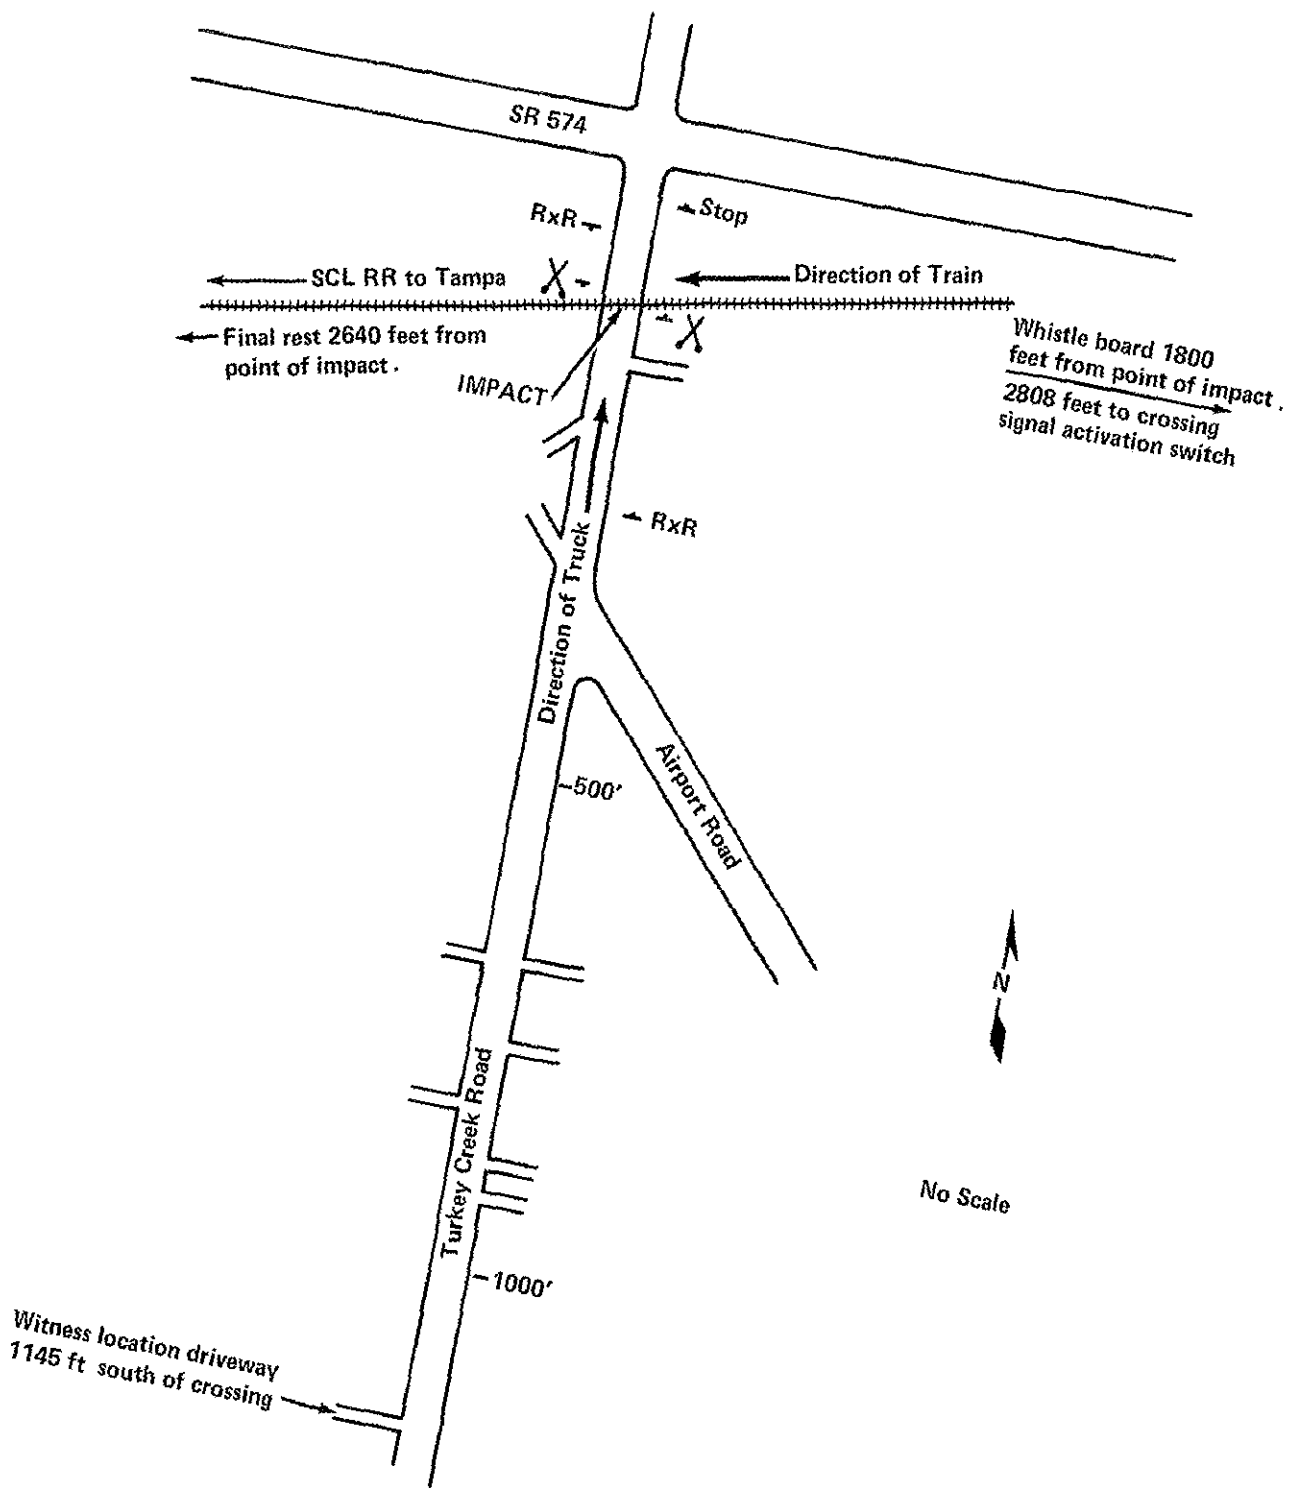
Figure 1. Accident diagram.

The fireman and engineer of the train saw the truck approach the tracks when the train was about 600 feet from the crossing. (See figure 1.) At that time, the engineer began sounding a series of short blasts of the train horn. When the train was 100 feet (1 second) from the crossing, the engineer realized that the truck would not stop and he set the train brakes in emergency application. The truck moved onto the track without stopping and was struck in the middle on the right side. (See figure 2.) The front of the locomotive penetrated the truck cab just ahead of the "B" pillar. The truck wrapped around the front of the locomotive, and the metal box-type cover was torn off. Fire erupted immediately and the truck was still aflame on the front of the train when the train stopped 2,640 feet from the point of impact. The two occupants of the truck cab remained within; six of the eight occupants in the bed of the truck were ejected and strewn along the south side of the track for a distance of 332 feet.

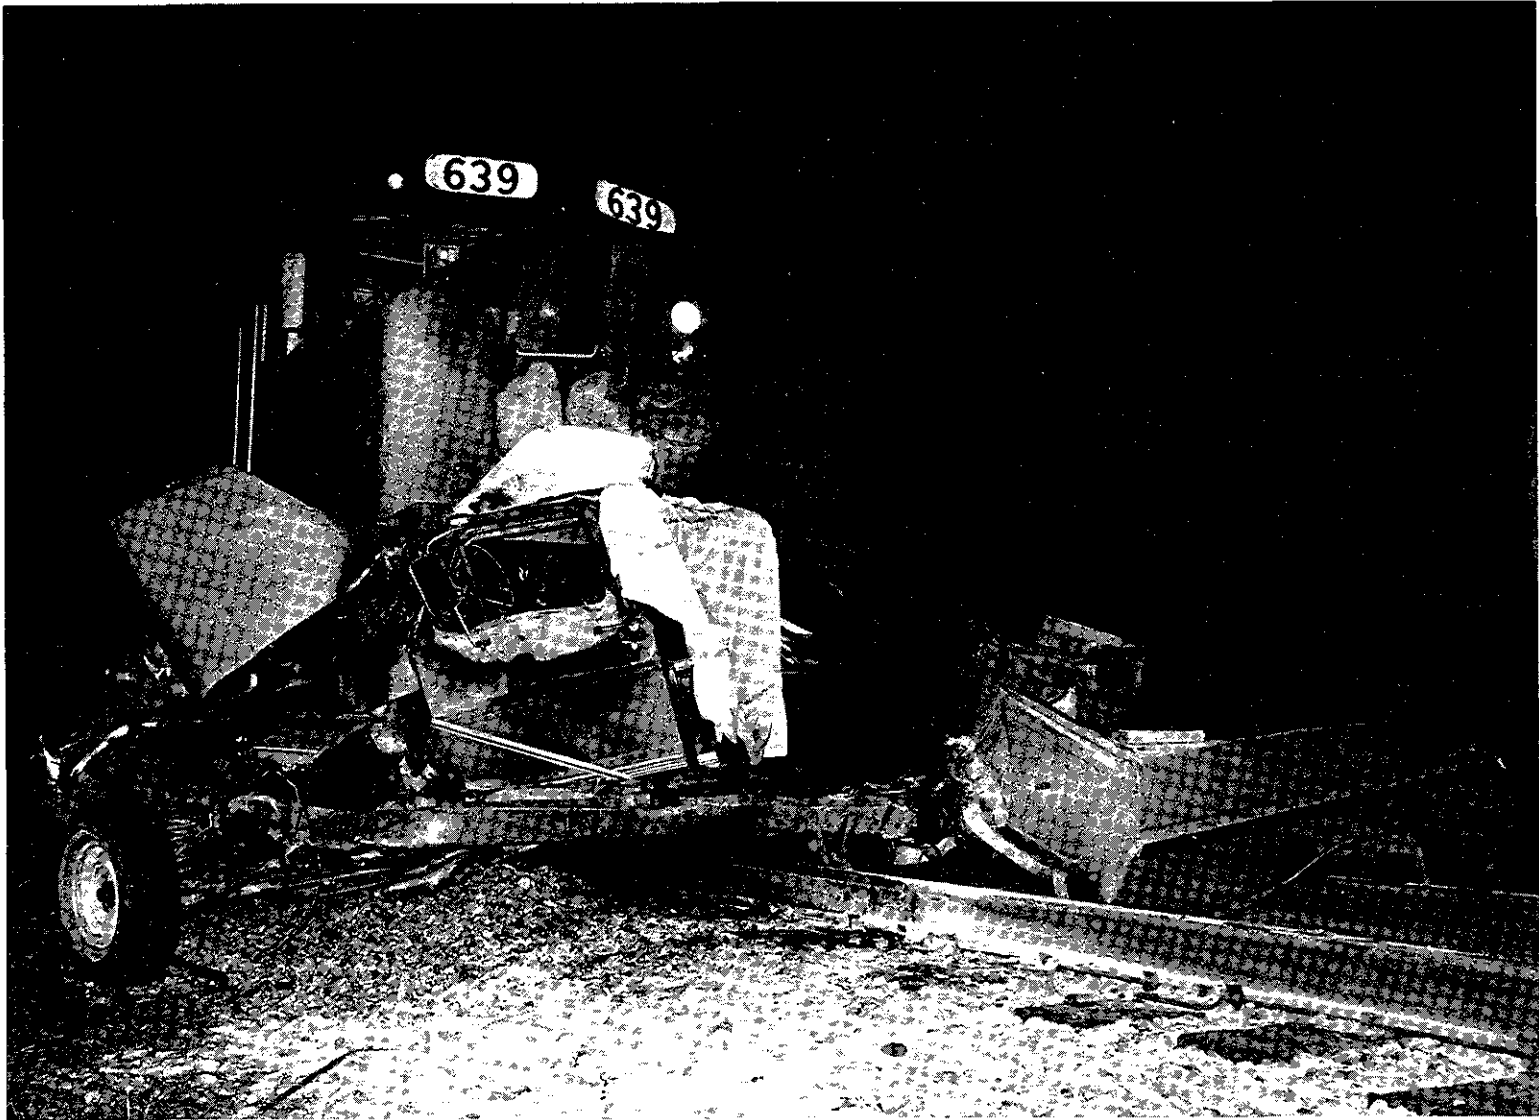
Figure 2. Pickup truck on front end of the locomotive.

When the train stopped, the truck was fully engulfed by fire and wrapped around the front of the locomotive. The traincrew's efforts to extinguish the fire were unsuccessful. The Dover-Turkey Creek Volunteer Fire Department's 1,000-gallon pumper and rescue unit arrived at the site about 15 minutes after the accident. The fire was extinguished within 2 minutes.

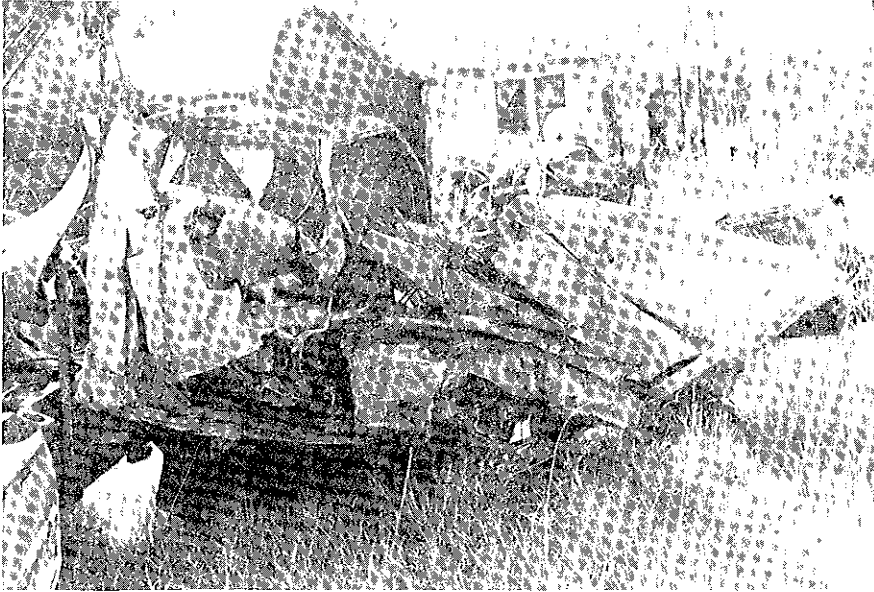
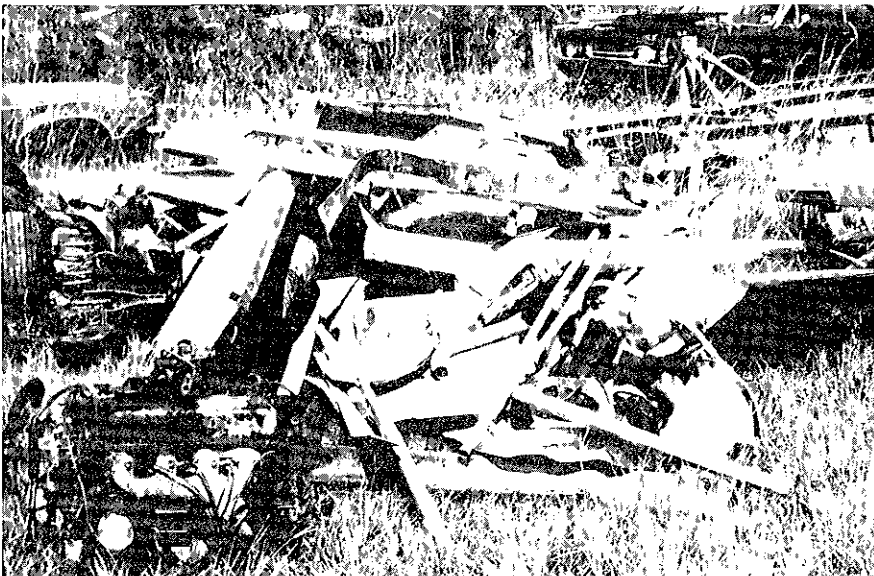
The truck and cover were destroyed in the collision and fire. (See figures 3 and 4.) A postcrash inspection revealed that the cab windows were down. The front-axle brakeshoes were badly worn, and the rear lining on the shoes of both front wheels were completely worn through. The rear-axle brake lining rivets were just beginning to contact the brakedrum. A person who had driven the truck 6 hours before the accident stated that "it drove good," and noted no mechanical problems.

Figure 3. Right side - pickup truck cab.

Figure 4. Pickup truckbed.

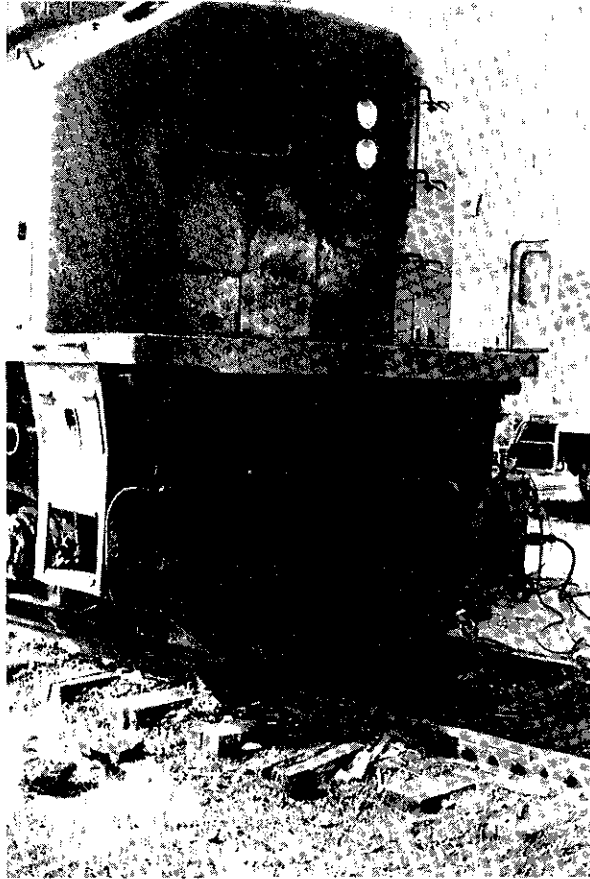
There was minor damage to the front end of the locomotive. Some cars sustained minor sheet metal damage; no other damage was noted. (See figure 5.) The airbrakes, track sanding equipment, horn, bell, and lights of the locomotive were inspected by Federal Railroad Administration (FRA) and Safety Board personnel; all were found to be in operating condition.

Figure 5. Damage to front of locomotive.

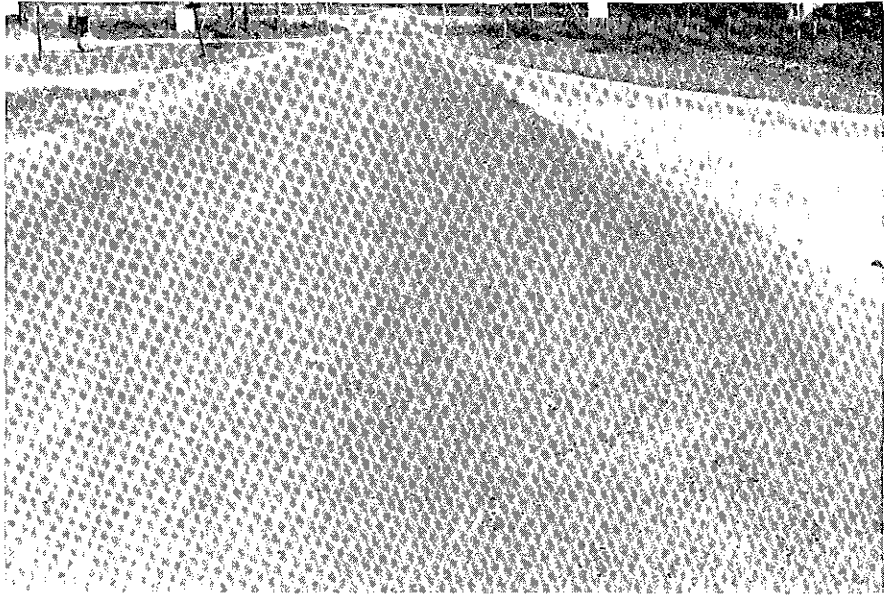
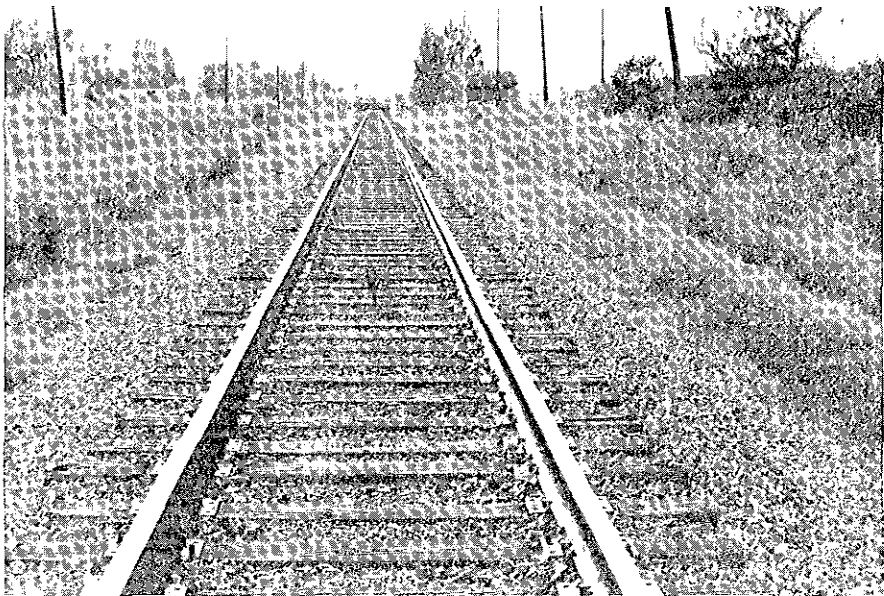
Turkey Creek Road is a north-south, 2-lane, bituminous-surfaced roadway that runs from Florida State Route 60 north to Florida State Route 574 and beyond. The roadway is not a Federal-aid highway. The road crossed the SCL mainline in Plant City at grade, 168 feet south of the centerline of State Route 574. (See figure 1.) The crossing had been designated crossing number "U.S. Dot AAR 624-329L." The 24-foot-wide roadway widened slightly to about 26 feet as it crossed the single track. The northbound road had a 1-percent negative grade but leveled somewhat at the crossing. (See figures 6 and 7.)

Figure 6. View to the north of Turkey Creek Road from 400 feet south of grade crossing.

Figure 7. View to the west of SCL railroad tracks from 600 feet east of crossing.

The terrain in the approach to the crossing is such that northbound Turkey Creek Road traffic cannot see westbound trains until vehicles pass a stand of trees about 400 feet from the crossing. (See figures 6 and 8.) Although trains may be obscured during daylight, at night the oscillating and fixed headlamps on the lead locomotives of westbound trains are clearly discernible before the train becomes visible, because the beams reflect off objects surrounding the tracks.

"Cooperate with the Florida DOT and the Seaboard Coast Line Railroad to bring about the installation of the recommended reflectorized, lighted, automatic gates and cantilever flashing light signals and uniform warning signal timing devices at the Turkey Creek crossing in Plant City. (Class II, Priority Action) (H-78-72)"

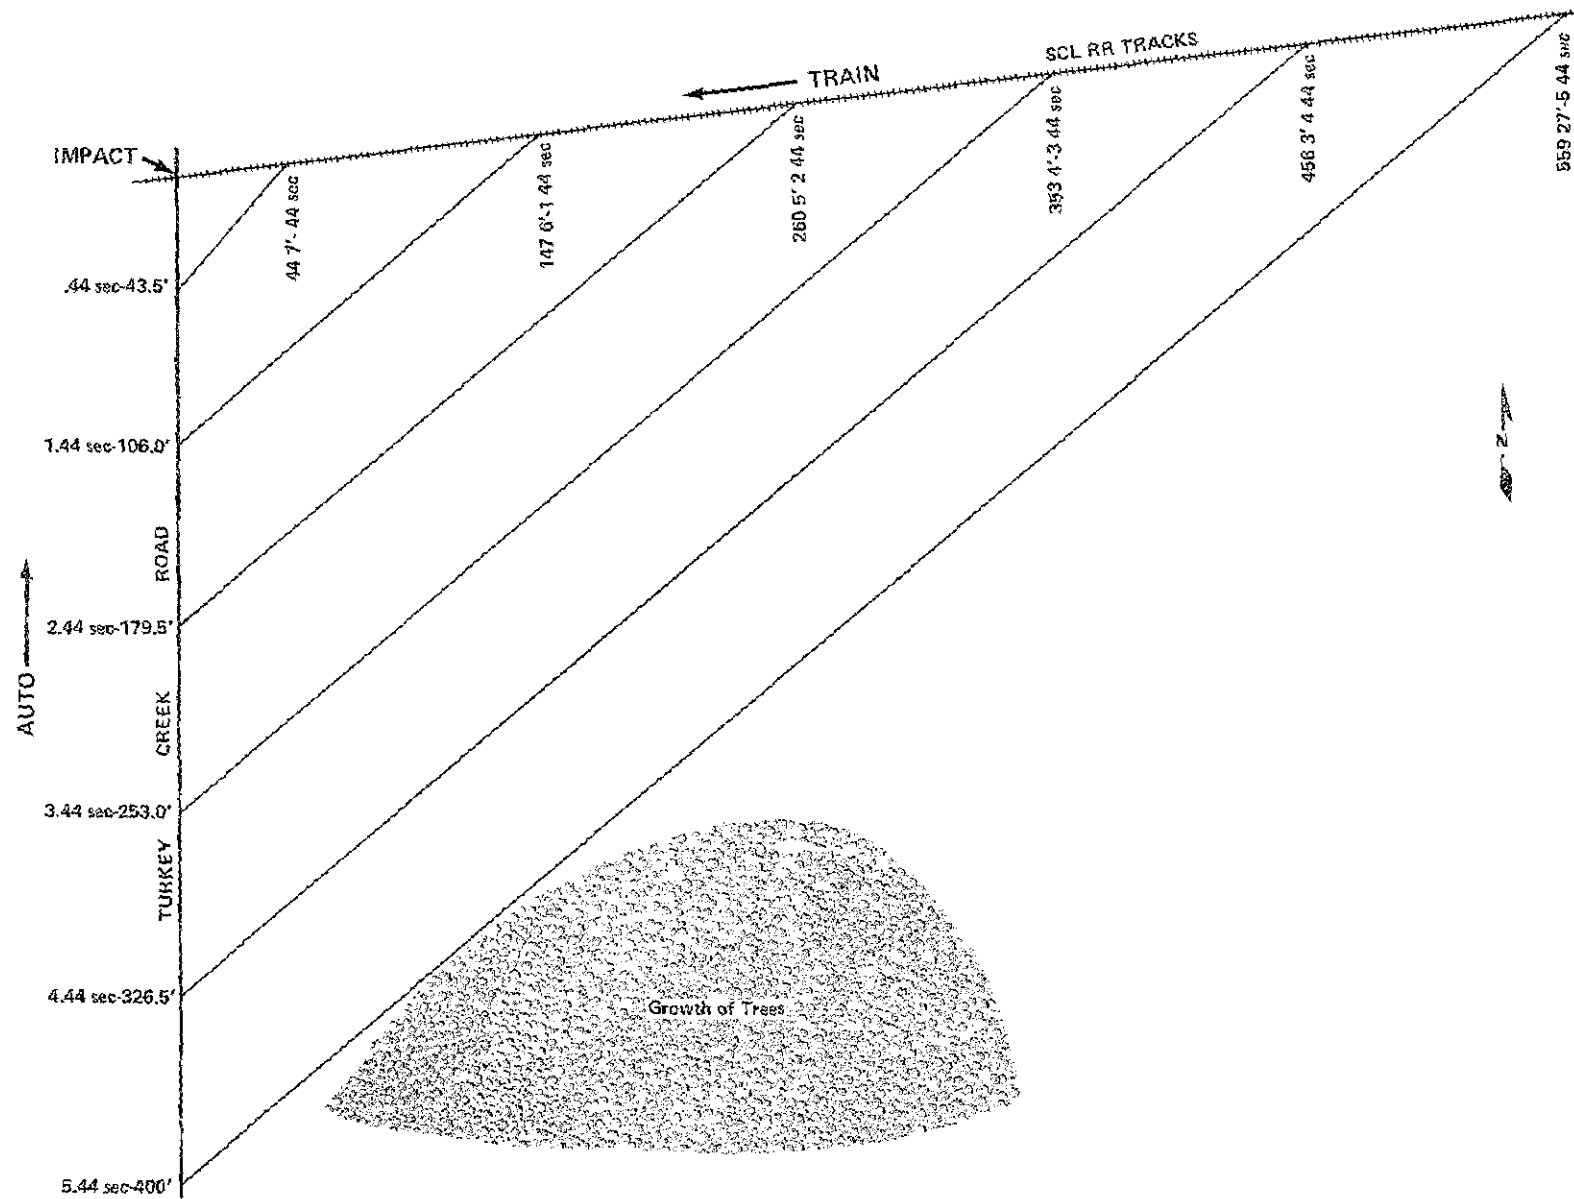
Figure 8. Time vs. distance traveled during which train was visible to truckdriver.
