DERAILMENT OF
SEABOARD COAST LINE RAILROAD
TRAIN NO. 120,
AT COLONIAL HEIGHTS, VIRGINIA
MAY 31, 1982

NTSB/RAR-83/04

**DERAILMENT OF SEABOARD COAST LINE RAILROAD
TRAIN NO. 120 at COLONIAL HEIGHTS, VIRGINIA
MAY 31, 1982**

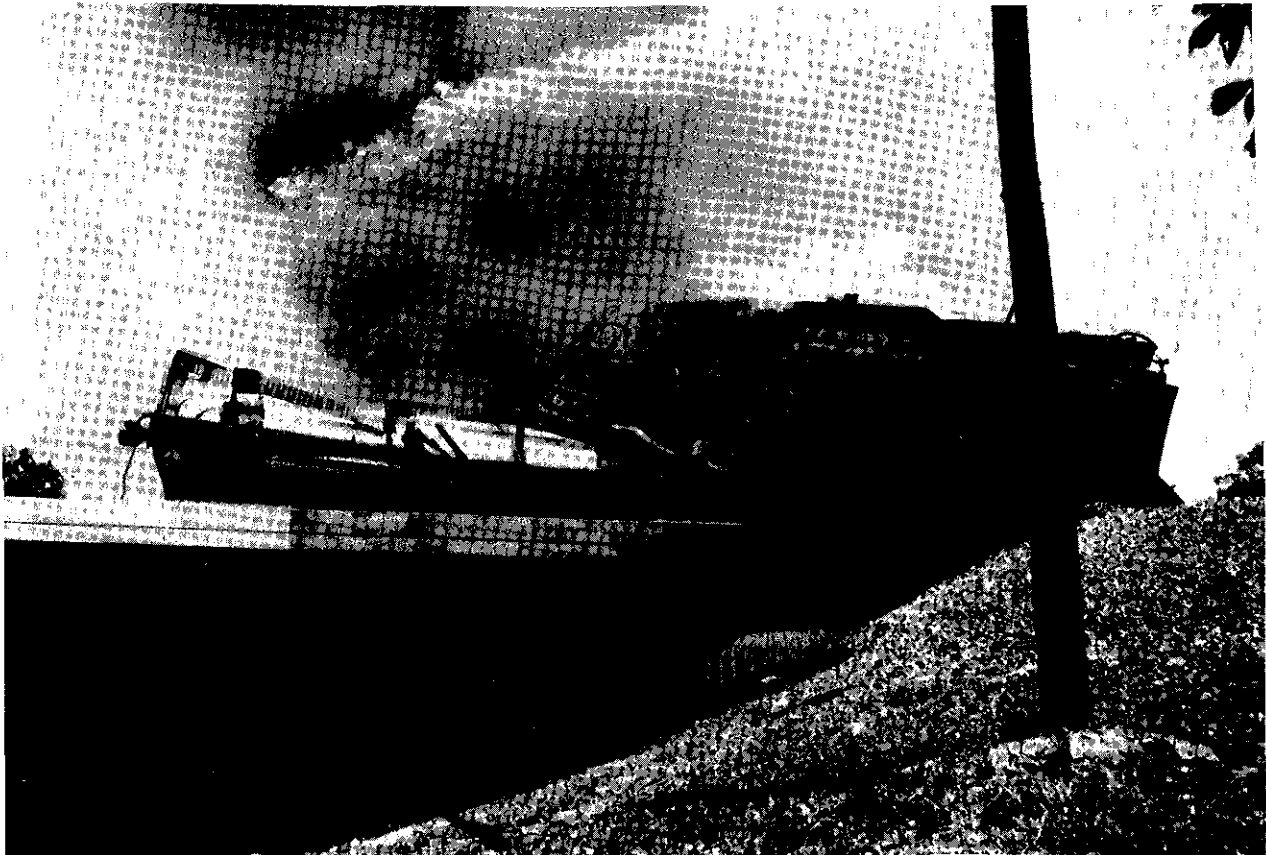
Although the fact was not known immediately after the accident, three tank cars were involved in the derailment. Derailed car No. 96, tank car GATX 27256, came to rest on the east edge of the south end of the bridge with the dome pointing approximately 110° vertically downward. The tank was punctured in the head area on the B end of the car.

Flammable liquid 2/ escaping through the puncture ignited immediately. Thereafter, the burning liquid flowed beneath the overturned tank car, and 30 feet to the ground underneath the bridge and east into a 100-square-foot area through which Swift Creek flowed and in which several derailed cars were located. (See figure 2.) The fire spread quickly to other cars and their contents including creosote treated crossties, the burning of which created a heavy black smoke.

Figure 3.--Tank car on bridge.
