NATIONAL TRANSPORTATION SAFETY BOARD

RAILROAD ACCIDENT REPORT

**DERAILMENT OF
AUTO-TRAIN NO. 4 ON
SEABOARD COAST LINE RAILROAD
FLORENCE, SOUTH CAROLINA
FEBRUARY 24, 1978**

1. Report No: NTSB-RAR-78-6,		2. Government Accession No.		3. Recipient's Catalog No.	
4. Title and Subtitle Railroad Accident Report.-- Derailment of Auto-Train No. 4 on Seaboard Coast Line Railroad, Florence, South Carolina, February 24, 1978				5. Report Date September 21, 1978

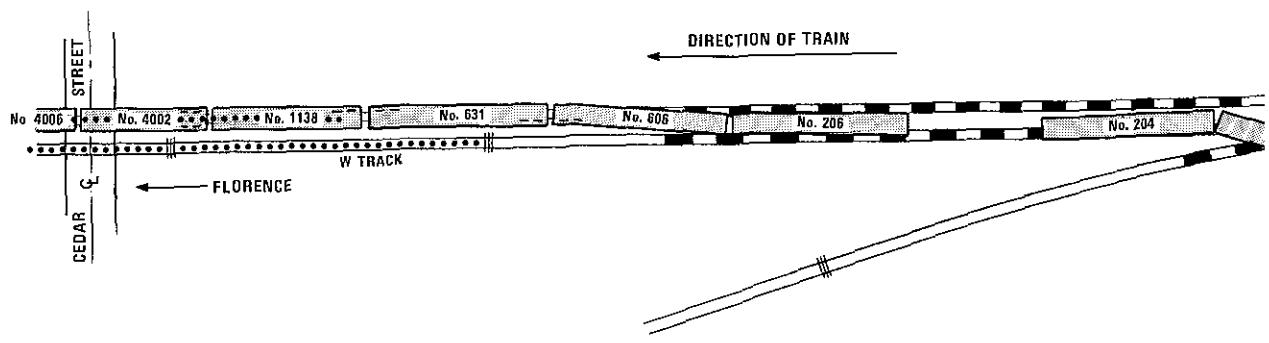
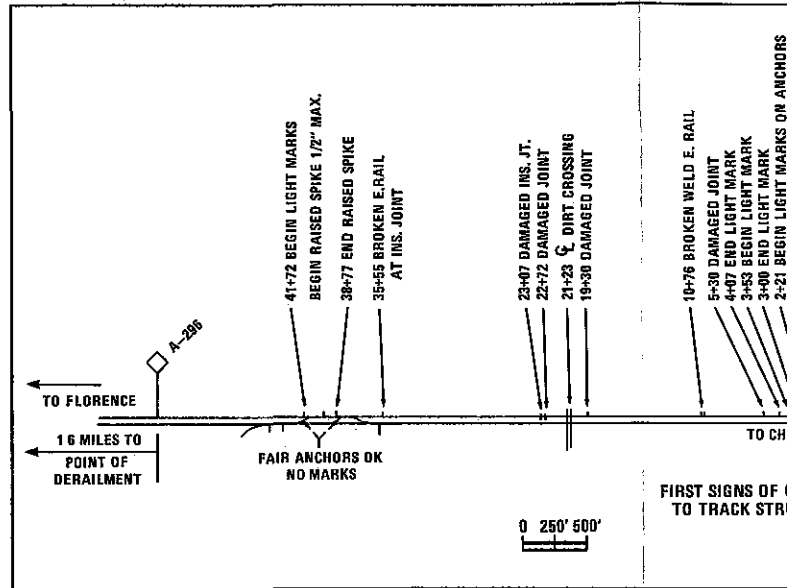
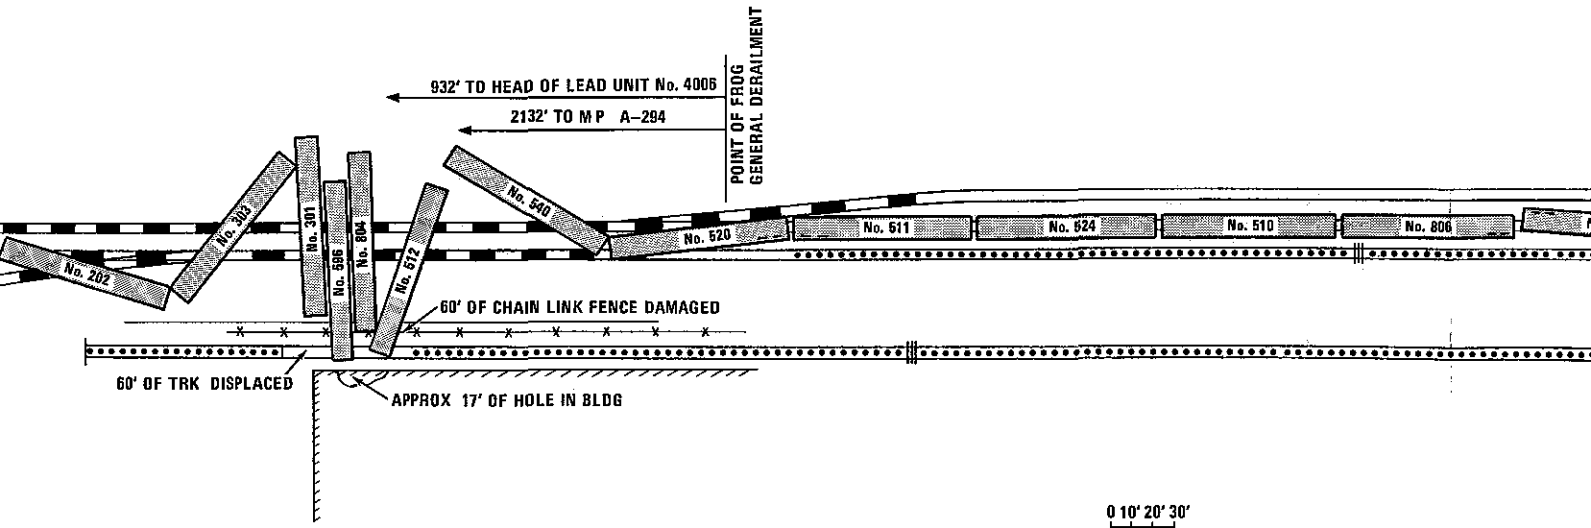
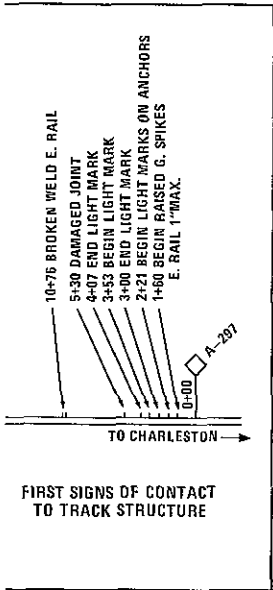
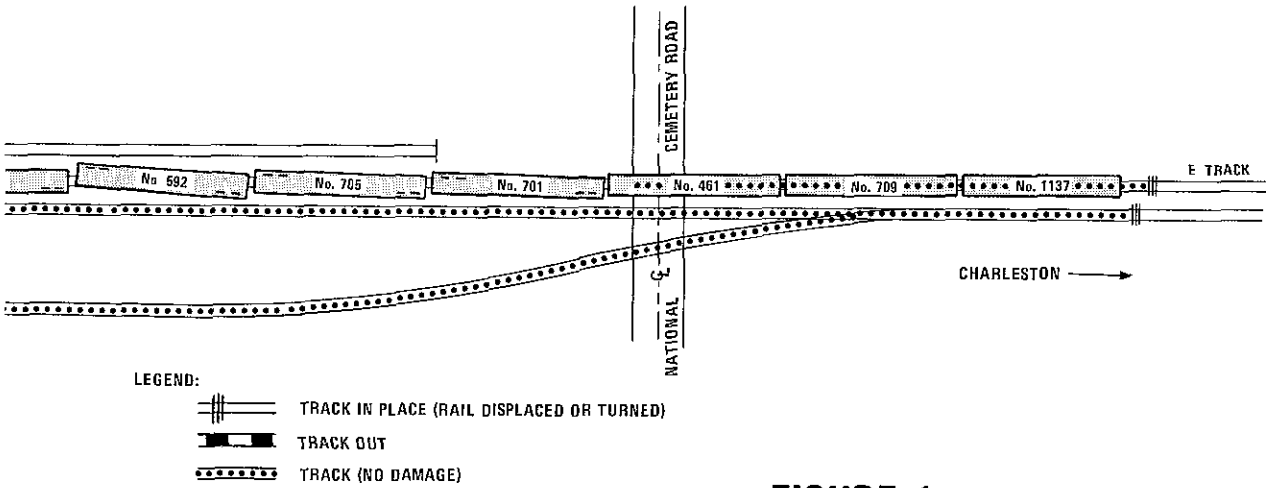
FIGURE 1

At the accident site, the northbound track was paralleled on the west by the southbound track and on the east by a stub-ended industrial siding. (See Figure 1.) The switch to the siding was located at its north end. Approaching the accident point from the south, the grade ascends 0.56 percent, and the track alignment is straight.

Marks on the heel of the frog of the turnout to the siding at the accident site indicated that the derailed left No. 2 wheel of the trailing truck on the second locomotive unit struck the frog and was diverted to the west. The left wheels on the following cars struck the frog and derailed.

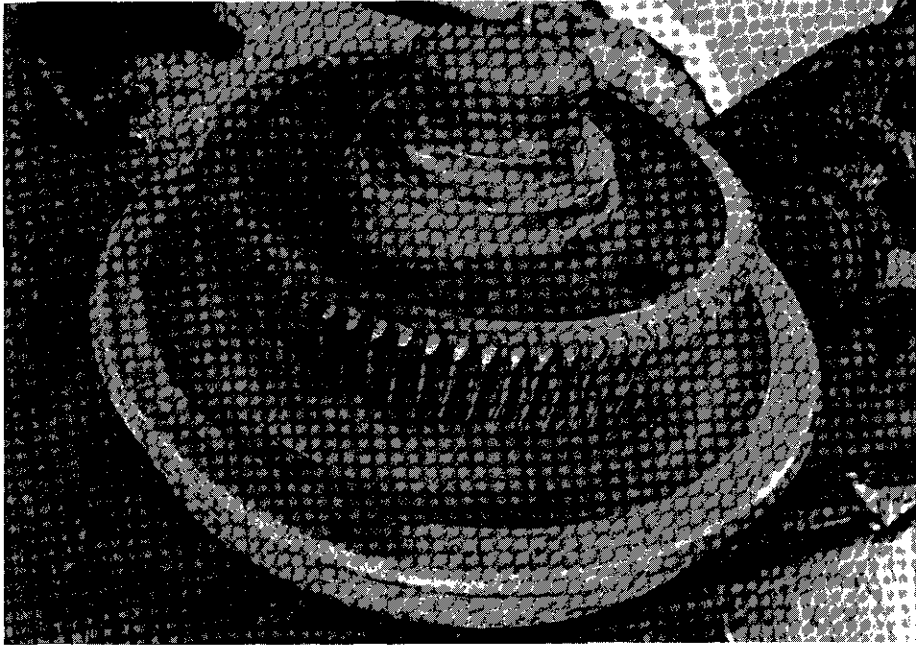
The fracture in the axle was located 30 1/4 inches from the left end, at a point where the axle diameter was 8 7/8 inches. The fracture was about midway under the bearing on the drive side of the axle. The fractured axle had a journal size of 6 1/2 by 12 inches, was of grade F steel, and was manufactured by the Bethlehem Steel Corporation (Bethlehem) in May 1972. Specifications listed in the AAR Manual of Standards and Recommended Practices were used in the manufacturing process. Specification M-101 prescribes manufacturing procedures, chemical requirements, and mechanical properties and tests. Bethlehem certified to GE that the axle complied with the requirements of M-101, including ultrasonic inspection. (See Appendix A.)

Drive side of failed axle (marked for cutting).

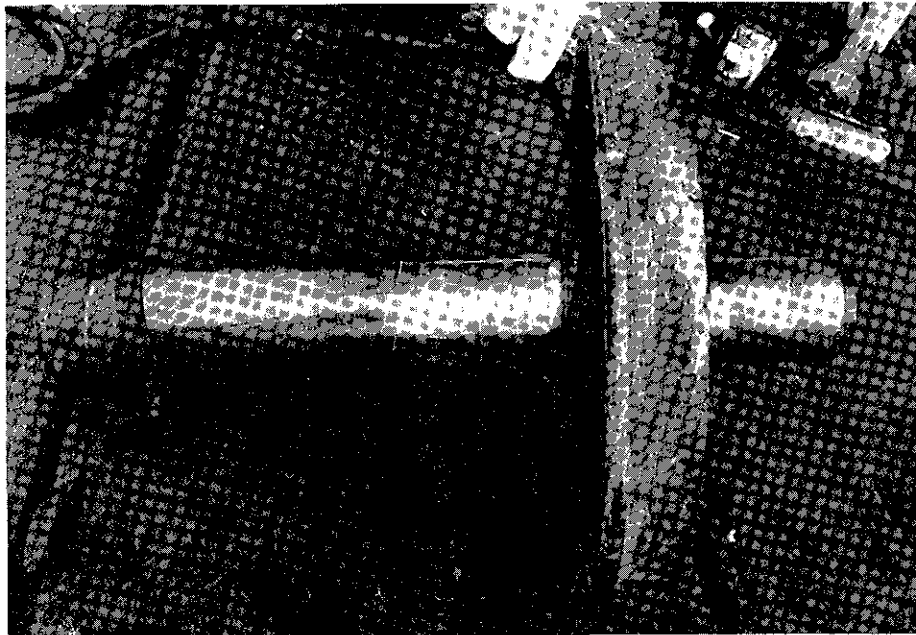
Commutator side of failed axle (marked for cutting).

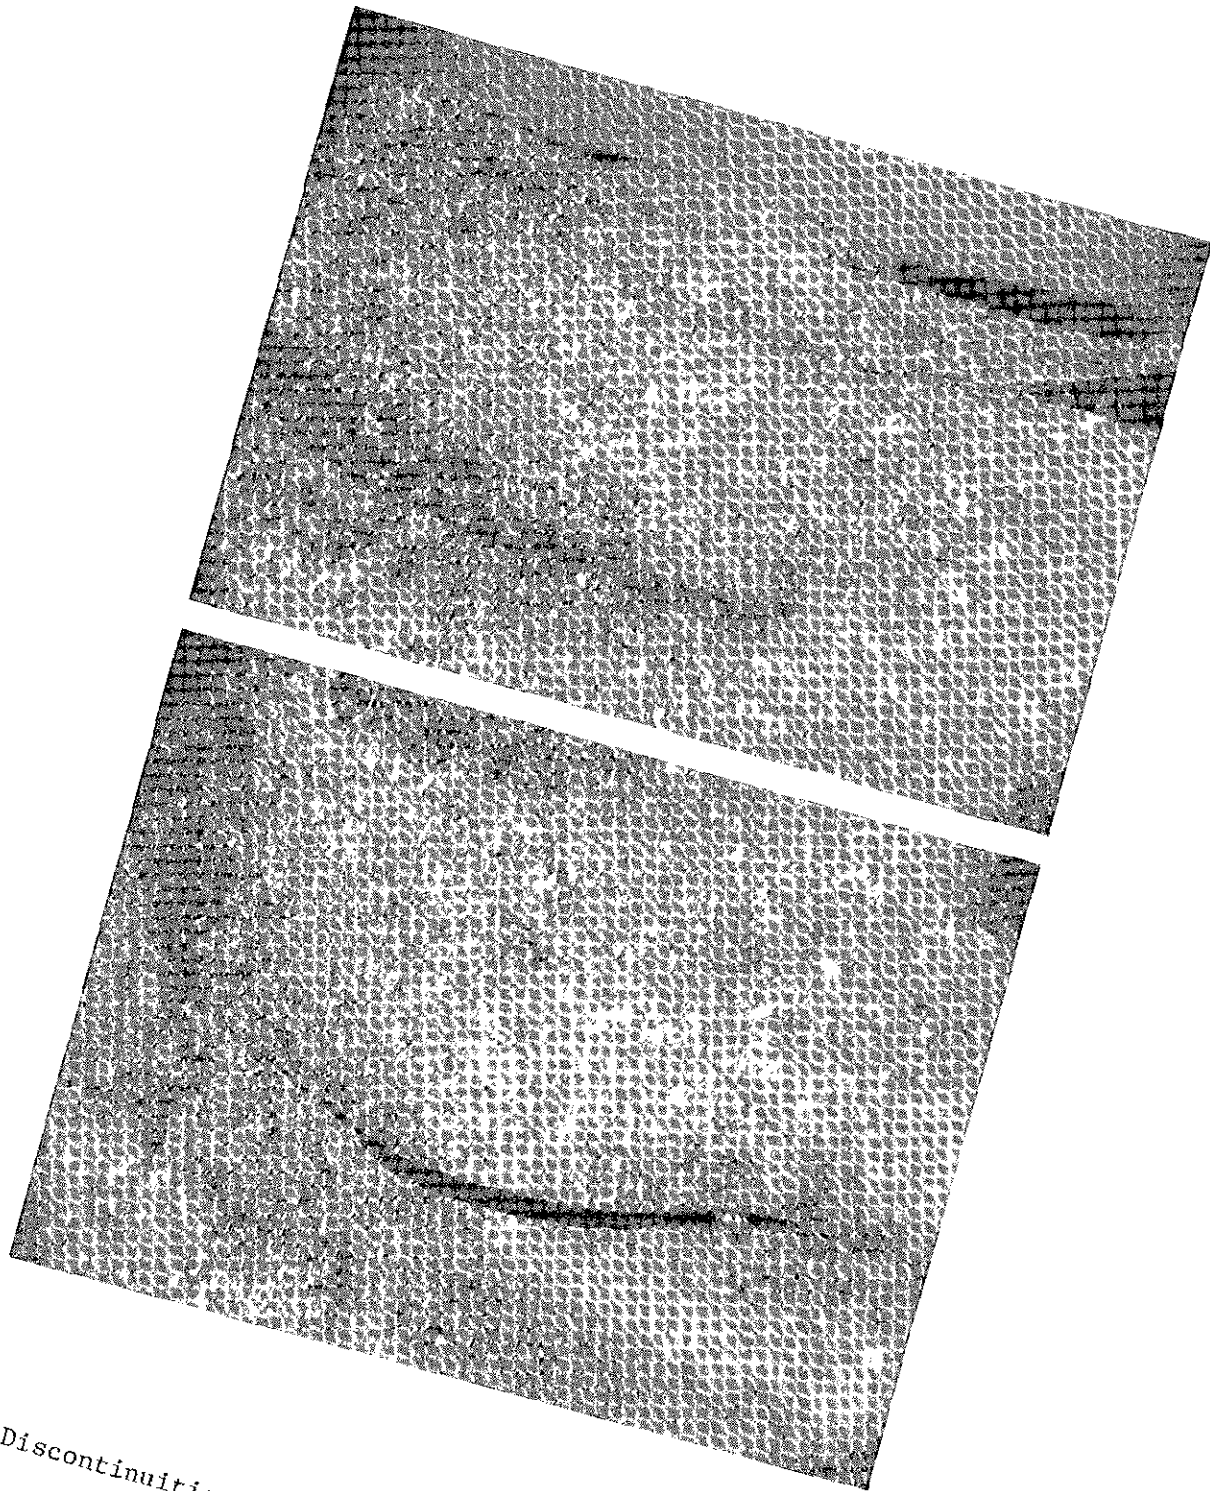
Metallurgical, mechanical, and chemical tests indicated that the axle contained preexistent cracks and voids. (See Appendix B.) Several cracks extending to the axle surface appeared to have initiated in the voids in the axle core. Scanning electron microscope examination of the void surfaces disclosed features which develop when axles are manufactured. Also the failed axle material did not meet the chemical requirements.

The metallurgical examination of the broken axle indicated that the axle probably broke before the bearing failed. Further examination disclosed several voids within the axle. Cracks extended from the voids toward the outer surfaces of the axle. The surfaces of the broken axle had been distorted by rubbing against each other for 17 miles and by the heat produced by this friction. Although this distortion prevented precise determination of the cause of the failure, it is possible that one of the cracks from the voids extended far enough toward the outer surface of the axle to weaken the axle structure, causing it to fail.

Some of the voids in the axle produced when the axle was manufactured. Discontinuities of this type usually can be detected by ultrasonic testing equipment, especially when progressive fractures begin to radiate from the voids. The AAR requires ultrasonic testing of new locomotive axles only. Magnetic particle testing of used axles, as required by AAR, will detect only those cracks that appear on the surface of the axle and will not detect voids below the surface, such as those found in this failed axle. By the time a crack from a void surfaces so that it can be detected by the magnetic particle method, the axle already has failed.

Based on the results of extensive metallurgical, chemical and mechanical properties testing the most probable cause for the axle failure appears to be due to the presence of a growing discontinuity or void within the axle

Discontinuities in failed axle, magnified 15 times.

"Amend the procedures for testing and inspecting used locomotive unit axles before they are remounted to insure that internal defects can be detected. (Class II, Priority Action) (R-78-53)"

"Revise 49 CFR 230.213, Axles, to establish specifications for the manufacturing and testing of locomotive axles to insure the discovery of internal defects before they are placed in service. (Class II, Priority Action) (R-78-54)

"Revise 49 CFR 230.213, Axles, to establish procedures and methods to test in-service locomotive axles to insure the detection of internal defects so they may be removed from service. (Class II, Priority Action) (R-78-55)
