RAILROAD ACCIDENT REPORT

DERAILMENT OF AUTO-TRAIN NO. 4
ON SEABOARD COAST LINE RAILROAD
FLORENCE, SOUTH CAROLINA
FEBRUARY 24, 1978

NTSB/RAR-84/03
(SUPERSEDES--NTSB-RAR-78-6)

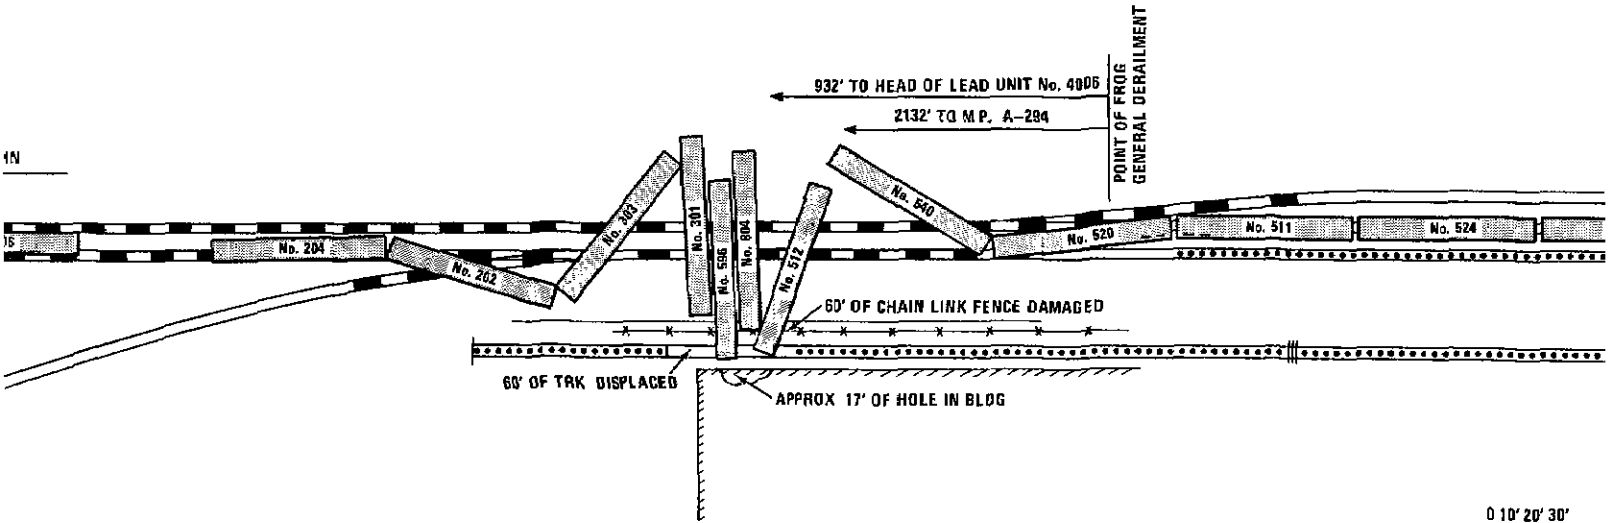
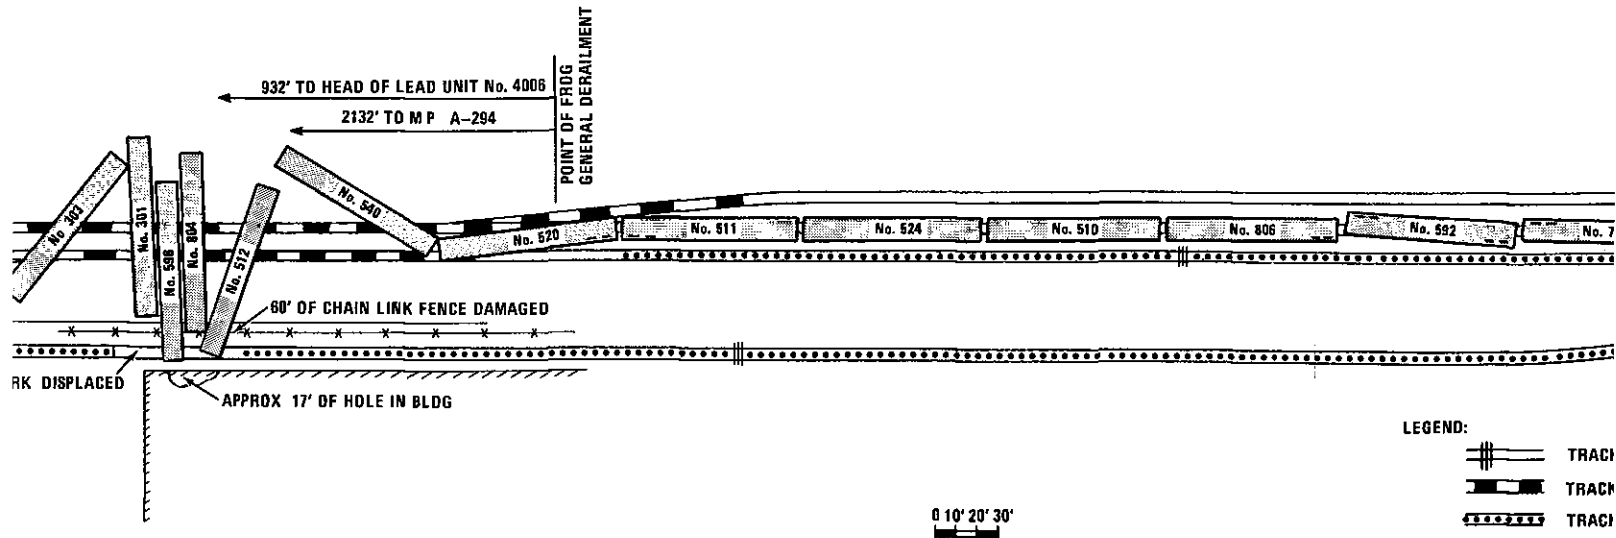
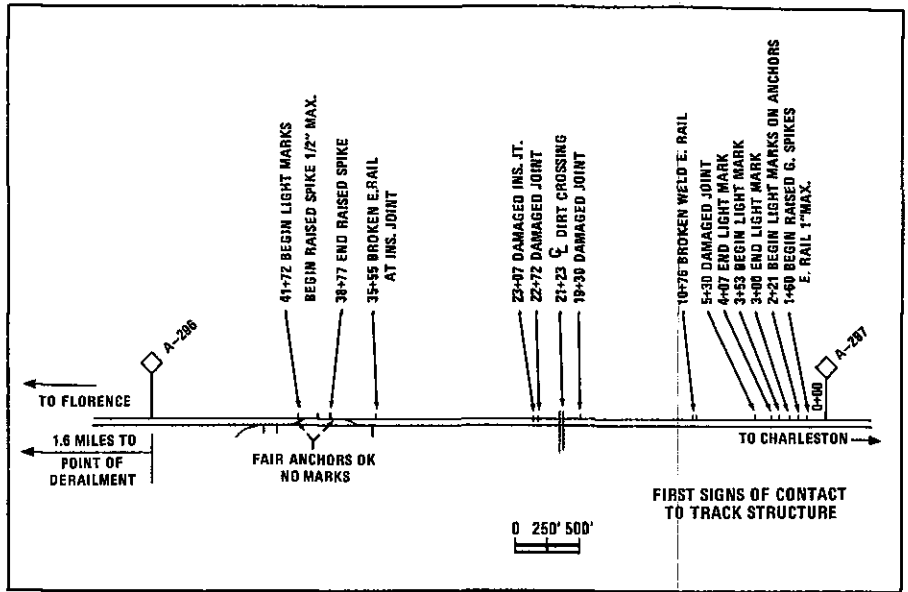
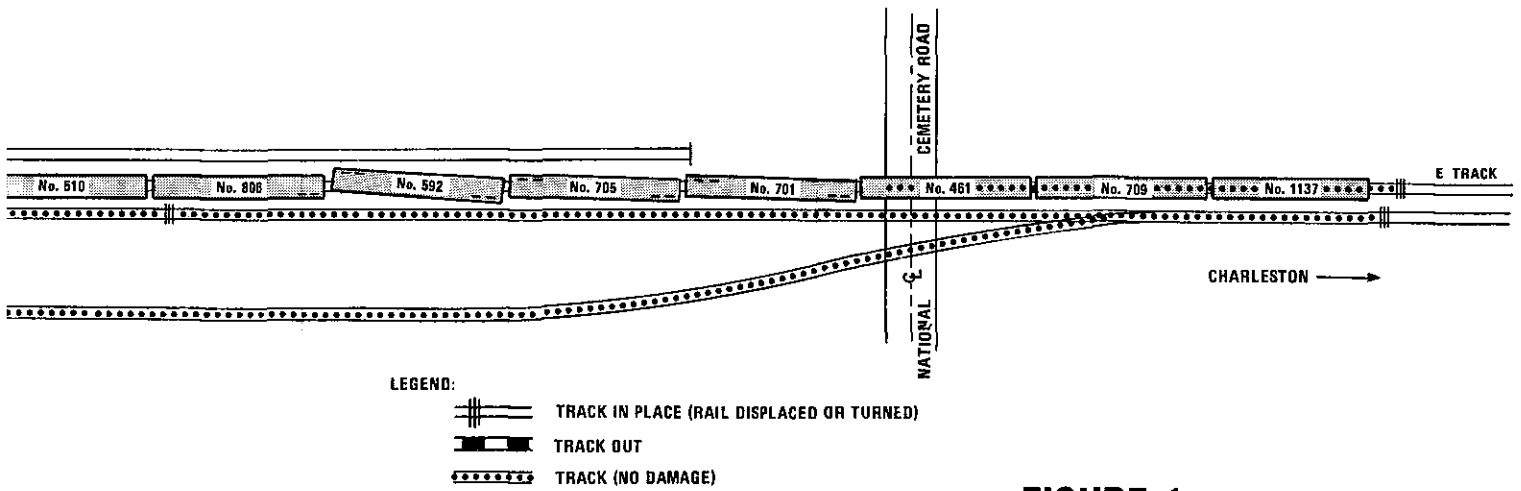
FIGURE 1

At the accident site, the northbound track was paralleled on the west by the southbound track and on the east by a stub-ended industrial siding. (See Figure 1.) The switch to the siding was located at its north end. Approaching the accident point from the south, the grade ascends 0.56 percent, and the track alignment is straight.

SEABOARD COAST LINE RAILROAD
FLORENCE DIVISION
AUTO—TRAIN DERAILMENT
ON FEB. 24, 1978
FLORENCE, S.C.
