NATIONAL TRANSPORTATION SAFETY BOARD

DERAILMENT OF
SEABOARD SYSTEM RAILROAD TRAIN NO. F-690
WITH HAZARDOUS MATERIAL RELEASE
JACKSON, SOUTH CAROLINA
FEBRUARY 23, 1985 AND COLLISION OF
SEABOARD SYSTEM RAILROAD TRAIN NO. F-481
WITH STANDING CARS
ROBBINS, SOUTH CAROLINA
FEBRUARY 25, 1985

NTSB/RAR-85/12

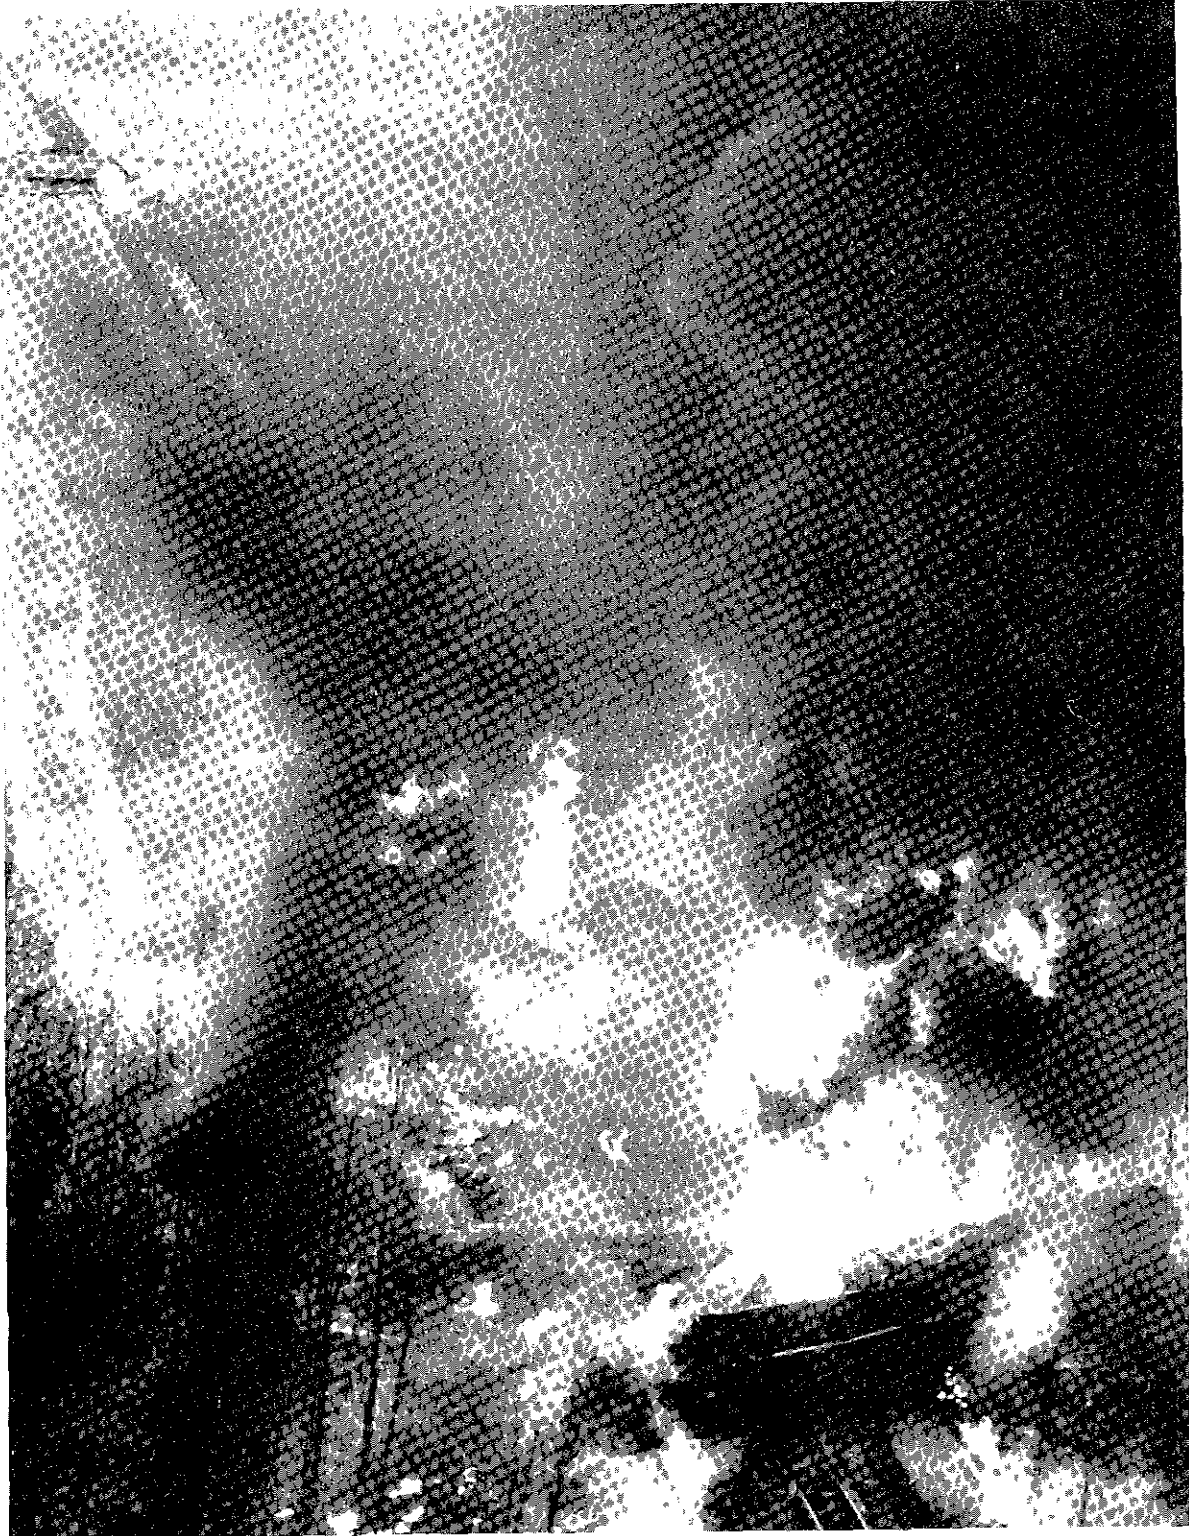
About 7:15 a.m., SBD train No. F-690, a run-through train with no cars to be set out or picked up en route, was passing through Jackson, en route from Savannah to Augusta. The engineer stated that his locomotive had just passed the defect detector and he had sounded the warning whistle signal for an at-grade road crossing near the defect detector when he got up from his seat to get a drink of water. "When I sat down, I felt and heard us hit something," the engineer stated. "When I looked out my window, I saw an object rolling out into the woods. I saw it come from underneath the train and go out into the woods and it looked about the size of a crosstie. But I couldn't tell you exactly what it was because there was debris flying all around it." Almost immediately afterwards, the train automatic airbrake applied in emergency. Twenty-seven cars--18 cars (the 2nd through the 19th cars) near the front of the train and 9 cars (the 40th through the 48th cars) further back in the train--were derailed. (See figure 2.) The five-unit locomotive and one car which remained coupled to the locomotive came to a stop after traveling about three-fourths of a mile. The engineer stated that the speed of train No. F-690 was about 49 miles per hour (mph) when the derailment occurred. (The defect detector recorded the train speed at 53 mph.) Located among the derailed cars near the front of the train were eight tank cars containing cyclohexane, a flammable liquid. All of the tank cars were severely damaged, leading to the release of cyclohexane, which ignited immediately. (See figure 3.)

Figure 3.--Aerial view of Jackson accident site.

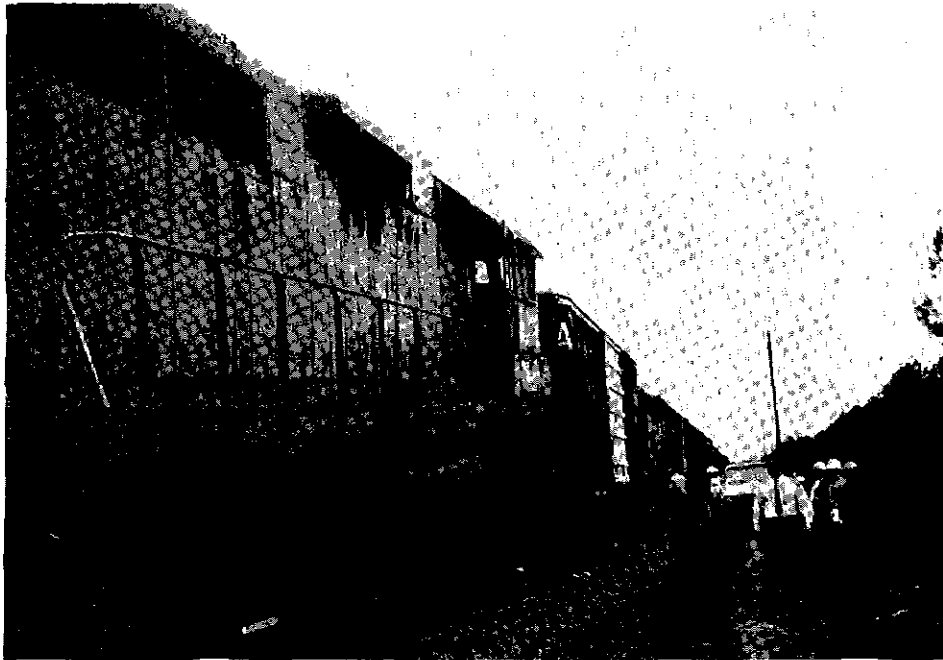
Figure 5.--View of lead locomotive unit of SBD train No. F-481 of February 25 after collision at Robbins accident site.

In the accident at Robbins, the caboose and the boxcar forward of the caboose in the standing cut of cars were destroyed, while another boxcar was moderately damaged. The lead locomotive unit of train No. F-481 of February 25 was severely damaged. Damage was estimated by the SBD to be as follows:

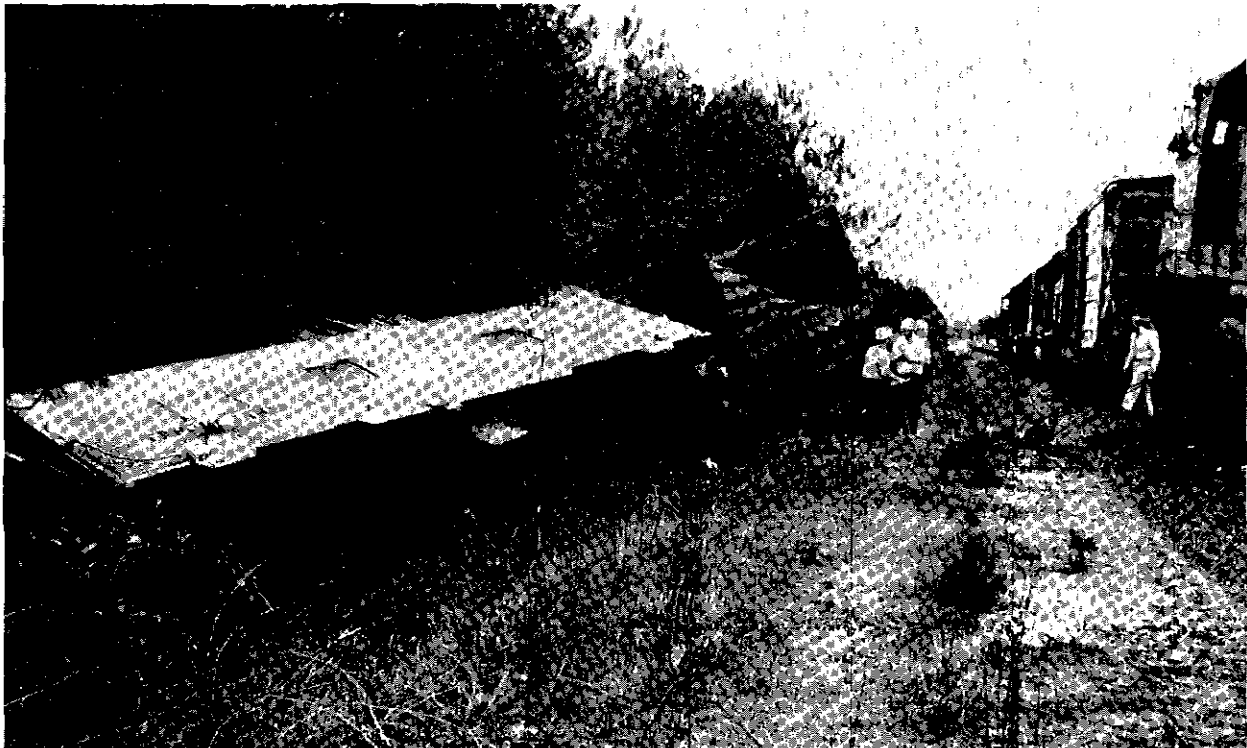
Figure 6.--View of derailed caboose and boxcar of standing cut of cars after collision at Robbins accident site.

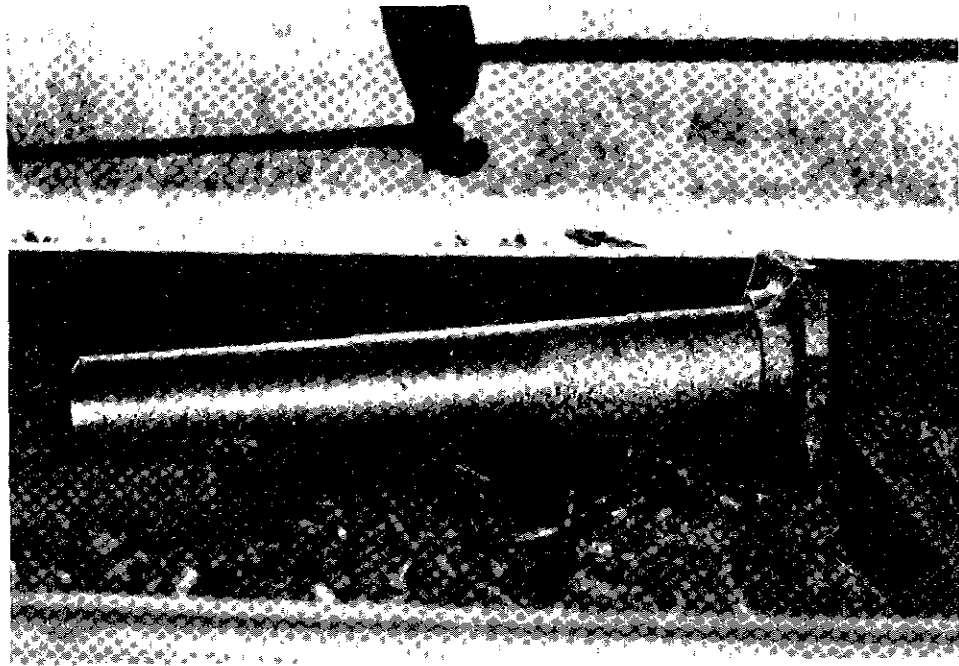
After the accident at Jackson, a cushion unit 7/ was found near the initial derailment. The unit's male portion (piston) was found inside the track gage (see figure 7) while the female portion (cylinder) was found outside the track gage (see figure 8). About 5 hours before the accident, train No. F-480 containing boxcar SBD 156678, passed through Jackson. A postaccident inspection of boxcar SBD 156678 at Sumter

Figure 7.--Cushion unit piston found inside the track gage at Jackson.

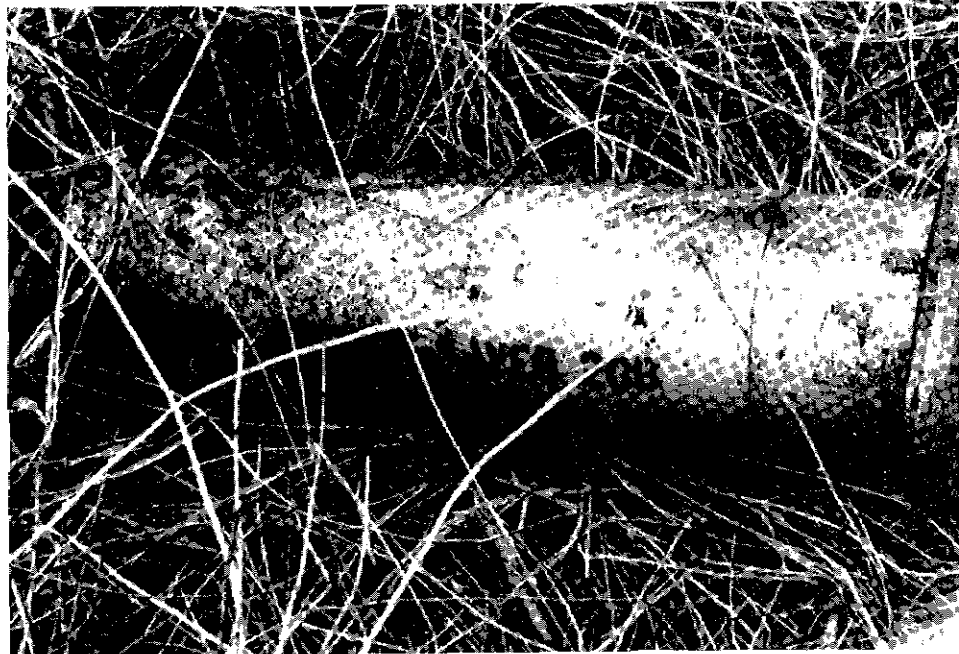
Figure 8.--Cushion unit cylinder found on south side of track at Jackson.

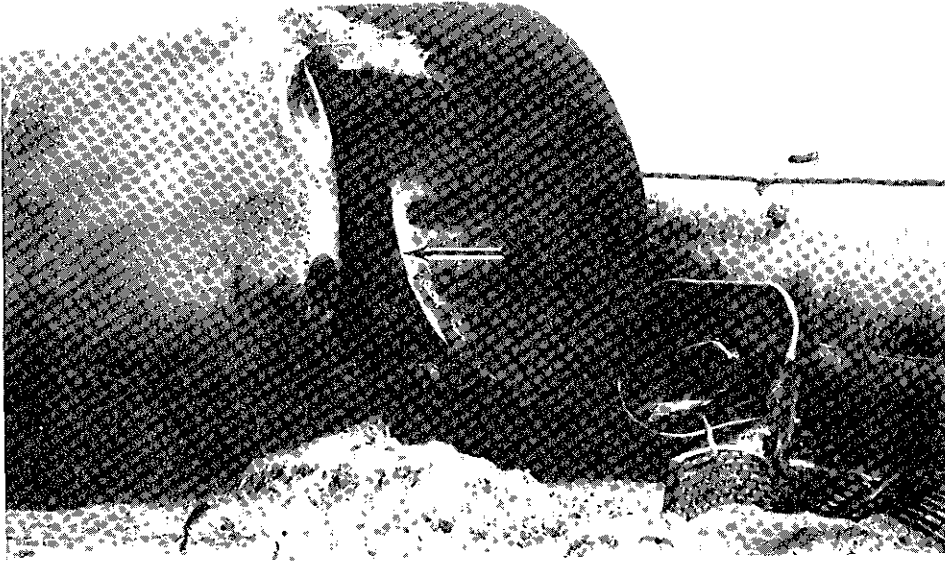
In the accident at Jackson, 27 cars were derailed, 25 of which were destroyed. All eight tank cars laden with cyclohexane were among the destroyed cars. The heads of five of the eight tank cars were penetrated during the derailment. (See figures 9 through 13.) All of the tank cars were equipped with type-"F" top-and-bottom shelf couplers, virtually all of which were broken or torn from their yokes. None of the tank cars was equipped with head shields, nor were they required to be so equipped by Federal regulation, notwithstanding the fact that the Emergency Response Guidebook published by the U.S. Department of Transportation (DOT) recommends evacuation of a one-half mile radius when a tank car of cyclohexane is involved in fire. About 900 feet of single main track and roadbed were destroyed in the accident. Damage was estimated by the SBD to be as follows:

Figure 11.--Tank car ACFX 77722 in the Jackson accident.
Note penetrated area of tank head shown at arrow.

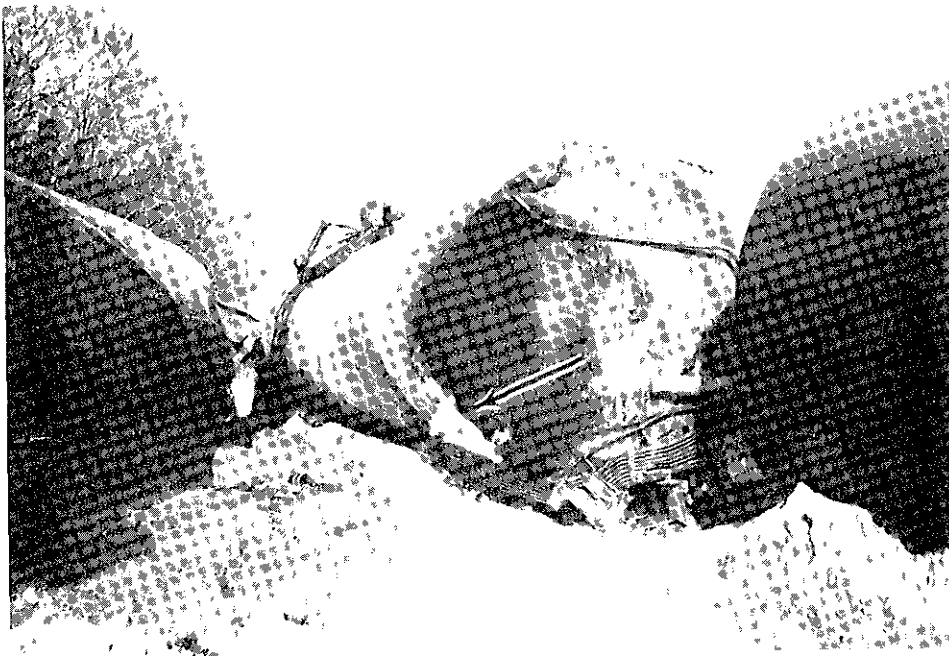
Figure 12.--Tank car ACFX 77720 in the Jackson accident.
Note penetrated area of tank head shown at arrow.

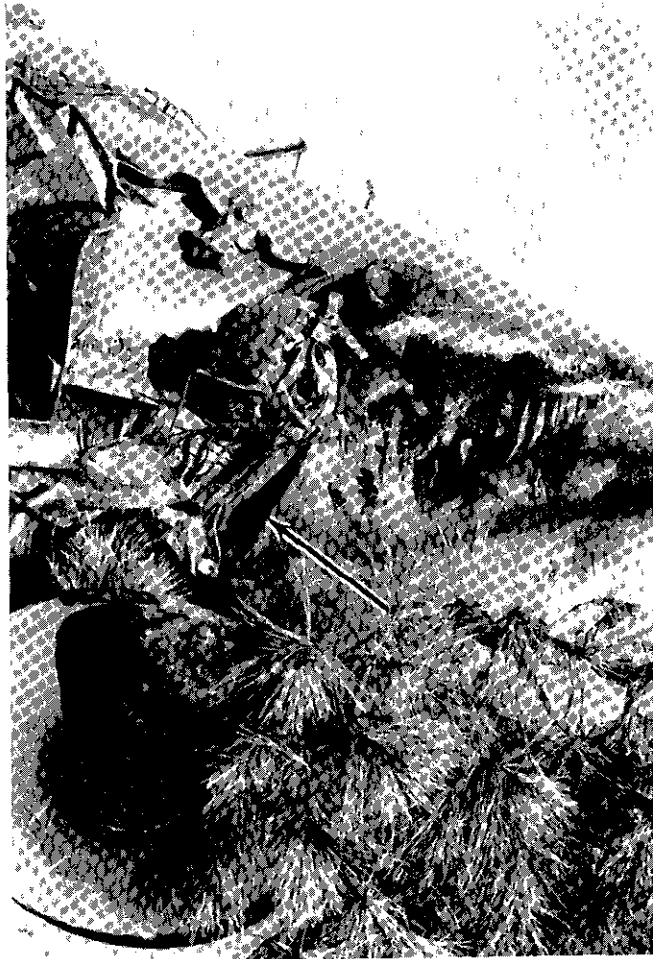
Figure 13.--Tank car ACFX 77711 in the Jackson accident.
Note penetrated area of tank head shown at arrow.

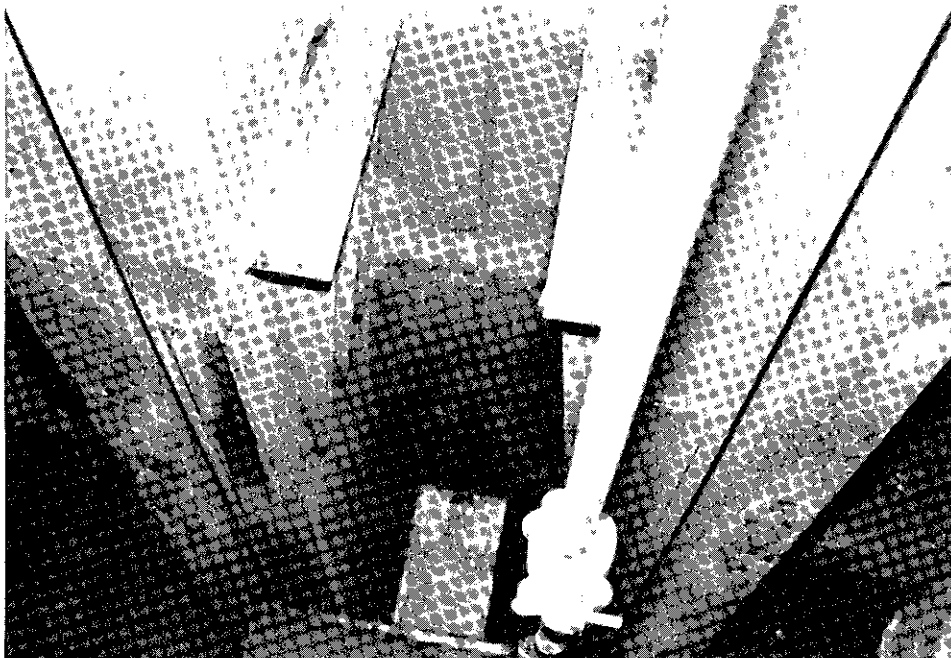
unit pocket was 1 inch longer than specified in construction drawings (see figure 14), and that the car showed signs of previous heavy repair or overhaul. However, the Pullman Standard representative stated that the permissible dimensional tolerances of such equipment within specification could result in a gap of $1 \frac{7}{16}$ inch between the fixed draft stop and the shortened end of a modified carrier plate. The SBD was unable to determine the repair history of boxcar SBD 156678 with regard to the previous heavy repair or overhaul of the underframe of the car.

Figure 14.--Cushion unit pocket on boxcar SBD 156678
