RAILROAD ACCIDENT REPORT,

DERAILMENT OF
AMTRAK TRAIN NO. 81
THE SILVER STAR
ON THE SEABOARD SYSTEM RAILROAD
KITRELL, NORTH CAROLINA
MARCH 5, 1984

✓
NTSB/RAR-85/03,

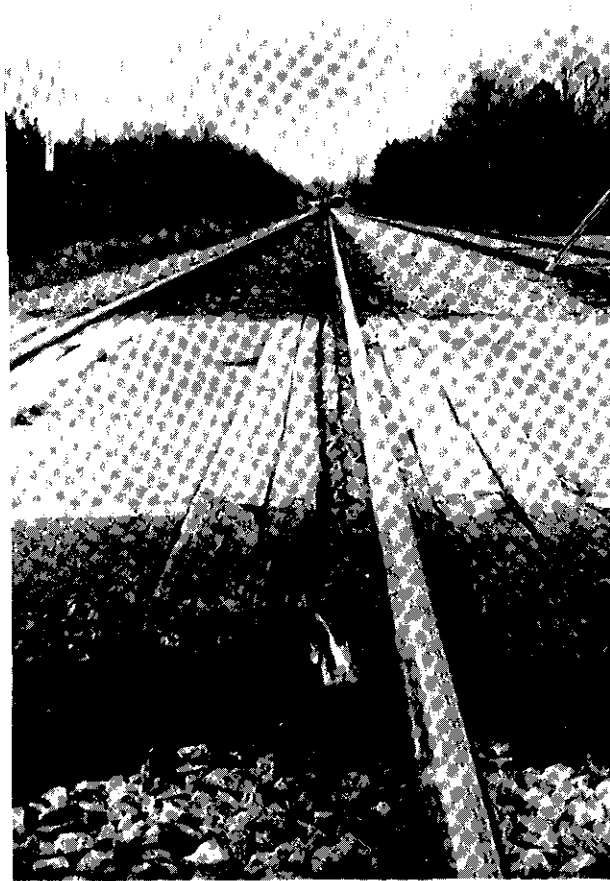
Figure 2.--View of grade crossing north of MP S-123.

The train was being operated in accordance with the operating practices of the SBD. The abrasion marks on the railroad grade crossing planks at Kittrell indicate that the locomotive axle broke north of Kittrell allowing the wheels to become out of gage and the

wheel flanges to strike and abrade the grade crossing planks. The fact that there were no marks on grade crossings north of Kittrell indicates that the axle failure probably occurred within 3 miles of the accident site. Wheel flange marks on the spikes and rail anchors indicate that the initial derailment of the No. 1 axle of Amtrak locomotive unit No. 378 occurred 58 feet north of MP S-123. The general derailment occurred when the derailed wheel on the broken axle struck the siding switch at MP S-123.

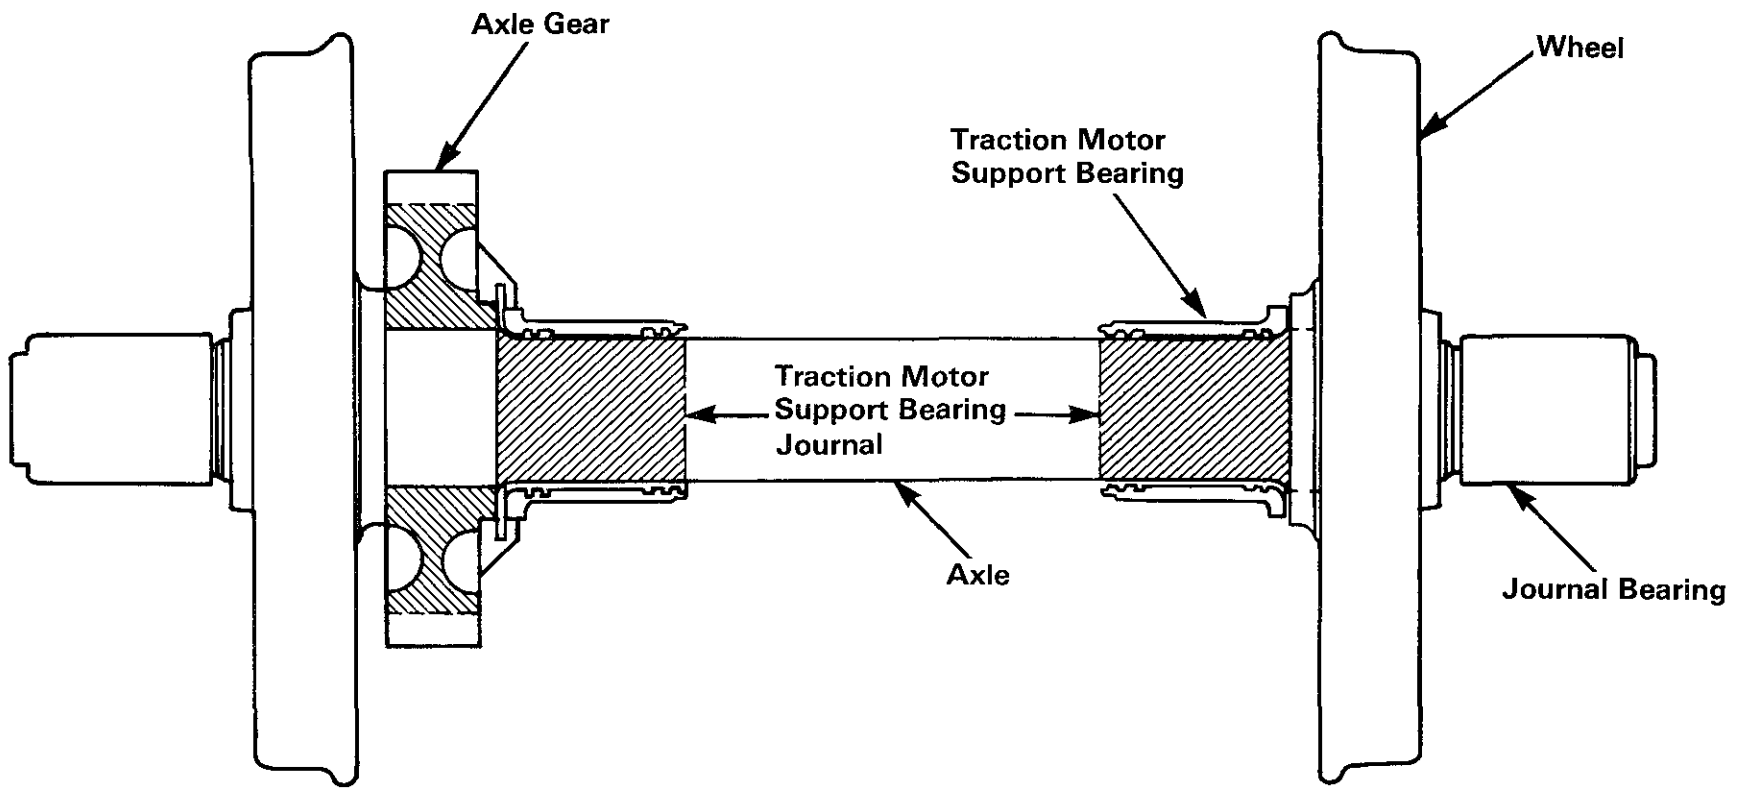
Figure 3.--Locomotive axle assembly showing gear and bearing locations.

Postaccident inspection revealed that the No. 1 axle of the third locomotive unit (Amtrak No. 378) was broken on the pinion (left) end in the traction motor support bearing area. (See figure 3.) The bearing was destroyed, the lubricator wick was burned and charred, and the axle in the bearing area showed evidence of intense heat. The axle was broken at an uneven angle; the short end was 6 7/8 to 8 inches long when measured from the face of the axle gear hub. (See figure 4.) All other support bearings, lubricator wick assemblies, and axles on the locomotive unit were inspected and found to be lubricated and in good condition.

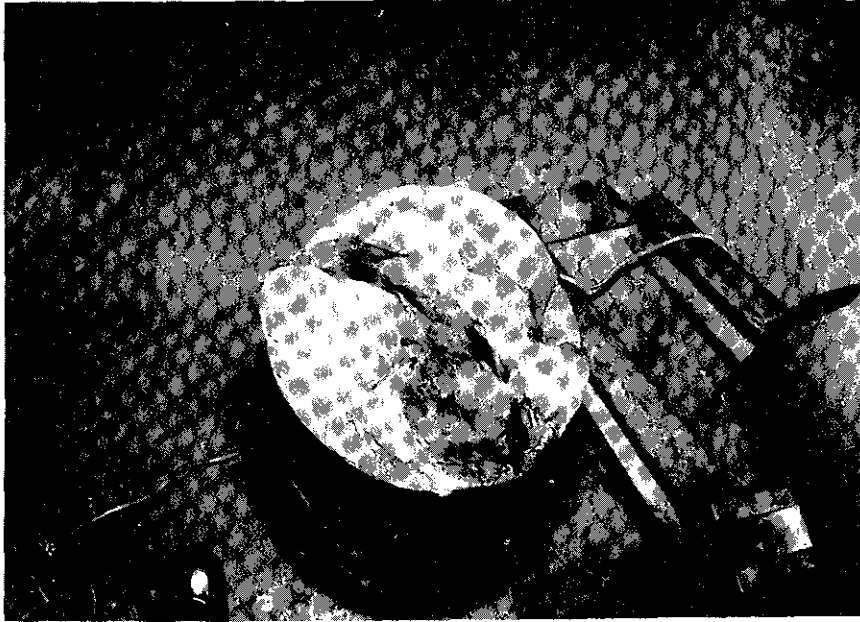
Figure 4.— End view of broken axle from Amtrak locomotive unit No. 378.

Examination of the broken axle from Amtrak locomotive unit No. 378 revealed that the damage to the surface finish of the axle in the failure area was too severe to measure and determine the actual condition of the original surface. The surface finish of the traction motor support bearing journal on the other (commutator) end of the axle was measured at 30 microinches. This surface finish measurement is over four times that which is recommended by the manufacturer and adopted as standard by Amtrak. Even allowing for some deterioration of finish due to derailment, it is unlikely that the surface was at the specified level of 7 microinches when the axle was applied to the assembly at the New Haven shop. There were marks on the bearing surface which suggest that a hand-held polishing tool was used on the axle which not only roughened the surface but also left "peaks and valleys" which can result in excessive bearing wear and interrupted lubrication. Therefore, the Safety Board believes that the surface finish of the failed end (pinion end) of the axle was in reasonably similar condition to the commutator end of the same axle when it was applied to the assembly. Since the bearing load on the pinion end is approximately three times as great as the load on the commutator end, the bearing on the

pinion end would be expected to fail first. The failure mode is characterized by (1) excessive bearing wear, (2) overheating of the axle and bearing, (3) degradation of the wick-type lubrication system, and (4) ultimate failure of the axle in the support bearing area when the axle becomes plastic due to overheating.

The cause of failure of the axle has been attributed to gross overheating of the suspension bearing journal at the pinion end of the traction motor. This overheating resulted in extensive bearing metal penetration, as evidenced by deposits of lead and copper discovered in subsurface cracks. During the overheating of the axle, an extensive secondary crack network developed, indicative of a severe breakdown in mechanical properties at high temperature. A combination of the embrittling action of the bearing metal contamination and the loss of strength, therefore, is judged to be the cause of axle failure.
