# NATIONAL TRANSPORTATION SAFETY BOARD

SEABOARD SYSTEM RAILROAD  
FREIGHT TRAIN FERHL  
DERAILMENT AND FIRE  
MARSHVILLE, NORTH CAROLINA  
APRIL 10, 1984

✓  
NTSB/RAR-85/05,

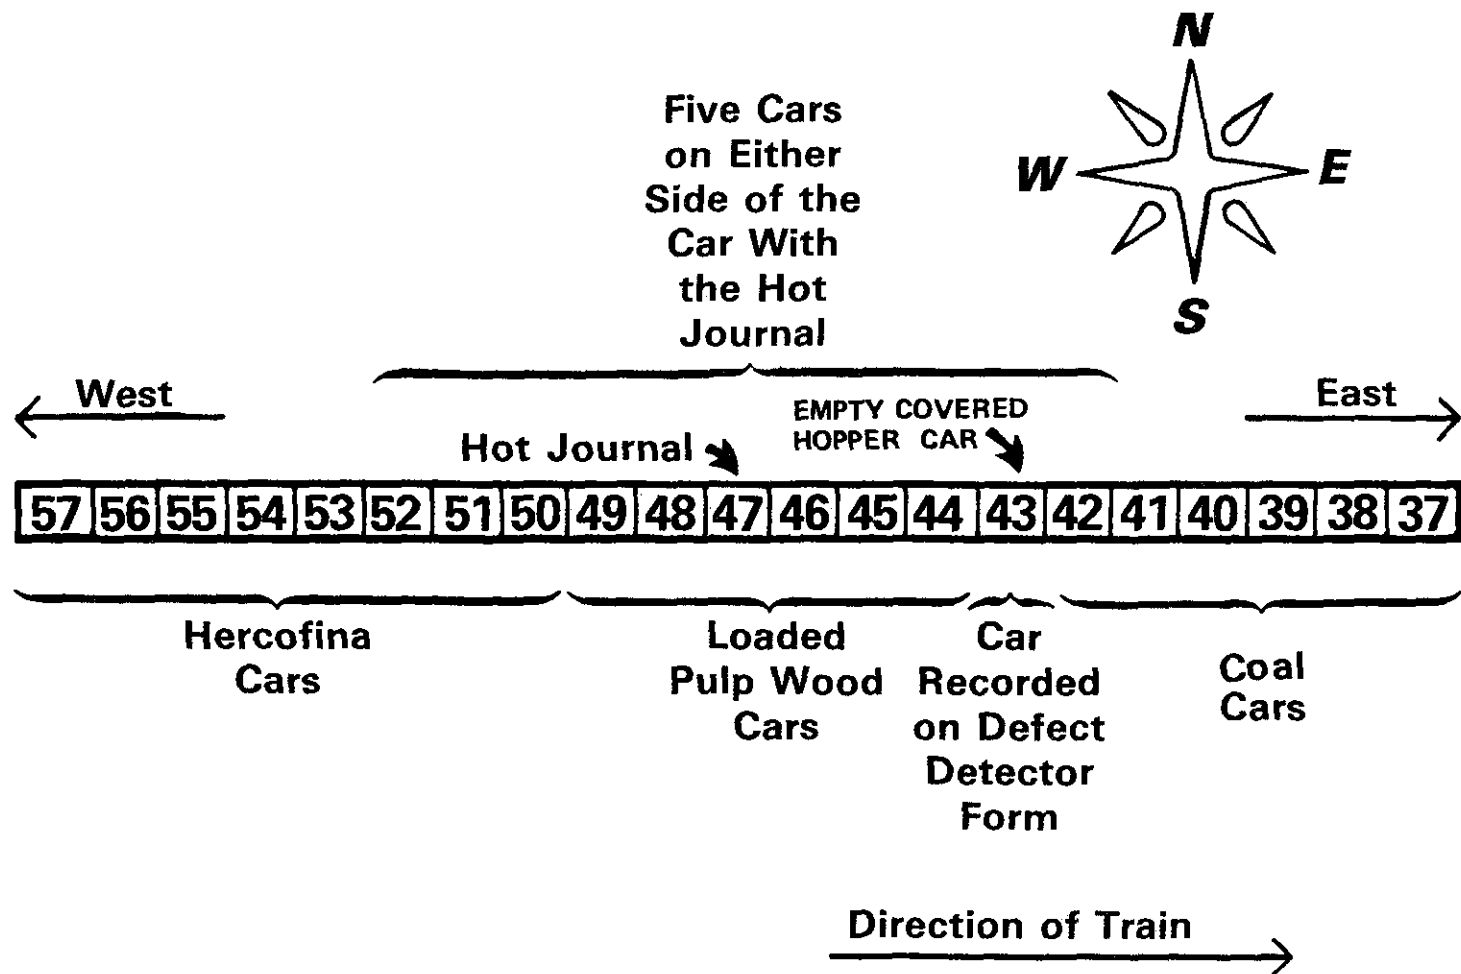
The train continued through the Charlotte Yard and Matthews, North Carolina, and passed a hotbox detector 2.1 miles east of Matthews. An alarm from the hotbox detector was received by the traincrew over the radio. The message advised that there were 362 axles in the train and that the journal on the left side of the 157th axle from the rear of the train was overheated. To determine which car to inspect, the front brakeman said he subtracted 4 axles for each of the three 6-axle locomotive units from 362 (the total number of axles in the train as stated by the alarm) and then subtracted 157 from the result. He divided the remainder by four, the number of axles on each freight car, and determined that the position of the car with the hot journal was the 47th car from the front of the train. (See figure 2.)

Figure 2.—Position of the cars near overheated journal  
in freight train FERHL at Charlotte and Matthews.

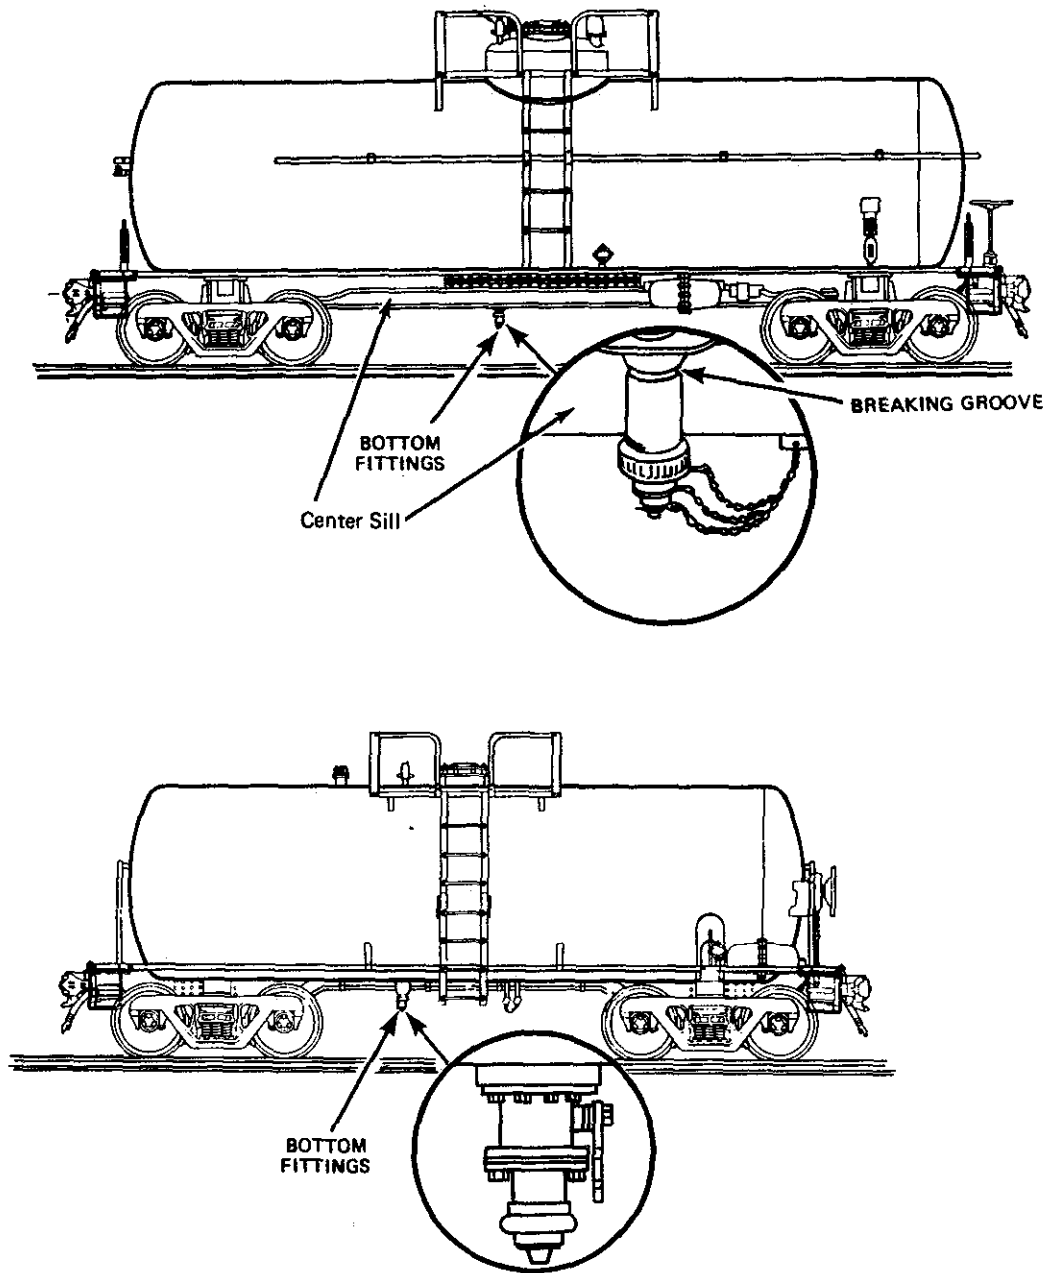
Figure 3.--Car with continuous full-length center sill (top) and car without continuous full-length center sill (bottom).

In this accident the tank cars transporting methanol were of the "stub sill" design, and their bottom outlets were struck during the derailment. The two tank cars that were not breached had internal valves, and their bottom outlet nozzles had breaking grooves that had been cut into the nozzles near the bottom of the tank. When these nozzles were broken from the tank, the valve seat was not destroyed, nor was a shearing force applied to the tank shell where the valve was attached; consequently, the methanol was contained safely by the tank. The two other tank cars containing methanol had bottom outlet nozzles less than 6 inches in length for which breaking grooves or other protection were not required. When these nozzles were struck during the derailment, the stress was transferred to the tank shells which were torn open, releasing their contents.
