# NATIONAL TRANSPORTATION SAFETY BOARD

## ✓ RAILROAD ACCIDENT REPORT, ///

REAR END COLLISION  
OF SEABOARD SYSTEM RAILROAD  
FREIGHT TRAINS EXTRA 8051 NORTH  
AND EXTRA 1751 NORTH  
SULLIVAN, INDIANA  
SEPTEMBER 14, 1983

✓  
NTSB/RAR-84/02,

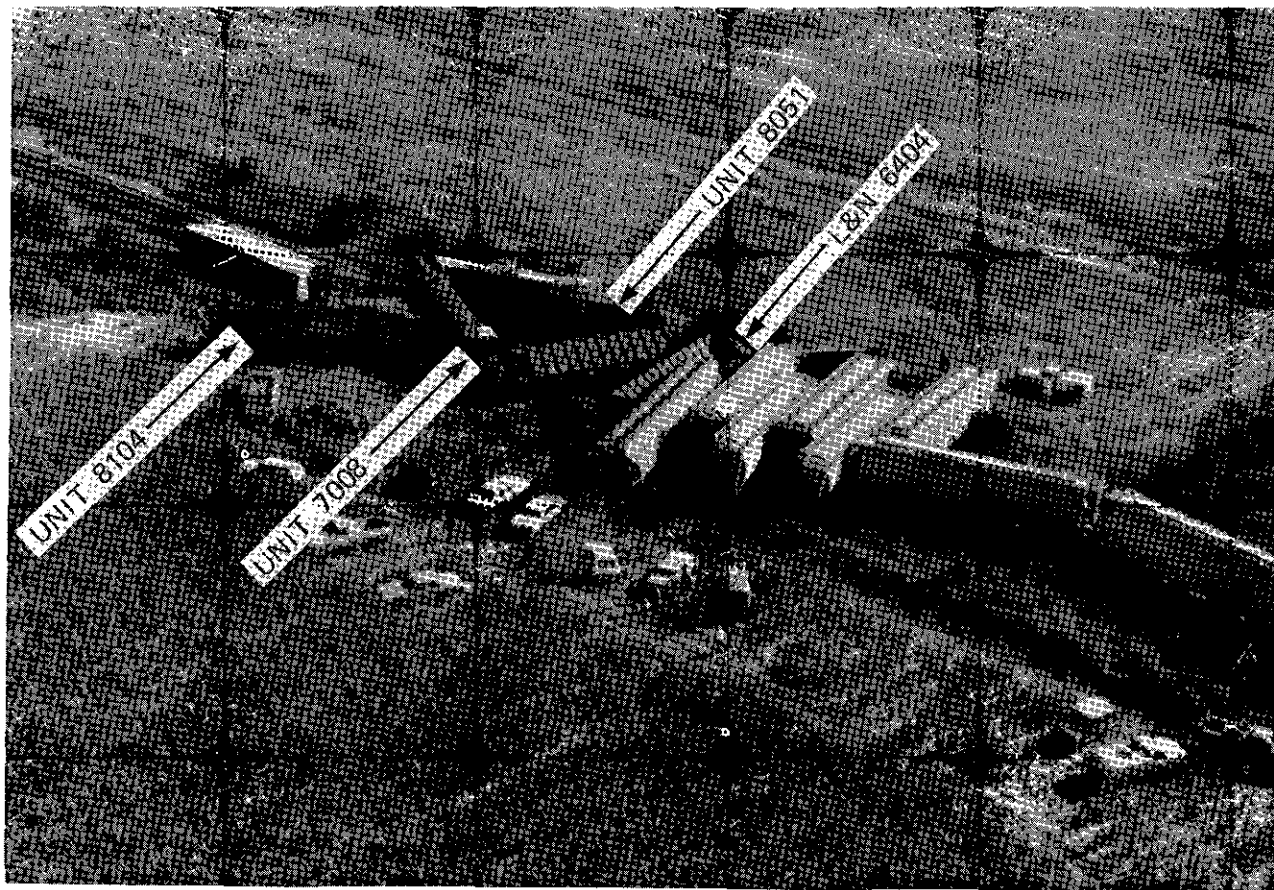
Figure 1.--Primary derailment of Extra 8051 North at point of impact.

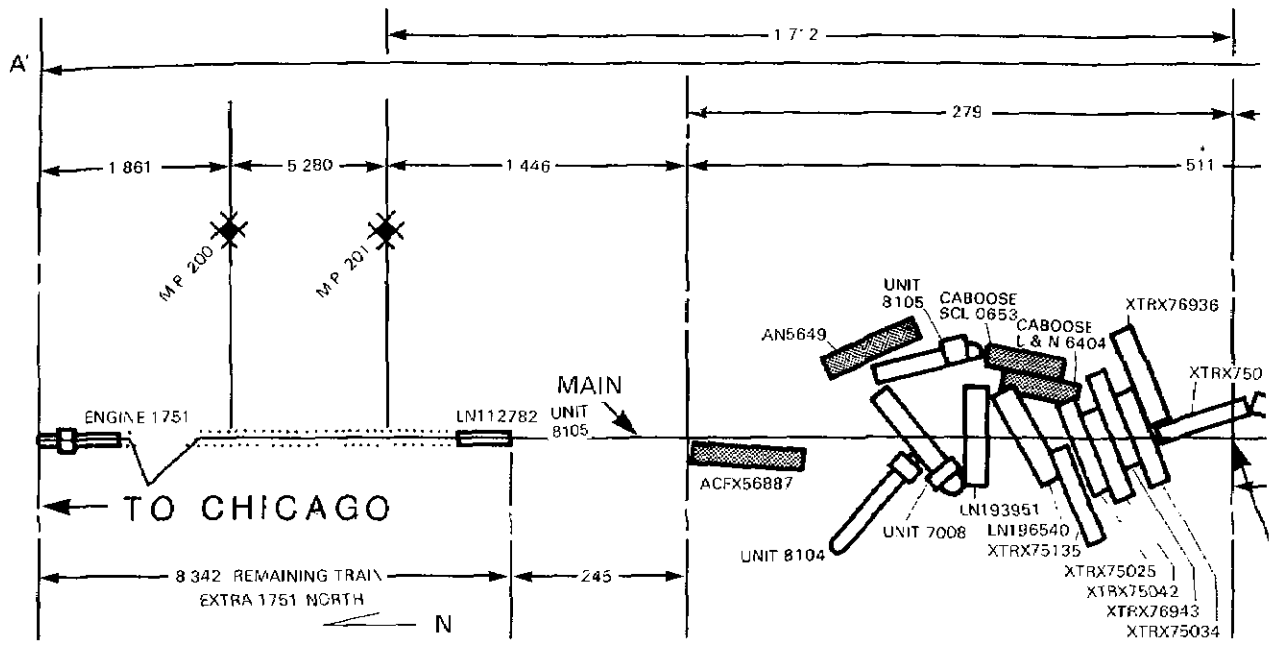
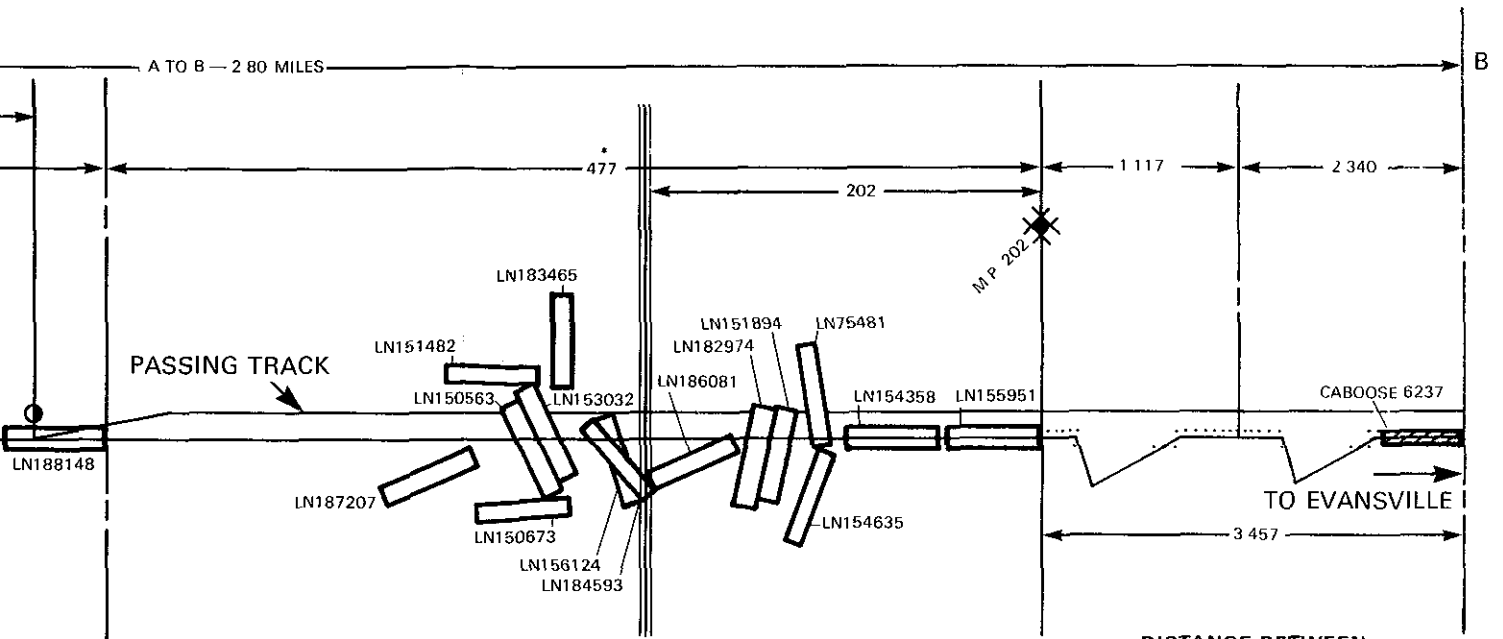
Primary derailment sites.

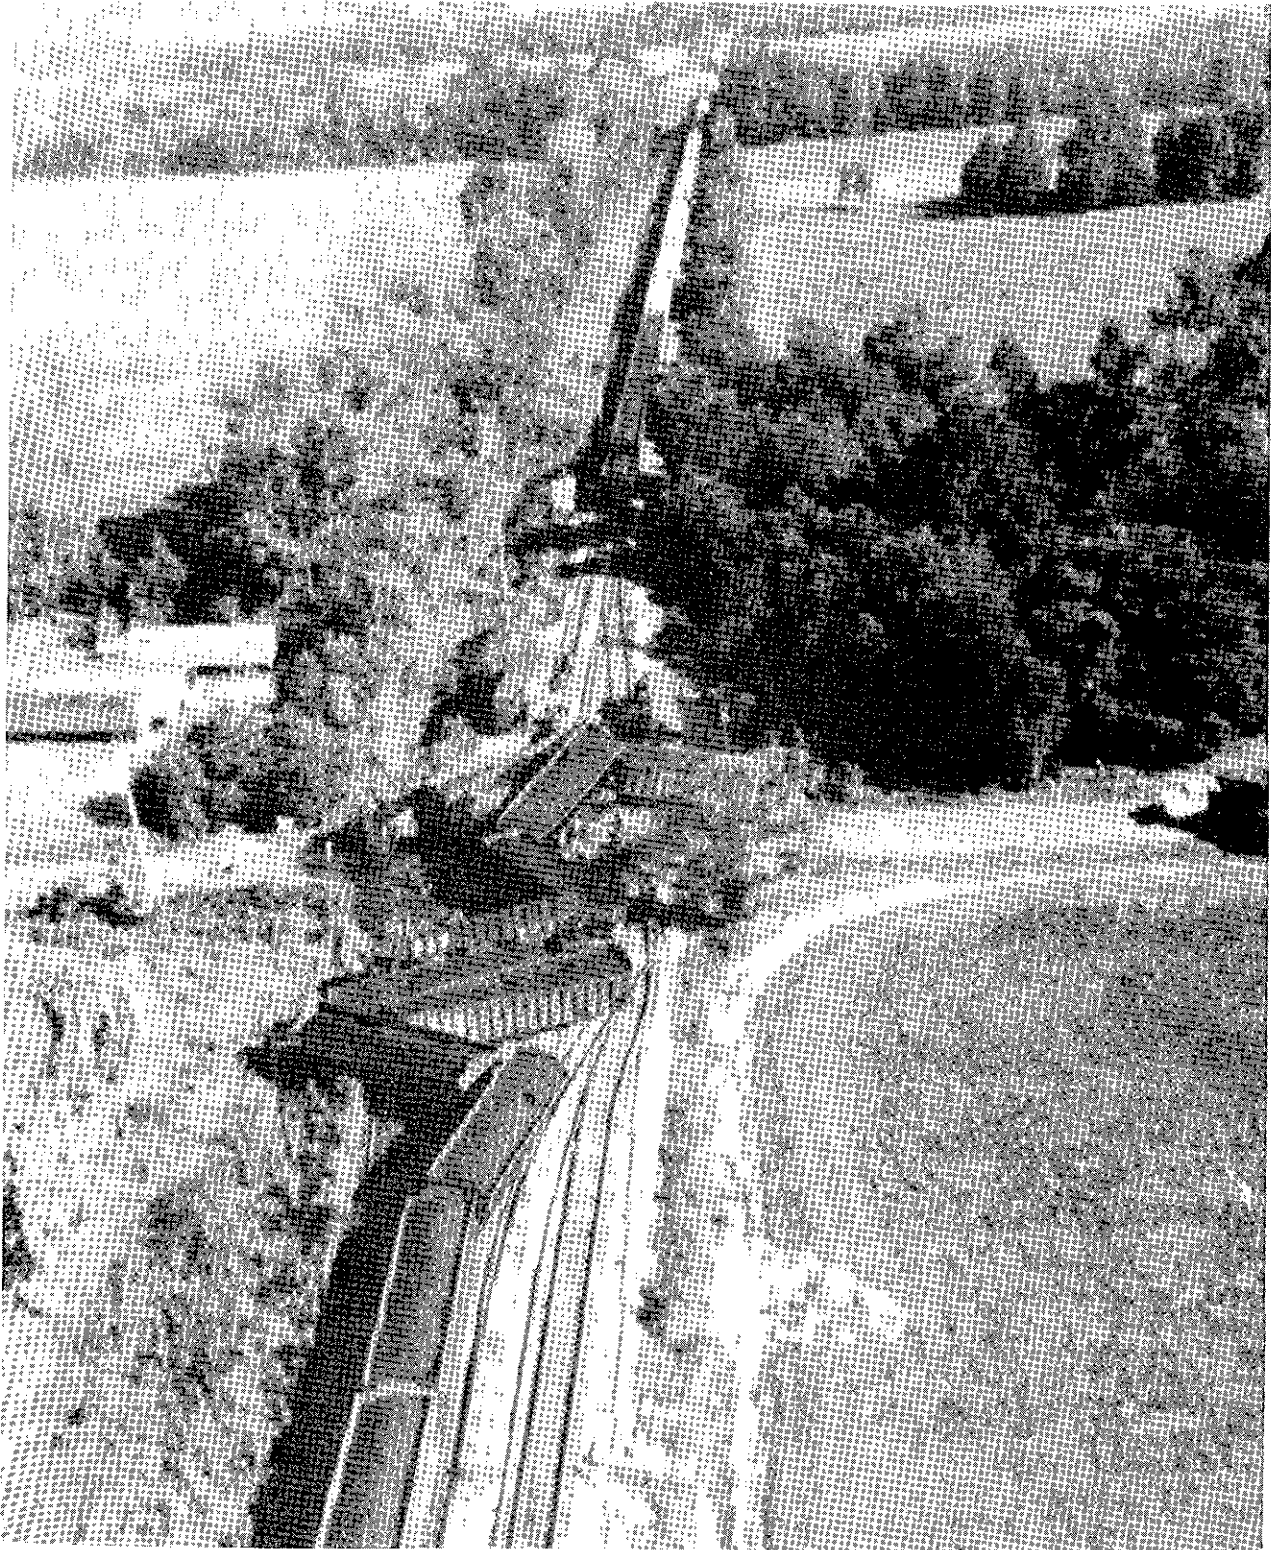
Figure 3.--Secondary derailment of Extra 8051 North  
at Glenora Street.

When the two cabooses and the two cars ahead of the cabooses of Extra 1751 North derailed, the derailed cars caused the airbrakes of Extra 1751 North to apply in emergency, and the train stopped with no damage to the balance of the train. Although the rear caboose of Extra 1751 North was damaged considerably by the striking locomotive of Extra 8051 North, the caboose was destroyed by the overriding fourth car of Extra 8051 North, which caused the caboose roof to collapse. (See figures 6 and 7.) The two cabooses and one car were destroyed, and one car was slightly damaged. The cars of both trains stopped generally perpendicular to the track, side-by-side, with some cars parallel to or in line with the track. (See figures 1, 2, and 3.)

At the point of impact, 312 feet of track built of 112-pound jointed rail were destroyed. At the point of the secondary derailment, 273 feet of main track and 240 feet of the siding were destroyed. In addition, a paved public road crossing on county road 56 was destroyed, and some cropland with crops adjoining the railroad was damaged. The SBD estimated the railroad damage to be:

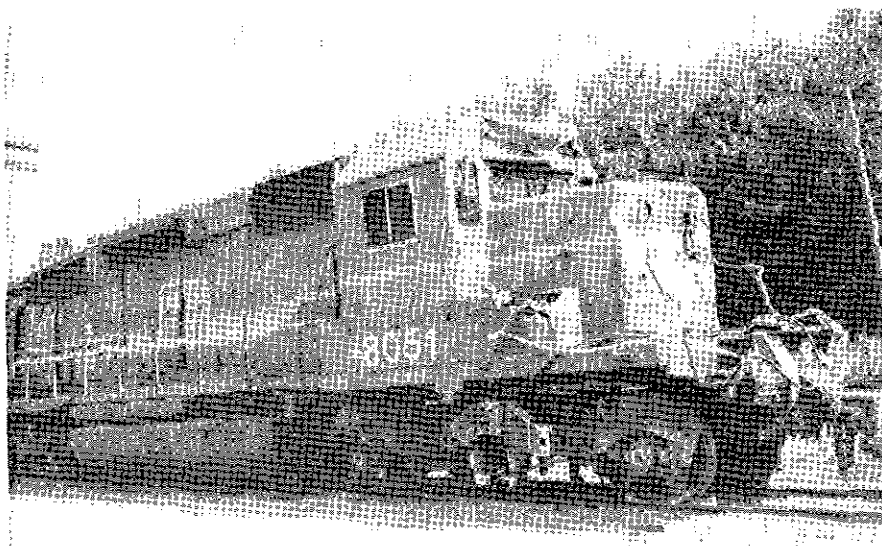
The trucks, brake equipment, and fuel tanks underneath the chassis of locomotive unit 8051 were damaged. (See figures 4 and 5.) The short hood and left side of the operating compartment of the unit were extensively damaged, and the long hood and safety appliances <sup>7/</sup> were bent and twisted. Also, the train line anglecock on the lead end of locomotive unit 8051 was missing. The second and third units, 8104 and 7008, received damage similar to that of the lead unit in the same general areas, but the damage was not as extensive.

Figure 4.--Damage to the engineer's side of the lead unit, L&N 8051, of train Extra 8051 North.

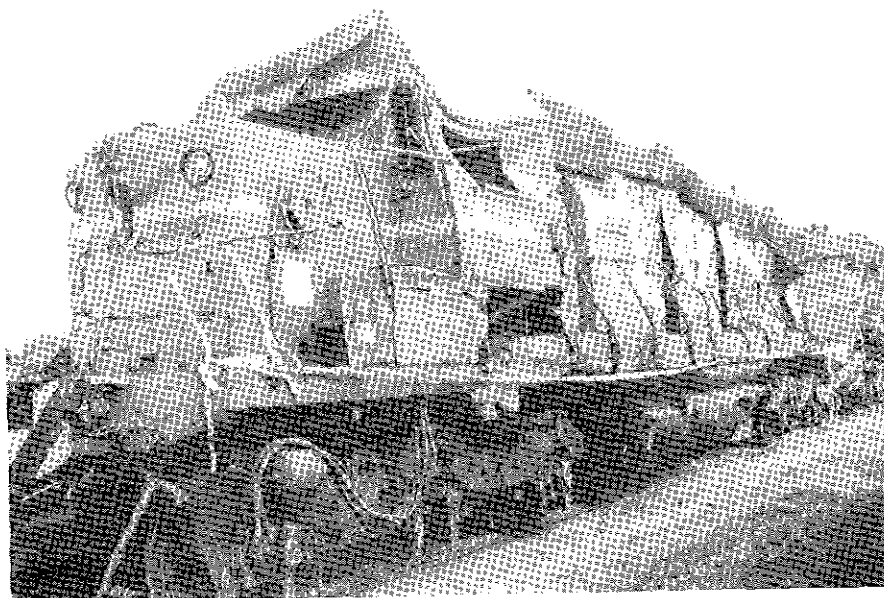
Figure 5.--Damage to the fireman's side of the lead unit, L&N 8051, of train Extra 8051 North.

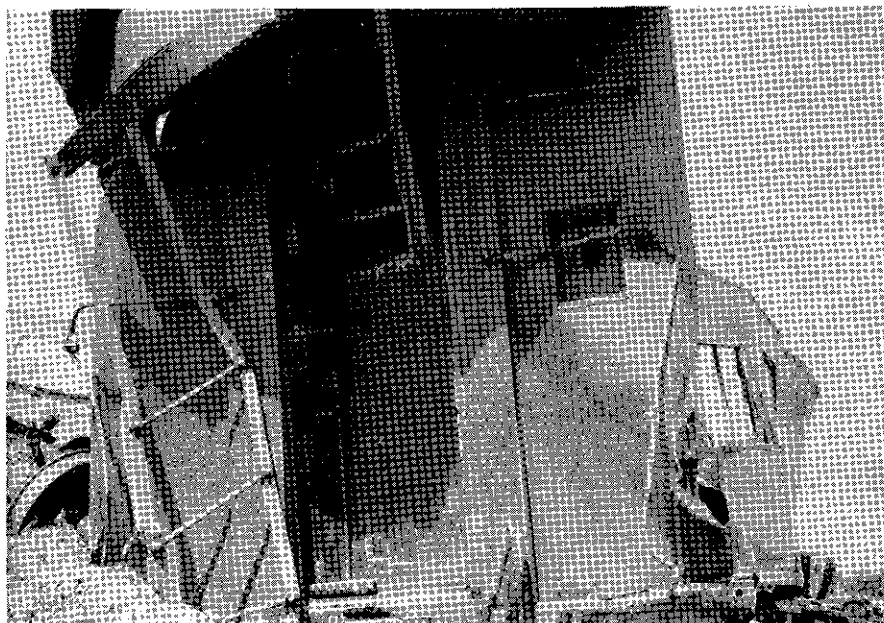
Figure 6.--Damage to "A" end of rear caboose, L&N 6404,  
of train Extra 1751 North.

The rear caboose of Extra 1751 North was destroyed when the fourth car behind the locomotive of Extra 8051 North landed on the caboose's roof during the derailment. The force and weight of the car collapsed the roof of the caboose into the interior and crushed the two crewmembers riding there. The conductor was pinned in his seat, and the rear brakeman was found lying partially on the floor in the caboose and extending to the ground through a separation in the caboose floor.

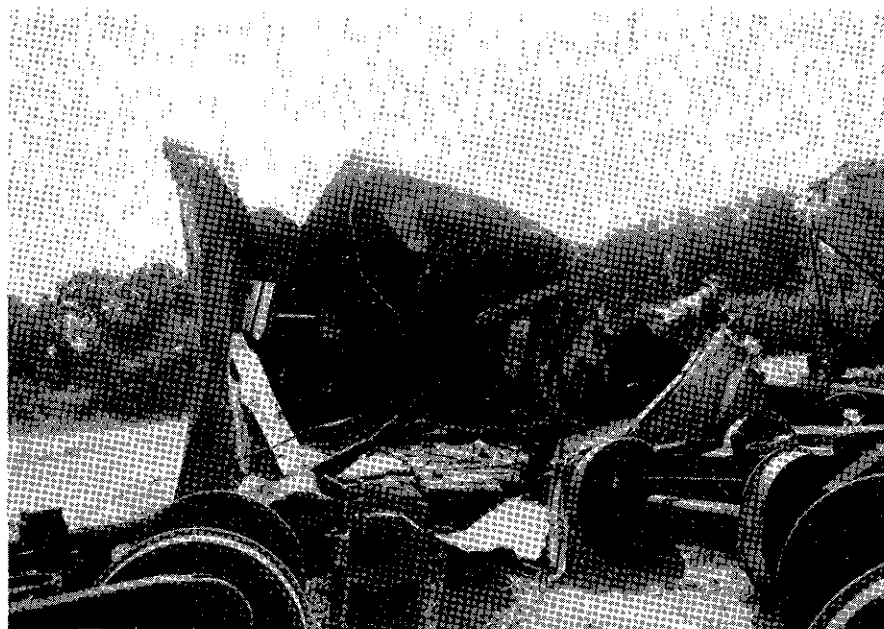
Figure 7.--Damage to "B" end of rear caboose, L&N 6404,  
of train Extra 1751 North.
