Department
of Transportation
**Railroad
Administration**

Railroad Accident Investigation Report, No. 12-88.

**Southeastern Pennsylvania Transportation Authority
Norristown, Pennsylvania
January 12, 1988**

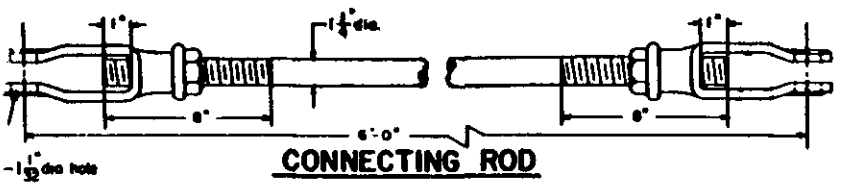
CONNECTING ROD FOR NEW CENTURY SWITCH STAND

The Matlack Company siding is located about 1/4 mile north of the turnout which begins the Stoney Creek Branch of Conrail and also leads to the Elm Street SEPTA Station. The attached sketch shows the track arrangements in the general area. The Matlack siding was equipped with a Hayes sliding derail, operated by a hand-throw stand of a design used widely by the old Reading Company, which originally owned this trackage. The investigation found the derail in the "off", or non-derailing, position. Examination revealed a broken screw jaw on the end of the connecting rod which attaches to the hand throw crank with a steel pin. The break appeared to be a 100 percent new break. The piece broken off was found several feet away against a fence, indicating a sudden failure due to high impact forces being applied, most likely by the lead wheels of the runaway car as it passed over the derail. The screw jaw at that end of the connecting rod were flared, or spread apart, enough to not allow the connecting pin to go through both, thus placing the full impact force onto one screw jaw. The screw jaw broke rather than the pin because the screw jaw is cast steel and the pin is forged.

There were marks that would indicate that the derail shoe was hit by a wheel and pushed back out of the way, but they were slightly rusty. In any case, failure of the device was caused by Conrail's failure to replace a bent screw jaw whenever it occurred which forced the full impact of a rolling car onto the one undamaged side of the screw jaw which was unable to sustain the stress.
