RAILROAD ACCIDENT INVESTIGATION

REPORT NO. 4131

SOUTHERN PACIFIC COMPANY

BASSETT, CALIF.

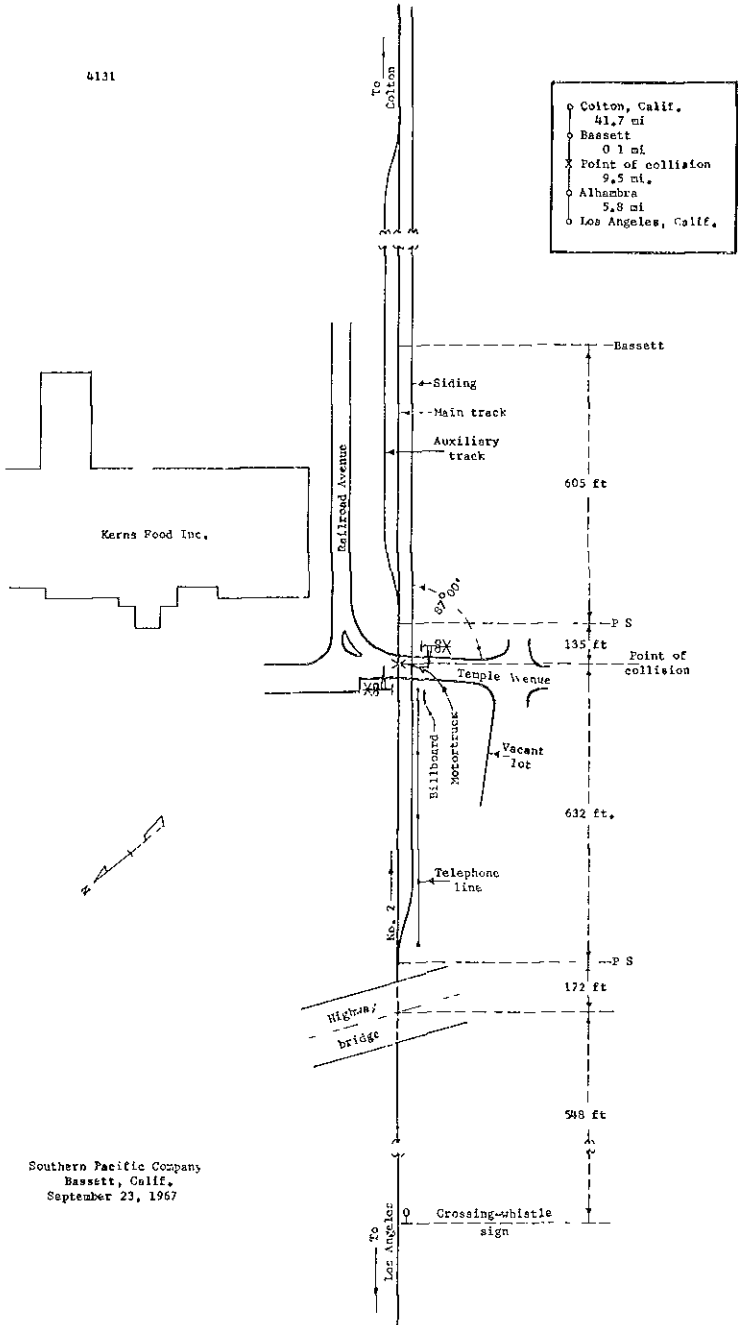
East of the crossing, Railroad Avenue parallels the main track on the north at approximately 110 feet. It intersects Temple Avenue north of the railroad crossing, as shown in the sketch appended to this report. A plant of Kerns Food, Inc. is in the northeast angle of the intersection of Railroad Avenue and Temple Avenue as also shown in the sketch. A vacant lot is across the tracks from this plant. It is in the southwest angle of the railroad crossing and is adjacent to both Temple Avenue and the railroad right-of-way. Motortrucks hauling commodities for Kern Foods, Inc. use the vacant lot for parking. When leaving the lot, the motortrucks may enter Temple Avenue at a point about 42 feet south of the center of the railroad crossing.

As a motortruck enters Temple Avenue from a point on the vacant lot immediately south of the railroad right-of-way and proceeds toward the crossing, the driver's view of the main track westward is intermittently restricted by the poles supporting the billboard, the line of telephone poles, the signal-circuit housings adjacent to one of the telephone poles, and piles supporting the highway bridge 804 feet west of the crossing. However, as the vehicle passes the line of telephone poles and approaches the main track within a distance of 30 feet, the driver's view westward increases and he may readily observe an eastbound train approaching the crossing throughout a distance of about one-half mile.
