✓  
RAILROAD ACCIDENT REPORT,

SOUTHERN PACIFIC RAILROAD COMPANY  
FRUITRIDGE ROAD GRADE CROSSING  
SACRAMENTO, CALIFORNIA  
February 22, 1967.

U.S. NATIONAL TRANSPORTATION SAFETY BOARD,

SOUTHERN PACIFIC RAILROAD COMPANY  
FRUITRIDGE ROAD GRADE CROSSING  
SACRAMENTO, CALIFORNIA  
FEBRUARY 22, 1967

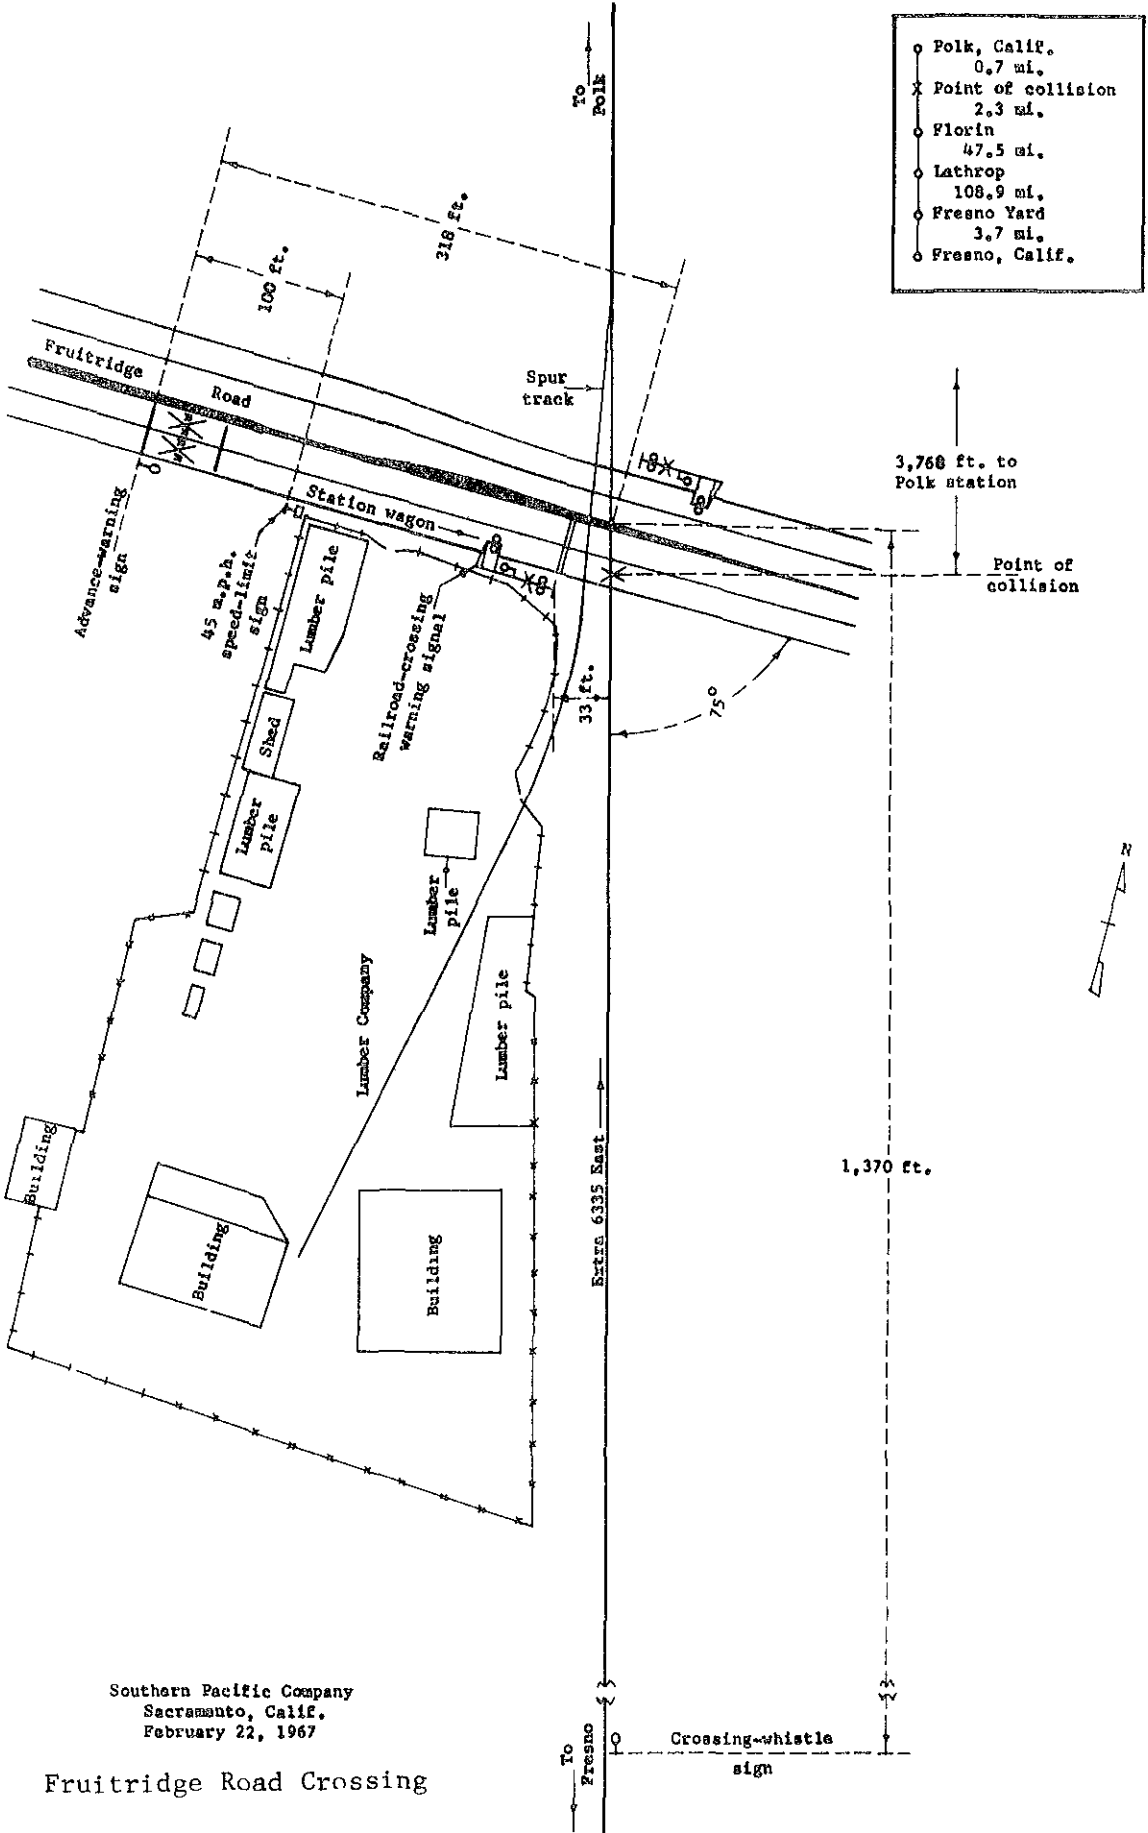
APPENDIX II

2. The Railroad Right-of-Way. (Appendix II) The accident occurred on part of the San Joaquin division of Southern Pacific Co. extending between Fresno and Polk, California, a distance of approximately 163 miles. In the accident area, this is a single-track line with centralized traffic control where trains are operated by signal indications. The Southern Pacific timetable shows train directions as eastward and westward, but the track actually runs geographically northward and southward. The geographic directions are used in this report.

The side track which serves the lumber yard originates 167 feet north of Fruitridge Road and crosses the road about 15 feet west of the main track. Side tracks serving Proctor & Gamble's plant and the Sacramento Army Signal Depot are also in the vicinity, but do not cross Fruitridge Road. Prior to the installation of the approach predictors after the accident, the railroad crossing warning devices were activated whenever any of the switches in the mainline serving these side tracks were opened. The main track is virtually straight and level for at least 1000 feet southward from the crossing.

4. Obstruction to Vision at the Grade Crossing. As eastbound traffic approaches the crossing on Fruitridge Road, view of northbound trains approaching from the south is restricted until a vehicle reaches a point 33

feet from the main track. A vehicle must also advance to this point before the engineman or brakeman in the cab of a northbound locomotive can see it. After an eastbound auto on Fruitridge Road crosses Power Inn Road, trains to the north of the crossing can be seen without obstruction. Westbound highway traffic has a sufficient view of a train from either direction unless there are freight cars standing on the sidetracks in the Proctor and Gamble plant adjacent to the crossing on the east side of the mainline.
