## INTERSTATE COMMERCE COMMISSION

REPORT OF THE DIRECTOR OF THE BUREAU OF SAFETY CONCERNING AN  
ACCIDENT ON THE LINE OF THE SOUTHERN PACIFIC COMPANY  
NEAR COCHRAN, OREGON, ON AUGUST 6, 1935.

Inv. No. 2002  
Southern Pacific Company  
Cochran, Oregon  
August 6, 1935

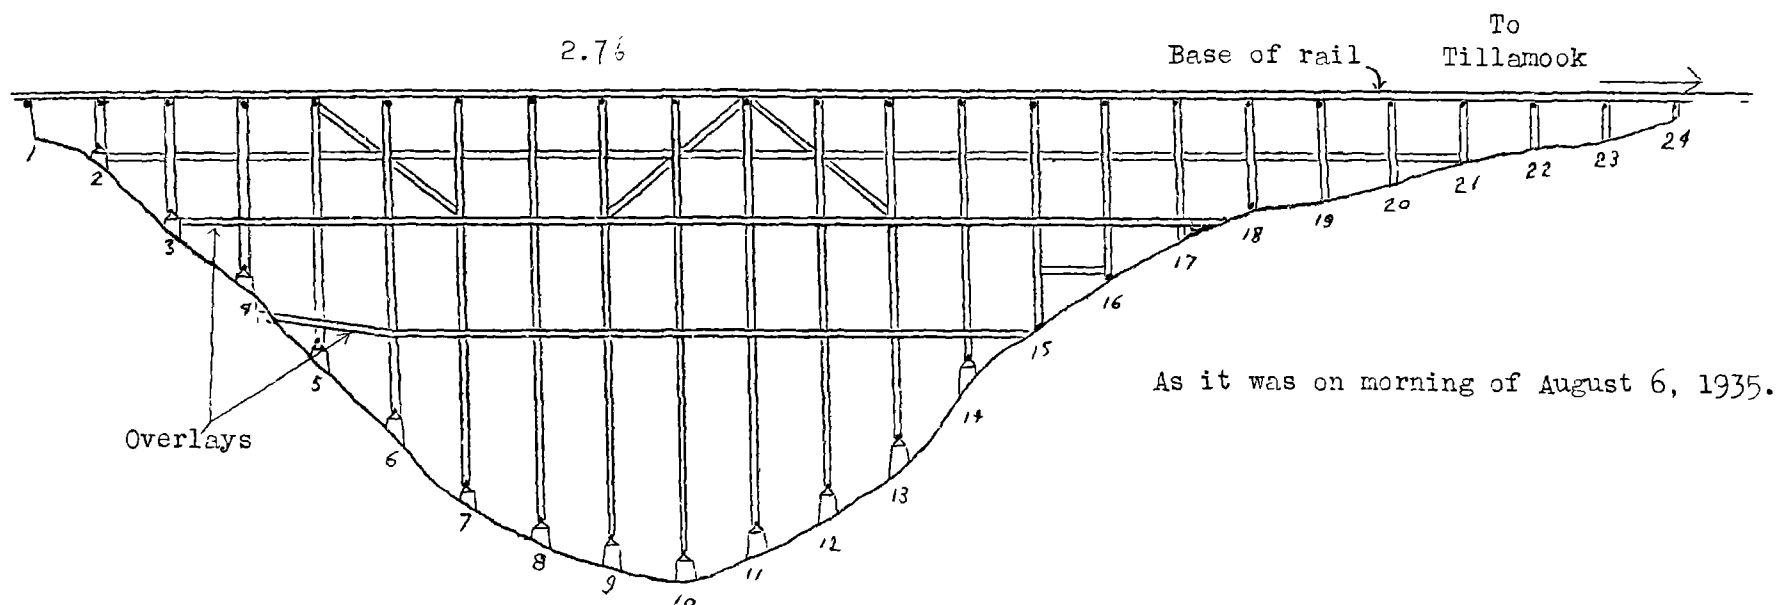
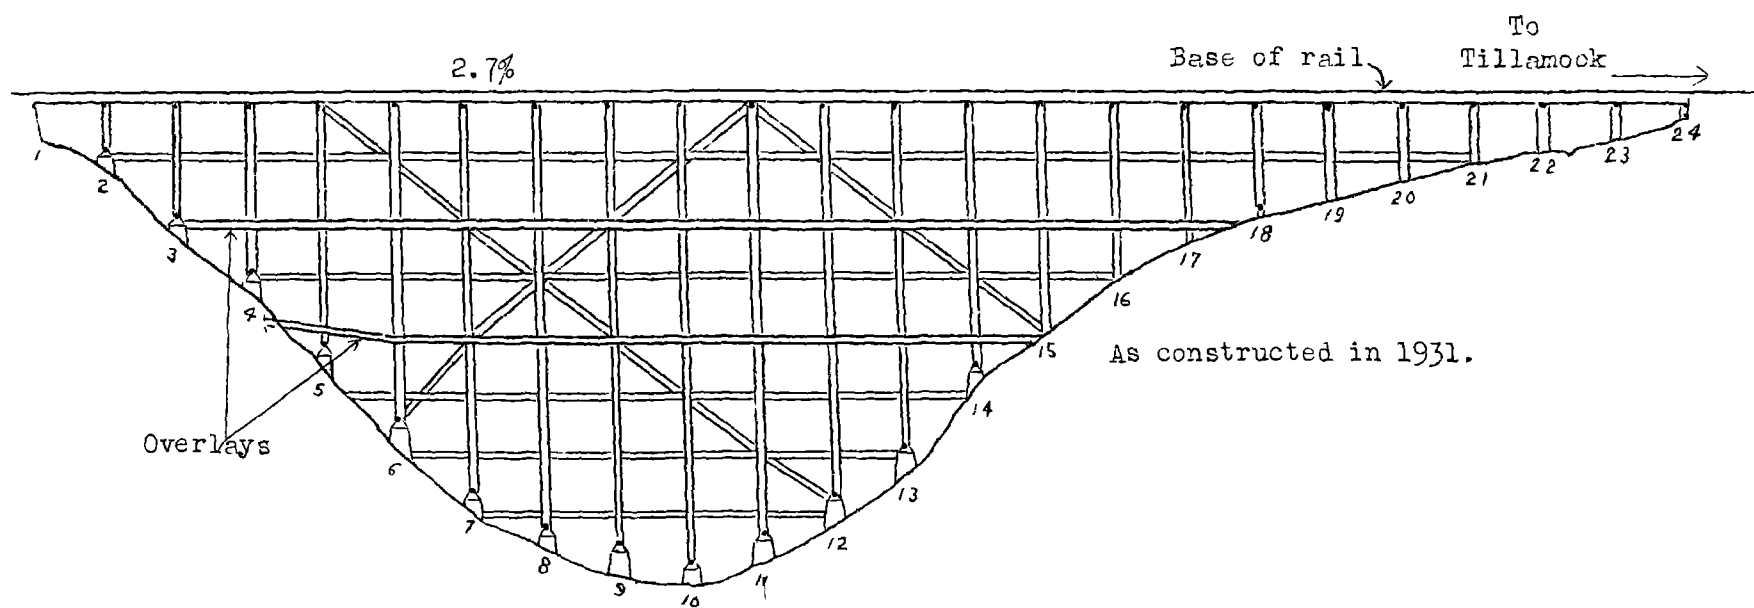
Profile on Centerline of Trestle 802-K

Trestle 802-K, involved in this accident, is approximately 344 feet in length, with 6° curvature, and spans a deep canyon with precipitous slopes. The maximum height of the trestle is approximately 100 feet above Little Baldwin Creek. At the east end of the trestle is a concrete abutment, followed by 15 frame bents on concrete pedestal piers, bents 8 to 10, inclusive, practically spanning the creek. The trestle continues up the slope, bents 15 to 24, inclusive, consisting of cedar piles and timber bulkheads. The highest frame bent is No. 9, with

This trestle is constructed in three separate stories, upper stories resting upon a floor system of overlay timbers, 12 by 12 inches in size, extending longitudinally. The lower story rests upon sills placed upon concrete pedestals. The deck of the trestle consists of 6 stringers, all bents bolted together, with longitudinal girt consisting of 8 courses of timbers, 6 by 8 inches in size.

Repair work involving replacement of the lower stories of bents 4 to 14, inclusive, was commenced on July 8, 1935. The central story, including the overlay systems, had been completed; replacement of the lower story had progressed eastward from bent 14 and the bridge gang was working on bents 7 and 8 at the time of accident. The new creosoted bent 9 was completed and in place on pedestal piers, the old bent displaced to the west but not removed. Creosoted bent 8 had been shoved and framed into position east of old bent 8. The individual posts of creosoted bent 7 had been dropped into place but not framed. The duties of sash and sway braces are to prevent spreading of vertical members and to prevent lateral sway, while longitudinal and tower braces prevent longitudinal movement.

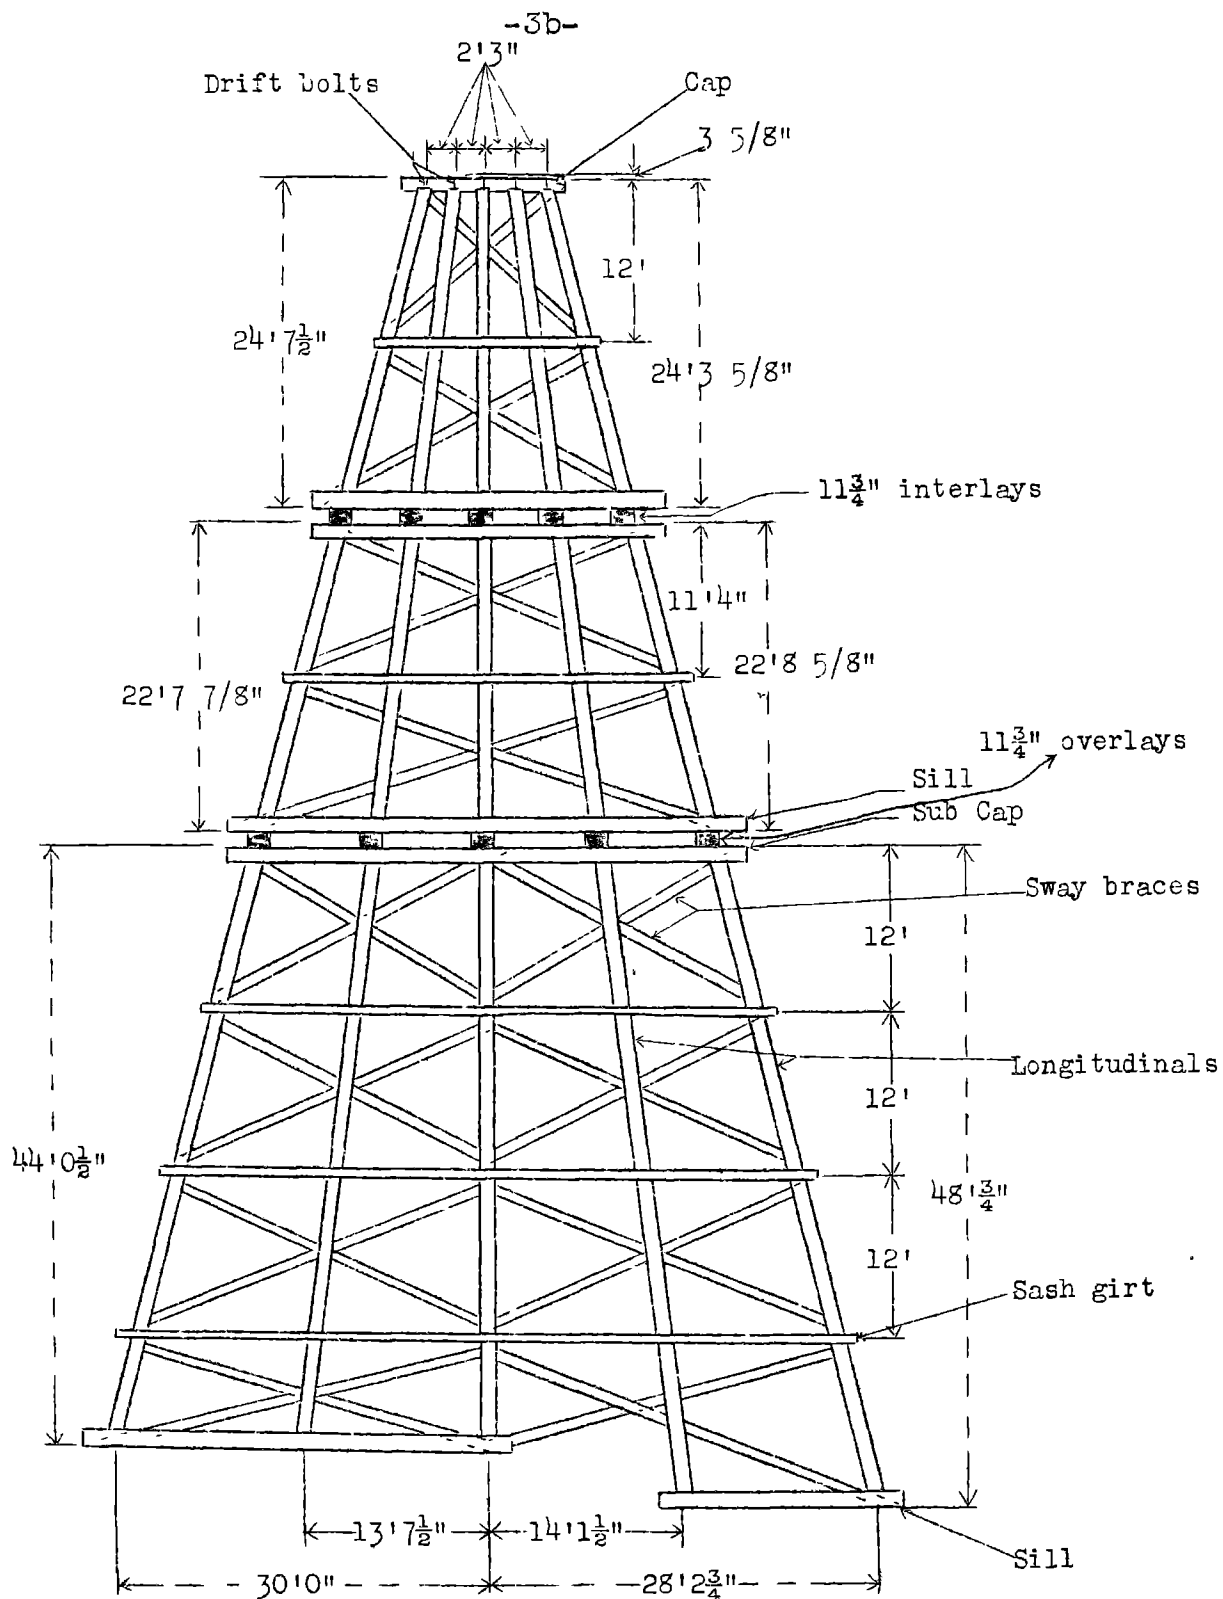
Bent No. 9

Bent 9 is typical of the structure. The upper story consists of 5 posts, sills and cap, 24 feet 7 inches in height, sway bracing in standard manner, sash bracing at 12-foot intervals, and bent resting on overlay or interlay timbers. The second story is similarly constructed, 22 feet 8 inches in height, and rests upon the second system of overlay or interlay timbers. The lower story is similarly constructed except for variation in height, upstream 44 feet and downstream 48 feet; the bottom rests on sills placed upon concrete pedestals.

Bridge and Building Supervisor Chesney stated that longitudinal braces are not immediately replaced on new construction, but all sway braces and sash girts are in place and the overlay is sufficient to prevent longitudinal movement. All tower and longitudinal braces between bents 7 and 14, below the upper overlay, were removed during reconstruction and had not been replaced. He thought the accident was due to the fact that bent 8 was weakened by removal of sway braces from its east side and by absence of longitudinal braces, permitting both lateral and longitudinal movement; probably movement of the train upon this bent and an emergency application of air brakes caused the structure to collapse. Examination of the wreckage disclosed that sway braces on the west side of bent 8 were broken.

Subsequent to the accident this bridge was examined by representatives of the Commission. A new creosoted bent, number 7, not completely framed, leaned against concrete pier 6; leaning on new bent 7 was old bent 7, which had been supporting its load, sash and sway braces not being removed; resting on old bent 7 was new bent 8, completely framed, old bent 8 had been supporting the load. Apparently the longitudinal braces on old bent 8 were unbolted and the sway braces on one side removed to permit replacement by new bent 8. New bent 9, fully framed and braced, rested on old bent 8; old bent 9, not in use, rested on new bent 9; new bent 10, completely framed, rested against old bent 9. Bent 10 was located at the bottom of the canyon.
