INVESTIGATION NO. 3100
SOUTHERN PACIFIC COMPANY
REPORT IN RE ACCIDENT
AT GUASTI, CALIF., ON
APRIL 27, 1947

Railroad: Southern Pacific
Date: April 27, 1947
Location: Guasti, Calif.
Kind of accident: Derailment
Train involved: Passenger
Train number: 6
Engine number: 4438
Consist: 18 cars
Speed: 65 m. p. h.
Operation: Timetable, train orders, and
automatic block-signal system
Track: Single; tangent; 0.514 percent
ascending grade eastward
Weather: Clear
Time: 9:48 p. m.
Casualties: 77 injured
Cause: Broken switch-rail

Accident at Guasti, Calif., on April 27, 1947, caused
by a broken switch-rail.

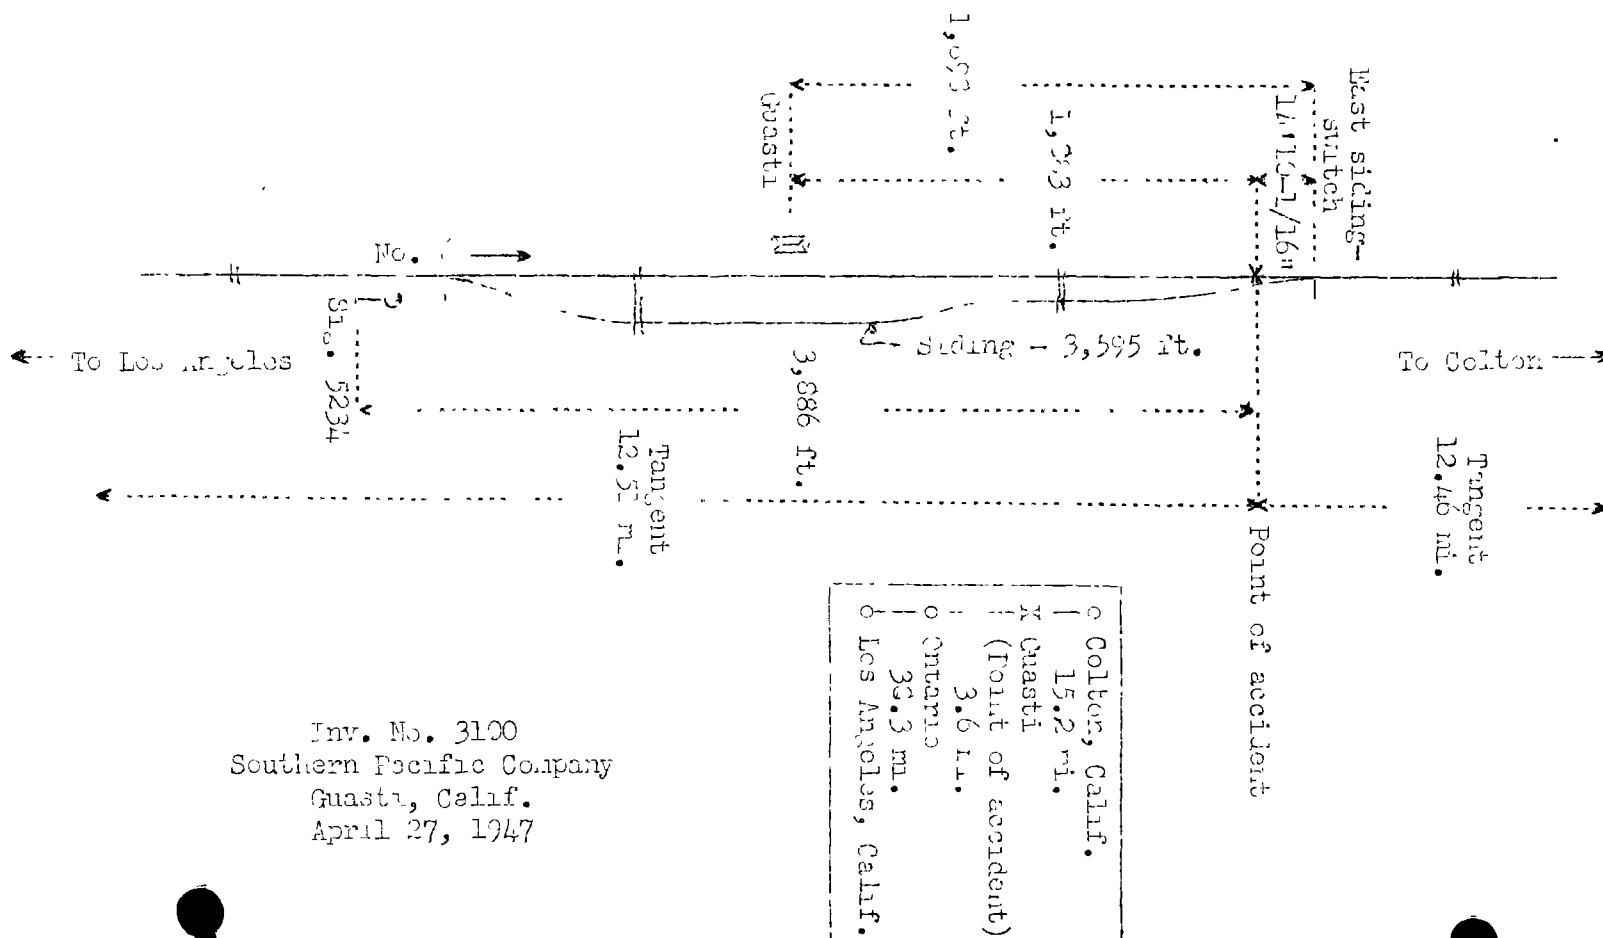
Sketch showing broken switch-rail

After the accident the south switch-rail of the east siding-switch at Guasti was found overturned toward the center of the track. It was broken into five pieces, four of which were recovered. The first break was an irregular break at a point 2-5/8 inches east of the heel of the switch-rail. This break extended diagonally downward and westward to a point where it broke out at the heel-end 1-7/8 inches below the head of the rail. The other breaks were a result of a horizontal fracture in the web which started at the heel-end and progressed eastwardly in an irregular line through both angle-bar bolt holes and the most westwardly of the rivet holes for securing the reinforcing bar. This rivet was located 19-1/2 inches east of the heel-end of the switch-rail. At this latter point the break separated into two legs, one of which progressed upward through the head of the rail in practically a square break at a point 19-15/16 inches east of the heel, and the other extended downward at a slight angle through the base of the rail at a point about opposite the break through the head. The receiving end of the second break through the head of the switch-rail was considerably battered by the flanges of wheels. The surfaces of the horizontal break were somewhat battered and were so polished by friction that it could not be determined if a progressive fracture had existed. However, there was some discoloration of metal on the surfaces of the horizontal fracture in the area between the two angle-bar bolt holes. Prior to the accident, this discoloration had not reached the

outer surfaces of the web of the rail. The remainder of the breaks were new. The division engineer said that in his opinion a hair-line horizontal fracture had existed between the angle-bar bolt holes and had progressed until breaks occurred through the head, the web and the base of the switch-rail at a point 19-15/16 inches east of the heel-end. Apparently, the portion above the horizontal fracture dropped inward during the passage of the wheels of the engine and the first two cars of No. 6, then the front wheels of the third car became derailed.
