## INTERSTATE COMMERCE COMMISSION

REPORT OF THE DIRECTOR OF THE BUREAU OF SAFETY IN RE  
INVESTIGATION OF AN ACCIDENT WHICH OCCURRED ON THE  
LINE OF THE SOUTHERN PACIFIC COMPANY NEAR DOME,  
ARIZ., ON AUGUST 5, 1931.

September 23, 1931.

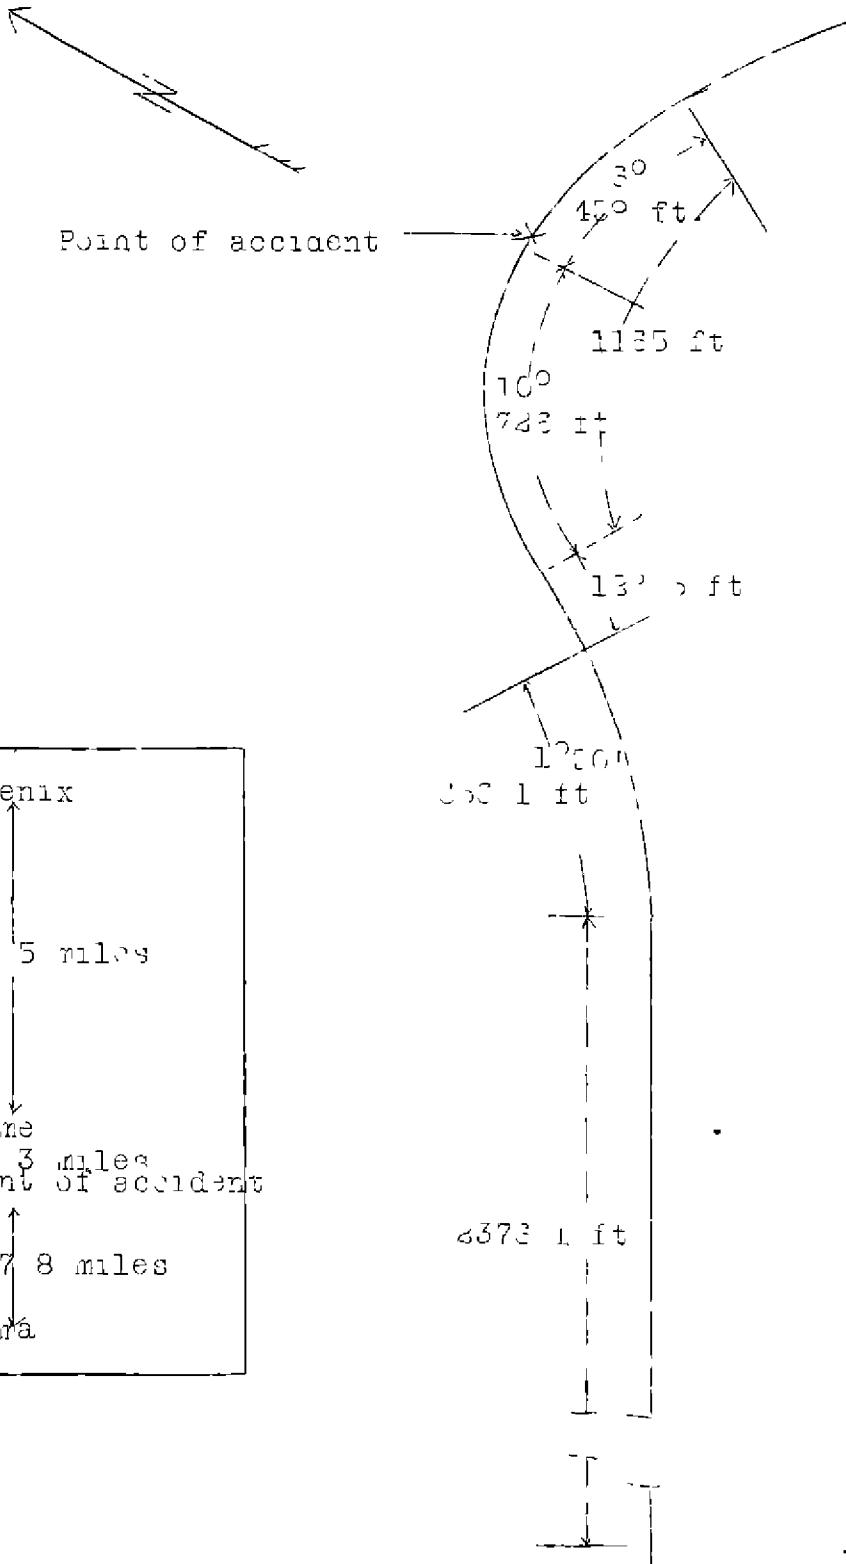
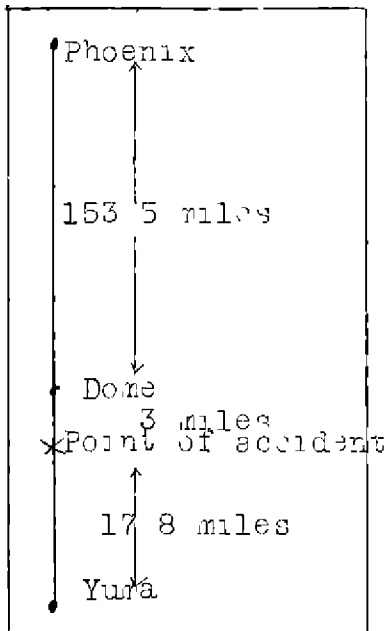
Inv No 1718  
 Southern Pacific Co ,  
 Done, Arizona  
 August 5, 1931

Point of accident

The first mark of derailment was found on the bolt heads on the outside of a rail joint on the high or outside rail at a point 15 feet east of the leaving end of the 10° curve. Flange marks also were found on the ends of the ties, leading down the embankment. There were no marks of any kind at the point of derailment on the low or south rail, or between the rails.

This accident was caused by excessive speed on a sharp curve.
