INTERSTATE COMMERCE COMMISSION

REPORT OF THE DIRECTOR OF THE BUREAU OF SAFETY CONCERNING AN
ACCIDENT ON THE LINE OF THE SOUTHERN PACIFIC COMPANY AT
ETIWA, CALIF., ON JANUARY 12, 1933.

Inv. No. 1804
 Southern Pacific Company
 Etiwa, Calif.
 January 12, 1933.

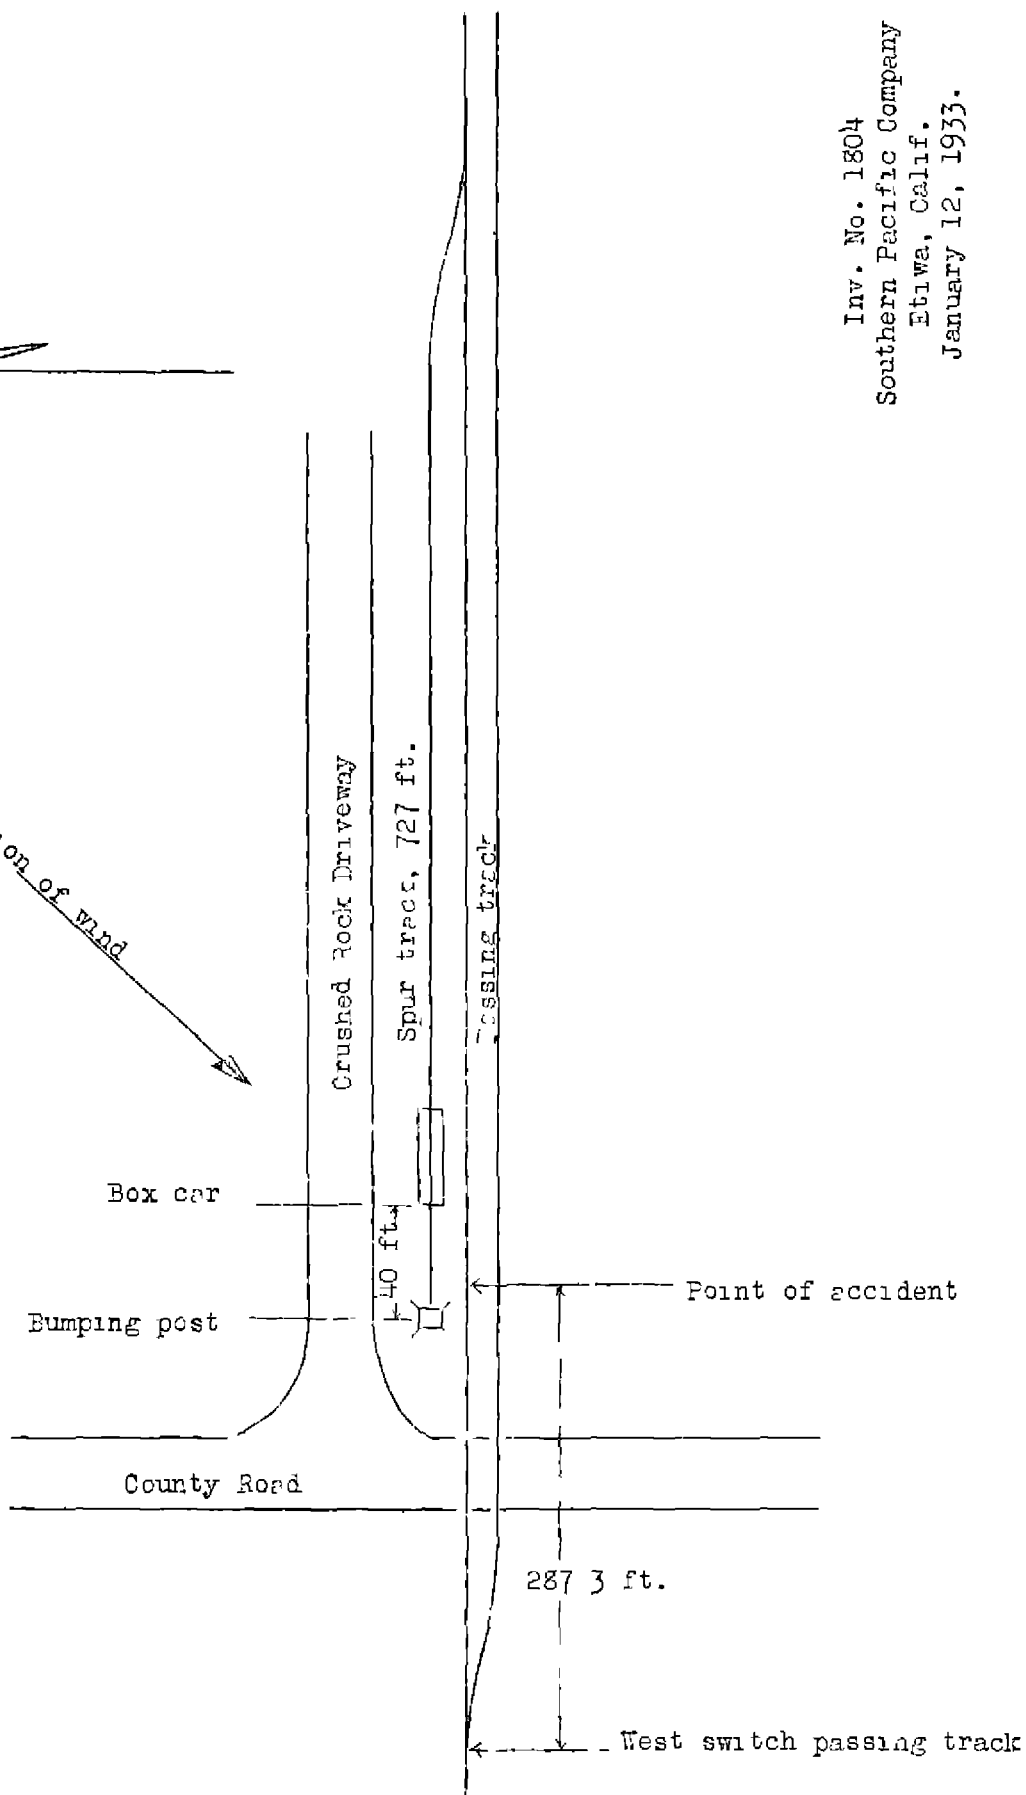
Direction of wind

This accident was caused by a drift of sand on the track.

The statements made by the surviving members of the crew of train No. 820 showed that sand had been blown on the track up to a depth of several inches above the tops of the rails, the sand extending along the track a distance of more than 20 feet. It was found that this drift had been formed by the sand swirling around a box car and the bumping post at the western end of the spur track, causing an eddy which resulted in accumulating the sand on the main track.
