REPORT NO. 3490
SOUTHERN PACIFIC COMPANY
IN RE ACCIDENT
AT GUADALUPE, CALIF., ON
OCTOBER 21, 1952

Date: October 21, 1952

Location: Guadalupe, Calif.

Kind of accident: Side collision

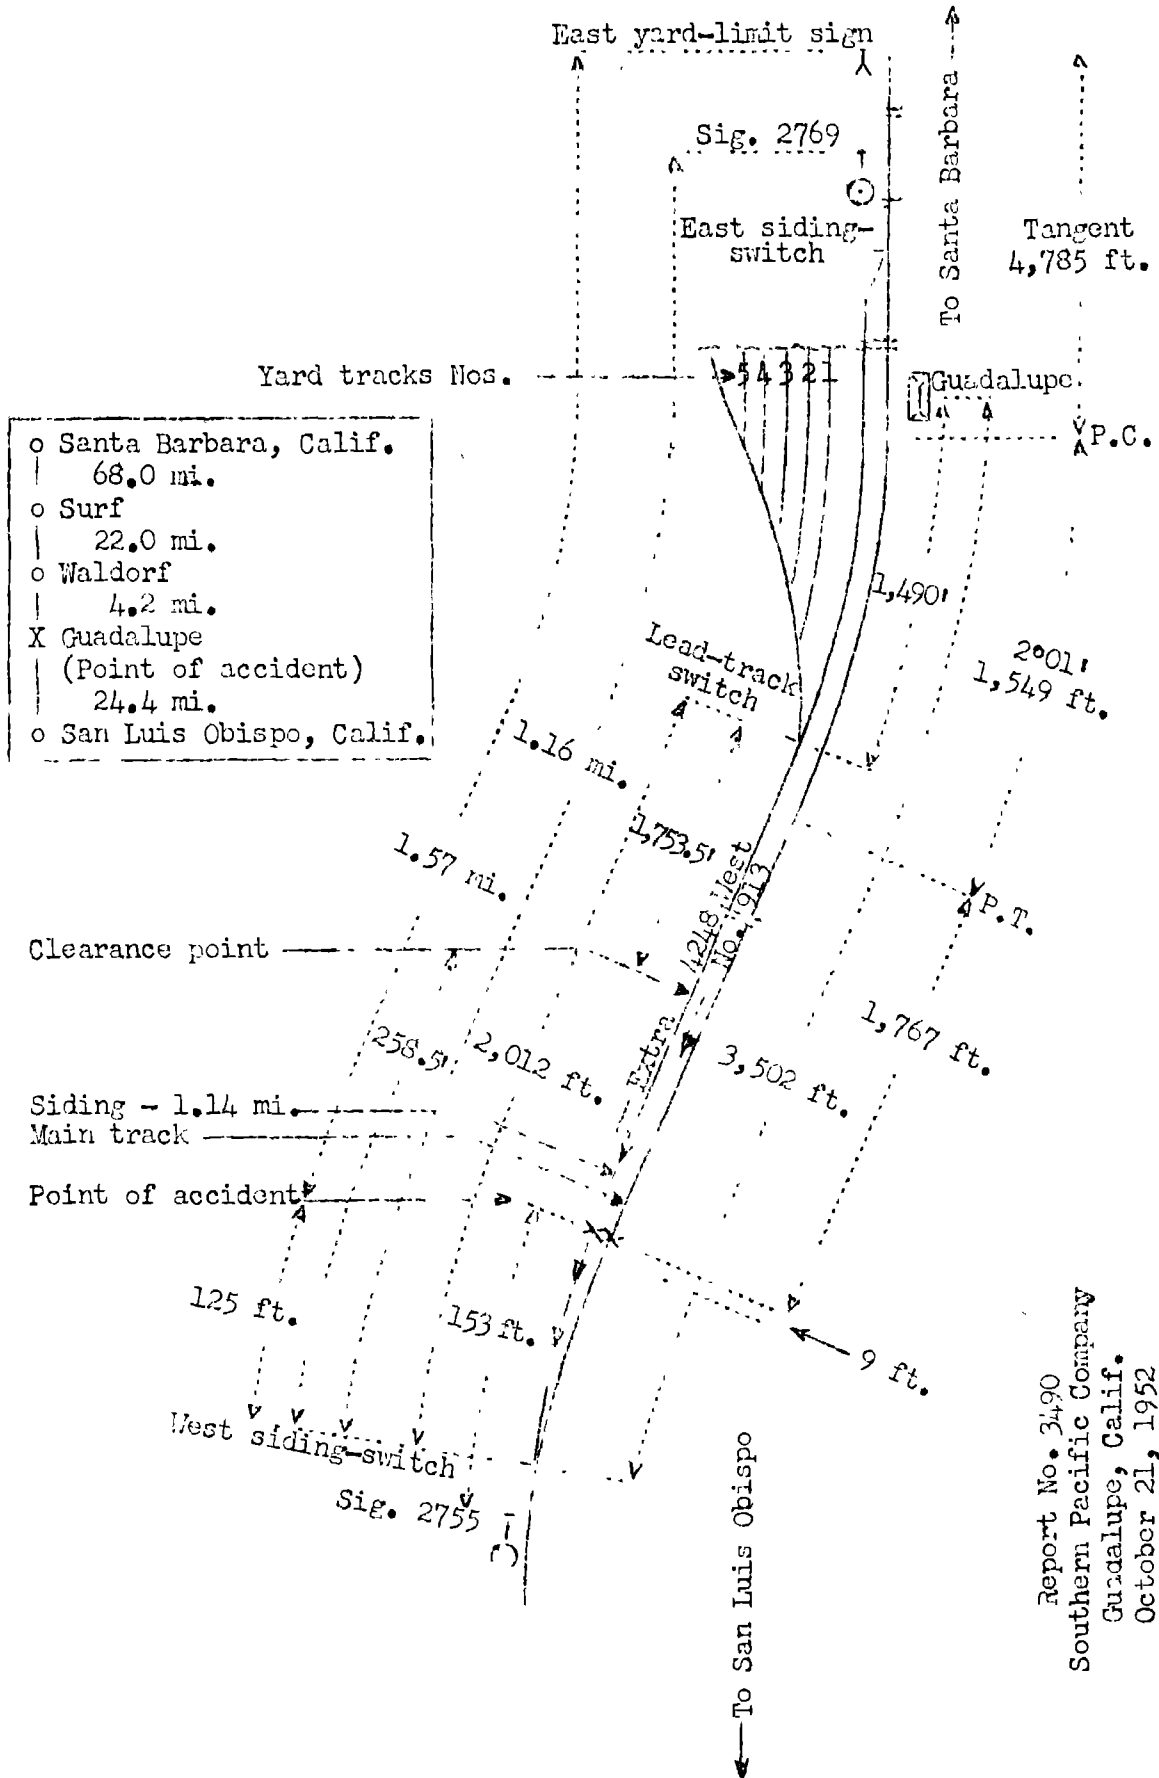
Report No. 3490
 Southern Pacific Company
 Guadalupe, Calif.
 October 21, 1952

This accident occurred on that part of the Coast Division extending between Santa Barbara and San Luis Obispo, 118.6 miles. In the vicinity of the point of accident this is a single-track line, over which trains are operated by timetable, train orders and an automatic block-signal system. At Guadalupe, 94.2 miles west of Santa Barbara, a siding 1.14 miles in length parallels the main track on the north. The west switch of the siding is 3,502 feet west of the station. Five yard tracks, designated from south to north consecutively as yard tracks No. 1 to No. 5, parallel the siding on the north. A lead track connects the west ends of the yard tracks with the siding. The lead-track switch, which is trailing-point for west-bound movements on the siding, is located 1,490 feet west of the station and 2,012 feet east of the west siding-switch. The accident occurred within yard limits at the fouling point of the siding, 1.57 miles west of the east yard-limit sign and 125 feet east of the west siding-switch. From the east there are, in succession, a tangent 4,785 feet in length, a 2°01' curve to the right 1,549 feet and a tangent 1,767 feet to the point of accident and 9 feet westward. The grade is 0.44 percent ascending westward at the point of accident.

moved westward on the lead track and the siding to double over and to couple to 41 cars previously assembled on the siding, to complete the train. When the rear car of the cut was closely approaching the lead-track switch, the engine fouled the main track at the west end of the siding. The westward movement was stopped and a reverse movement was immediately started. The engine and the cut of cars had moved eastward only a few feet when the engine was struck by No. 913.

No. 913, a west-bound third-class freight train, consisted of Diesel-electric units 6387, 8217 and 6386, coupled in multiple-unit control, 69 cars and a caboose. This train departed from Surf at 6:42 p. m., 3 hours 5 minutes late, passed the east yard-limit sign at Guadalupe, passed signal 2769, which indicated Proceed, passed the station, where copies of two train orders were delivered to the crew, and while moving at a speed of 33 miles per hour it collided with the engine of Extra 4248 West at the fouling point at the west end of the siding.

Engine 4248 was derailed on the turnout and stopped with the front end about 50 feet east of the west siding-switch. It leaned toward the north at an angle of about 15 degrees. The tender and the front truck of the first car were derailed and stopped upright and in line with the track. The engine was considerably damaged and the first, sixth and seventh cars were somewhat damaged. The Diesel-electric units of No. 913, the first car, the front truck of the second car, the front truck of the seventh car and all trucks of the eighth to the twelfth cars, inclusive, were derailed. The first Diesel-electric unit stopped on its left side, with the front end 110 feet west of the point of collision and 7 feet south of the track. The rear end of the unit was 42 feet south of the track. The second Diesel-electric unit stopped upright, with the front end against the rear of the first unit and the rear end on the track structure and against the south side of engine 4248. The third Diesel-electric unit stopped with the front end against the rear of the second unit and the side of engine 4248. Oil from the derailed equipment became ignited and the Diesel-electric units, which were badly damaged in the collision, were further damaged by fire. The derailed cars stopped in various positions on or near the track. The ninth to the twelfth cars, inclusive, were considerably damaged and the other derailed cars were somewhat damaged. Two houses on the south side of the track were damaged by derailed equipment.
