INTERSTATE COMMERCE COMMISSION

REPORT OF THE DIRECTOR OF THE BUREAU OF SAFETY CONCERNING AN
ACCIDENT ON THE LINE OF THE SOUTHERN PACIFIC COMPANY
NEAR HARGIS, N. MEX., ON AUGUST 29, 1933.

November 17, 1933.

INV. 1350
 SOUTHERN PACIFIC COMPANY
 HARGIS, N. MEX.
 AUG. 29, 1933.

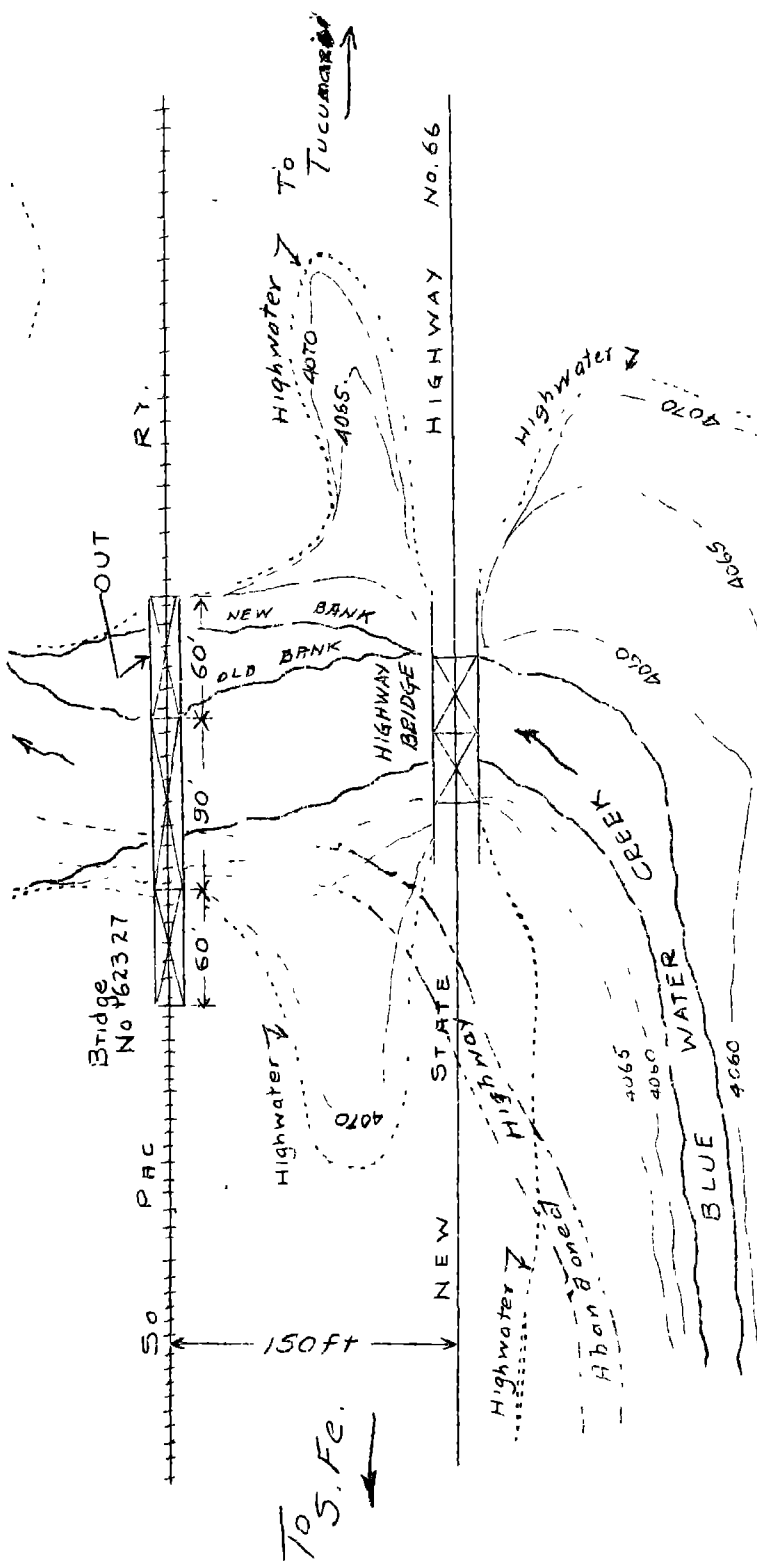
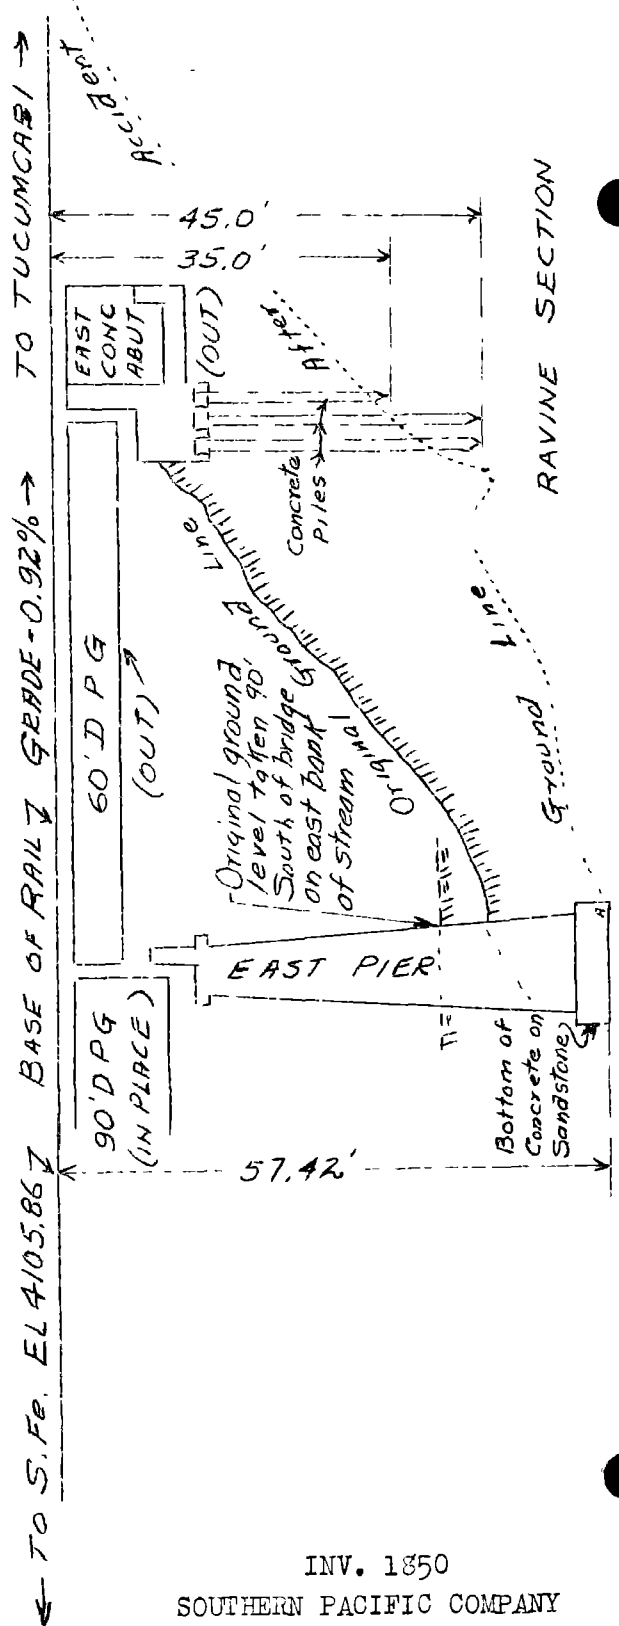
The west abutment and both piers of the bridge remained intact but the east abutment, which apparently had been undermined by flood waters in the creek, settled under the weight of the engine, resulting in the collapse of the eastern span of the bridge. The abutment toppled over upon its west face and slid part way down the embankment, the wings extending toward the southwest. The east girder was displaced and lodged between the east embankment and the southeast corner of the east pier approximately midway between the bridge seat and the bed of the stream, at an angle of approximately 40°. The engine overrode the dislodged abutment; the front end of the engine struck the embankment above the abutment and after the accident the rear of the boiler was on top of the abutment. The tender and first five cars were also derailed in the gap in the track caused by the collapse of this span of the bridge and were piled in various positions upon the engine, the bridge girder and the embankment. The sixth car fell over the north side of the bridge into the stream bed practically opposite the middle span of the bridge. The front truck of the seventh car was derailed but the rest of the train remained on the rails and sustained no damage. The derailed equipment was badly damaged and some of the cars were destroyed either by the derailment or in clearing up the wreckage. The

This accident was caused by high water from heavy rainfall undermining the earth fill supporting the east abutment of bridge 1623.27, resulting in the collapse of the eastern span of this bridge under the engine of train no. 4.

There were three principal conditions which contributed to the failure of this bridge, namely, very heavy rains resulting in an extraordinary amount of flood water in Blue Water Creek; the position of the highway bridge which increased the velocity of the current and probably directed it against the railroad embankment, and the fact that the railroad embankment had not been protected against erosion.

The evidence of engineers who testified in this investigation is convincing that the failure of this bridge could have been guarded against by rip rap, wing walls or other similar protective devices. The need for such measures at this point had existed since the construction of the highway bridge in 1931, and had a comprehensive survey been made by competent railroad engineers the changed hydraulic conditions at this point, as a result of the construction of the highway bridge, should have been recognized. Furthermore, it was brought out in this investigation that as a result of rains earlier in the month of August the east bank of the stream between the bridges, as well as the toe of the fill near the east pier, had been washed away to an extent clearly indicating the need for protection of the railroad embankment. A number of local residents and users of the highway were aware of this condition and recognized the possibility of danger to the railroad; however, the railroad company had not made sufficiently frequent or thorough inspections to discover this condition, and because of this failure to discover and heed the warning given by the partial washing away of the embankment
