INVESTIGATION NO. 3069

SOUTHERN PACIFIC COMPANY

REPORT IN RE ACCIDENT

FEBRUARY 4, 1947

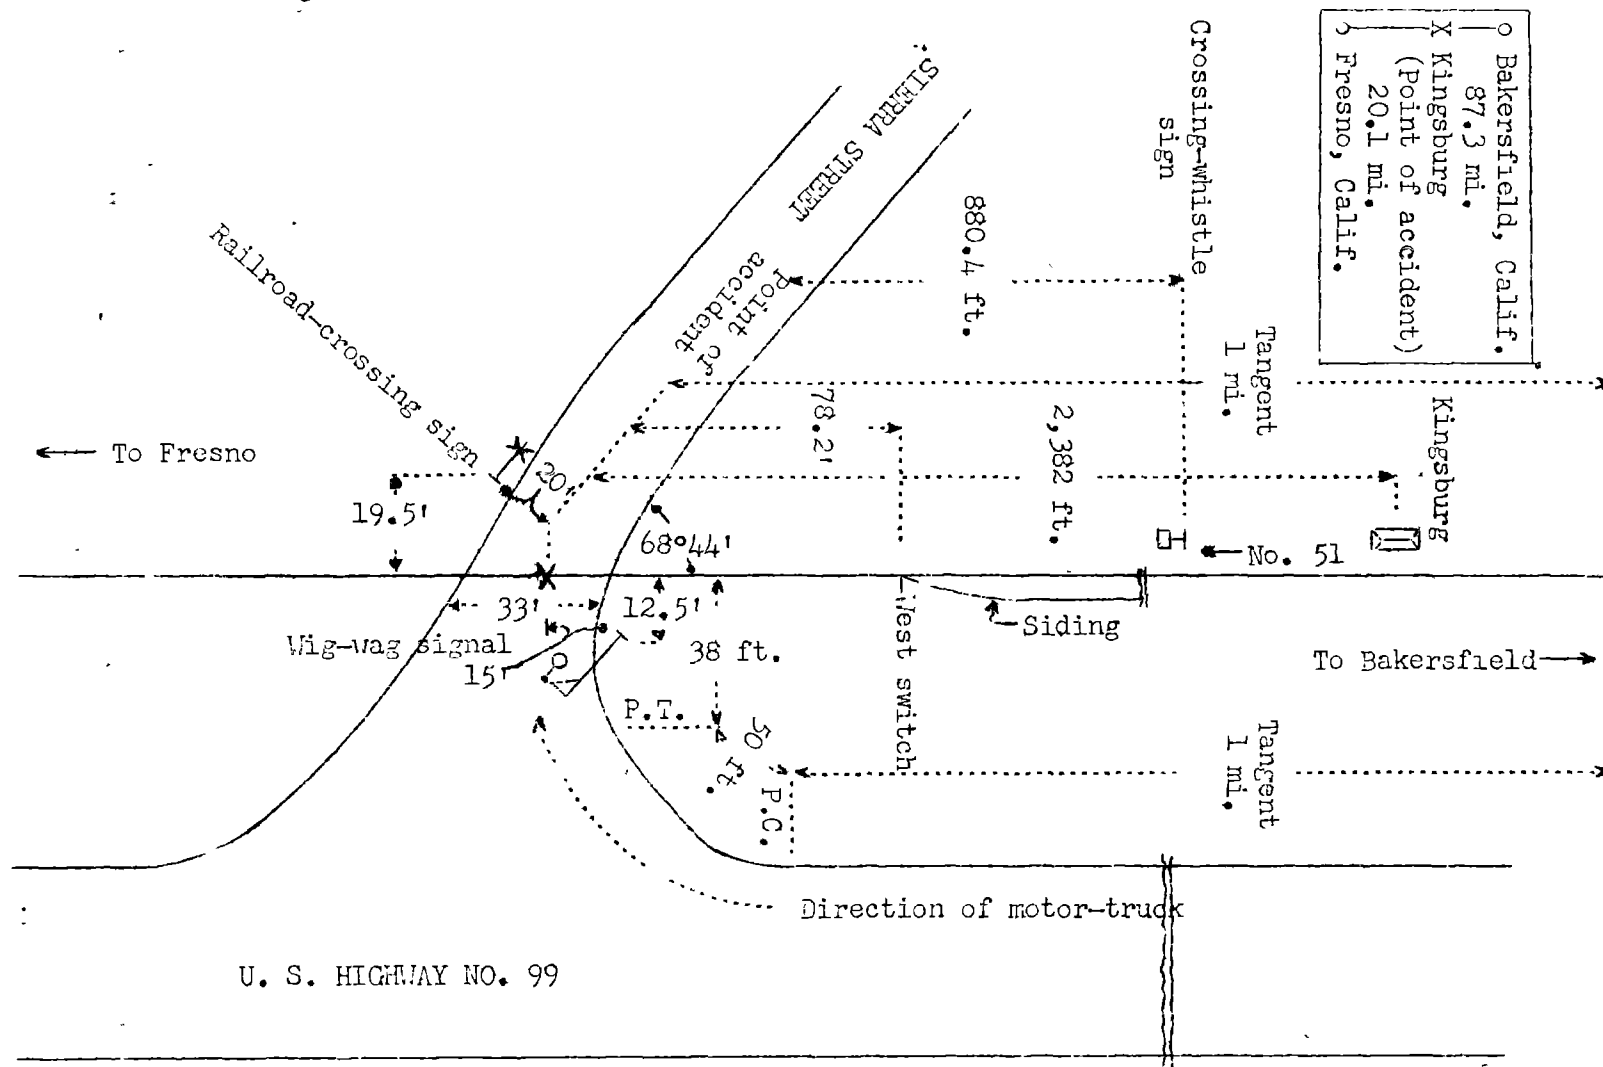
Inv. No. 3069
Southern Pacific Company
Kingsburg, Calif.
February 4, 1947

Sierra Street intersects the main track at an angle of $68^{\circ}44'$. U. S. Highway No. 99 parallels the railroad on the south and intersects Sierra Street at a point 28 feet south of the intersection of the main track and Sierra Street. From the east on U. S. Highway No. 99 thence northward on Sierra Street there are, in succession, a tangent about 1 mile in length, a sharp turn to the right about 50 feet and a tangent 38 feet to the crossing and some distance northward. The grade for north-bound vehicles is, successively, 4.0 percent ascending 50 feet to the crossing, level over the crossing and 4.0 percent descending about 50 feet northward. South of the crossing Sierra Street is surfaced with asphaltum to a width of about 35 feet. The crossing is 33 feet wide and is surfaced with asphaltum. Flangeways about 2-1/2 inches wide are provided.

A standard cross-buck railroad-crossing sign is located to the left of the direction of north-bound traffic, 19.5 feet north of the centerline of the main track and 20 feet west of the centerline of Sierra Street. This sign is mounted on a mast and bears the words "RAILROAD CROSSING" in black letters on a white background. An automatic wig-wag crossing signal is located to the right of the direction of north-bound traffic, 12.5 feet south of the centerline of the main track and 15 feet east of the centerline of Sierra Street. The wig-wag signal is equipped with a red light and a bell. The center of the lens is 13.15 feet above the level of the surface of the street. The light of the wig-wag signal is illuminated and the bell sounds when a west-bound train occupies any portion of the main track throughout a distance of 1,860 feet immediately east of the crossing. A crossing-whistle sign for west-bound trains is located 680.4 feet east of the crossing.
