INTERSTATE COMMERCE COMMISSION
WASHINGTON

REPORT OF THE DIRECTOR
BUREAU OF SAFETY

ACCIDENT ON THE
SOUTHERN PACIFIC RAILROAD

INVESTIGATION NO. 2047

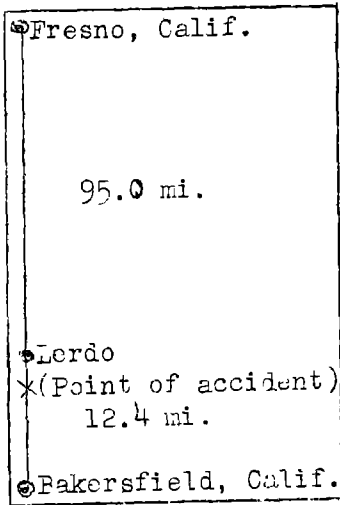
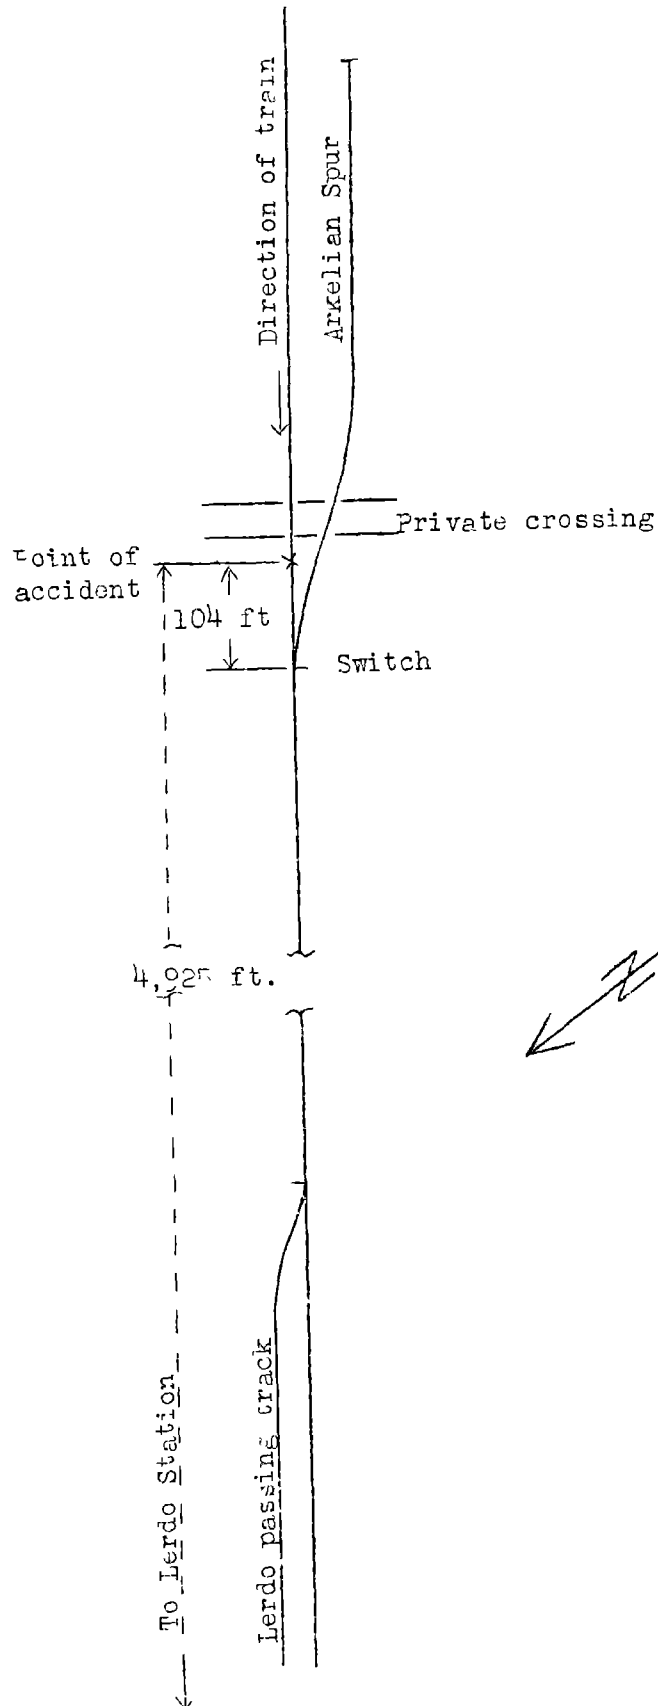
Inv. No. 2047
Southern Pacific R.R.
Lerdo, Calif.
Feb. 25, 1936.

and stopped on its right side to the north of the track, 400 feet behind the head portion of the train; the fifty-third to the fifty-fifth cars, inclusive, were partially derailed but remained coupled and stopped 440 feet behind car 2002; the fifty-sixth car stopped on its left side, south of the track, about 100 feet behind these three cars and the caboose was in a similar position about 175 feet behind the rear car. The employees injured were the conductor and a brakeman.
