INTERSTATE COMMERCE COMMISSION
WASHINGTON

INVESTIGATION NO. 3087
SOUTHERN PACIFIC COMPANY
REPORT IN RE ACCIDENT
AT LORDSBURG, N. MEK., ON
MARCH 21, 1947

Inv. No. 3087
 Southern Pacific Company
 Lordsburg, N. Mex.
 March 21, 1947

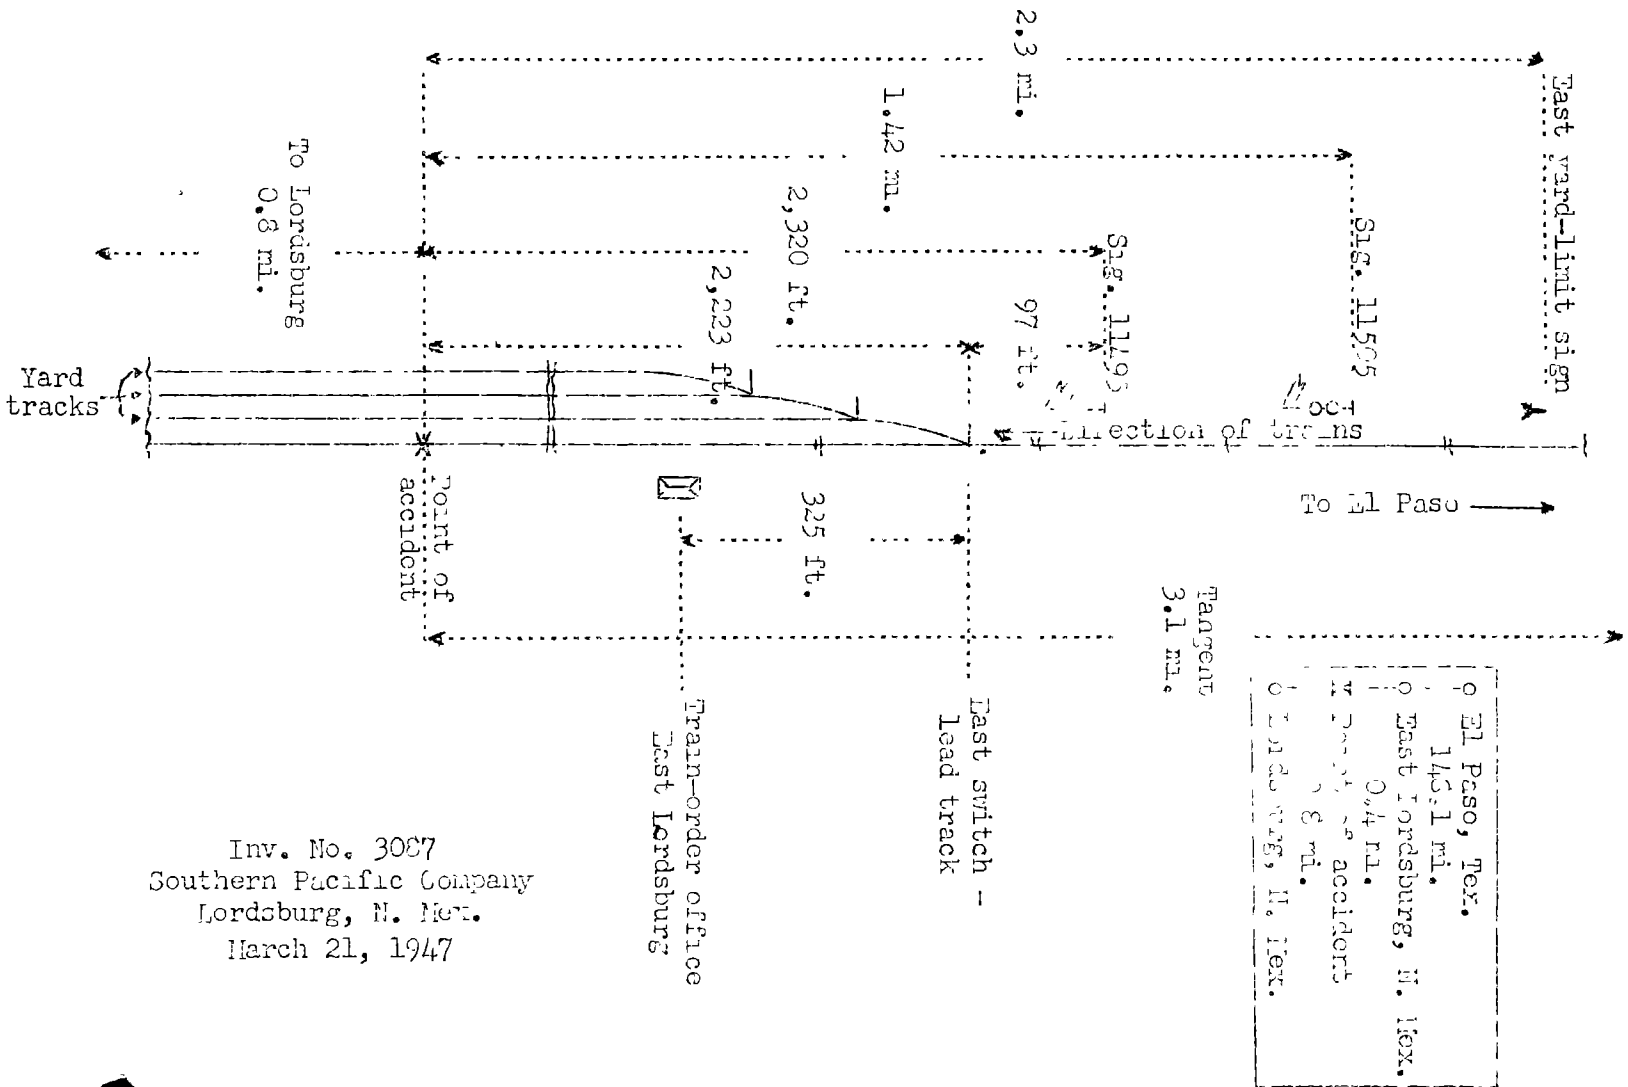
This accident occurred on that part of the Rio Grande Division extending between El Paso, Tex., and Lordsburg, N. Mex., 149.3 miles, a single-track line in the vicinity of the point of accident, over which trains are operated by timetable, train orders and an automatic block-signal system. The accident occurred within yard limits on the main track at Lordsburg, at a point 2.3 miles west of the east yard-limit sign and 0.8 mile east of the station. The main track is tangent throughout a distance of 3.1 miles immediately east of the point of accident and a considerable distance westward. The grade for west-bound trains varies between 0.06 percent and 0.60 percent ascending throughout a distance of 0.91 mile immediately east of the point of accident, where it is 0.44 percent ascending.

Automatic signals 11505 and 11495, governing west-bound movements, are, respectively, 1.42 miles and 2,320 feet east of the point of accident. These signals are approach lighted. Signal 11505 is of the one-arm, lower-quadrant, semaphore type. Signal 11495 is of the two-arm, lower-quadrant, semaphore type. The involved night aspects and corresponding indications of these signals are as follows:

East Lordsburg is 1.2 miles east of Lordsburg. The east switch of a lead track, which connects the main track and the east ends of several yard tracks located north of the main track, is 2,223 feet east of the point of accident, 325 feet east of the train-order office at East Lordsburg and 97 feet west of signal 11495. The lead-track switch is hand operated and is in the charge of the operator at East Lordsburg.

about 8 p. m. in the train of Extra 4390 West, which stopped on the main track. After the incoming engine and caboose were detached, the outgoing engines and caboose were coupled to the cars. About 9:10 p. m. the rear end of Extra 4193 West was struck by Extra 2434-5041 West at a point 2.3 miles west of the east yard-limit sign.

Extra 2434-5041 West, a west-bound freight train, consisting of engines 2434 and 5041 coupled, 65 cars and a caboose, passed the east yard-limit sign, passed signal 11505, which displayed proceed-with-caution, passed signal 11495, which displayed stop, and while moving at an estimated speed of 10 miles per hour it struck Extra 4193 West.
