REPORT OF THE DIRECTOR
BUREAU OF SAFETY

ACCIDENT ON THE
SOUTHERN PACIFIC RAILROAD

MORLEY, CALIF.

INVESTIGATION NO. 2397

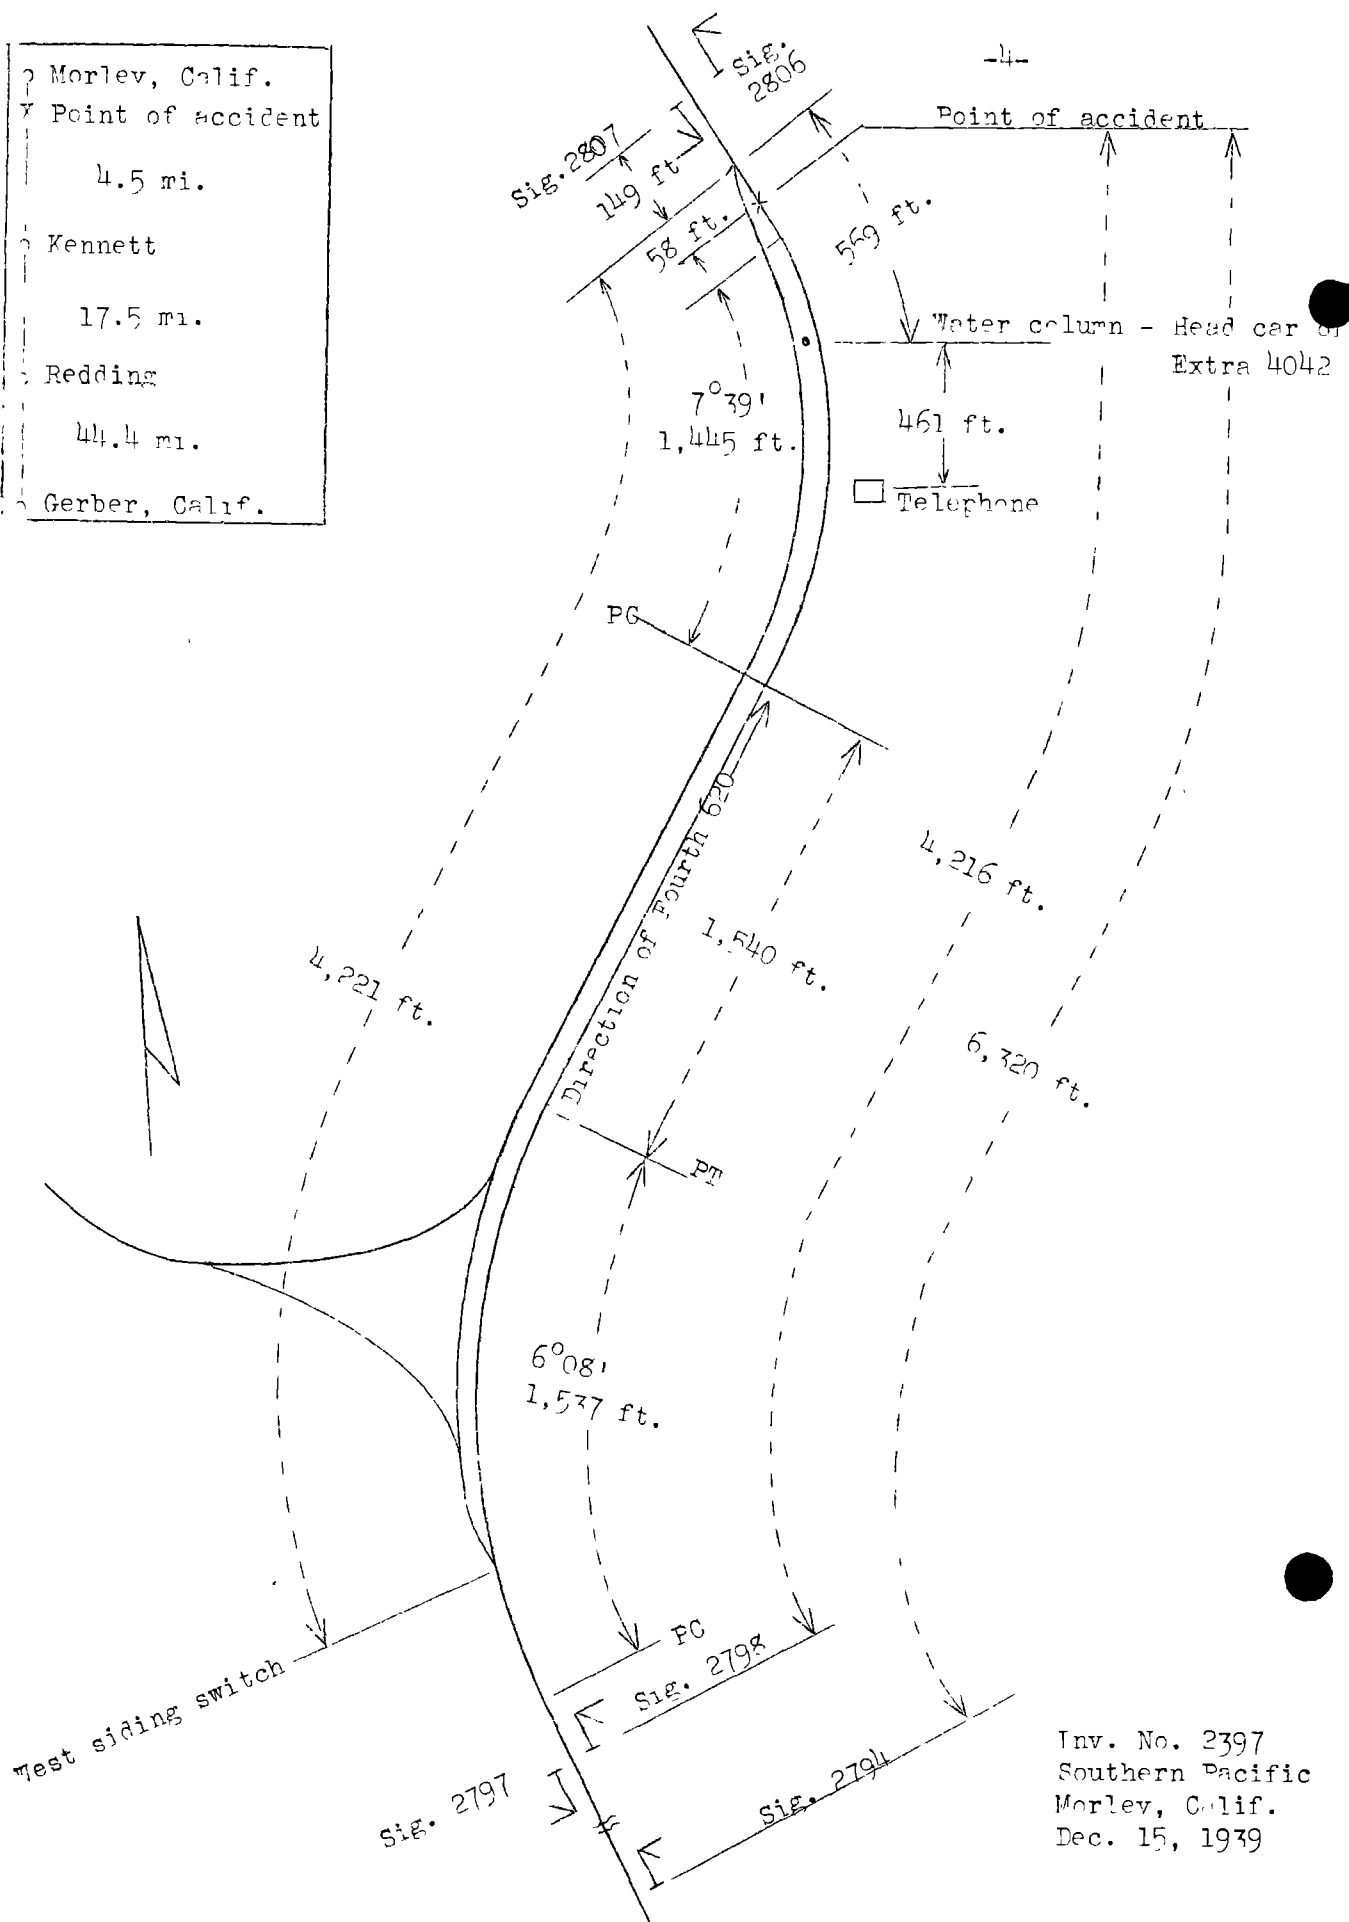
Inv. No. 2397
 Southern Pacific
 Morley, Calif.
 Dec. 15, 1939

This accident occurred on that part of the Sacramento Division designated as the Redding Subdivision which extends between Collier and Dunsmuir, Calif., a distance of 108.3 miles. This is a single-track line over which trains are operated by timetable, train orders and an automatic block system. At Morley a siding 4,221 feet in length parallels the main track on the north; the accident occurred on the main track at a point 58 feet west of the east switch of this siding. Approaching this point from the west there are, in succession, a compound curve to the right a distance of 1,537 feet with a maximum curvature of 6°38', a tangent 1,540 feet in length, a compound curve to the left a distance of 1,445 feet with a maximum curvature of 7°39', and a tangent extending 19 feet to the point of accident and a considerable distance beyond. The grade varies between 0.38 percent and 0.531 percent, ascending eastward, a distance of 2,542 feet to the point of accident and some distance beyond, and is 0.531 percent at the point of accident. The tracks are laid on a hillside cut; an embankment to the north rises at an angle of about 45 degrees to a height of approximately 90 feet. Because of track curvature and the embankment, the view had by a fireman of an eastbound train approaching the scene of accident is restricted to a distance of about 300 feet.

Distant signal 2794 and home signal 2793, governing eastward movements, are located 6,320 and 1,216 feet, respectively, west of the point of accident. Home signals 2806 and 2807, governing eastward and westward movements, respectively, are located on opposite sides of the main track 149 feet east of the east siding-switch. These signals are one-arm, lower quadrant, semaphore signals, approach-lighted; their aspects and indications are as follows:
