INTERSTATE COMMERCE COMMISSION

REPORT OF THE DIRECTOR OF THE BUREAU OF SAFETY CONCERNING AN
ACCIDENT ON THE LINE OF THE SOUTHERN PACIFIC COMPANY
AT PIRU, CALIF., ON FEBRUARY 12, 1933.

May 13, 1933.

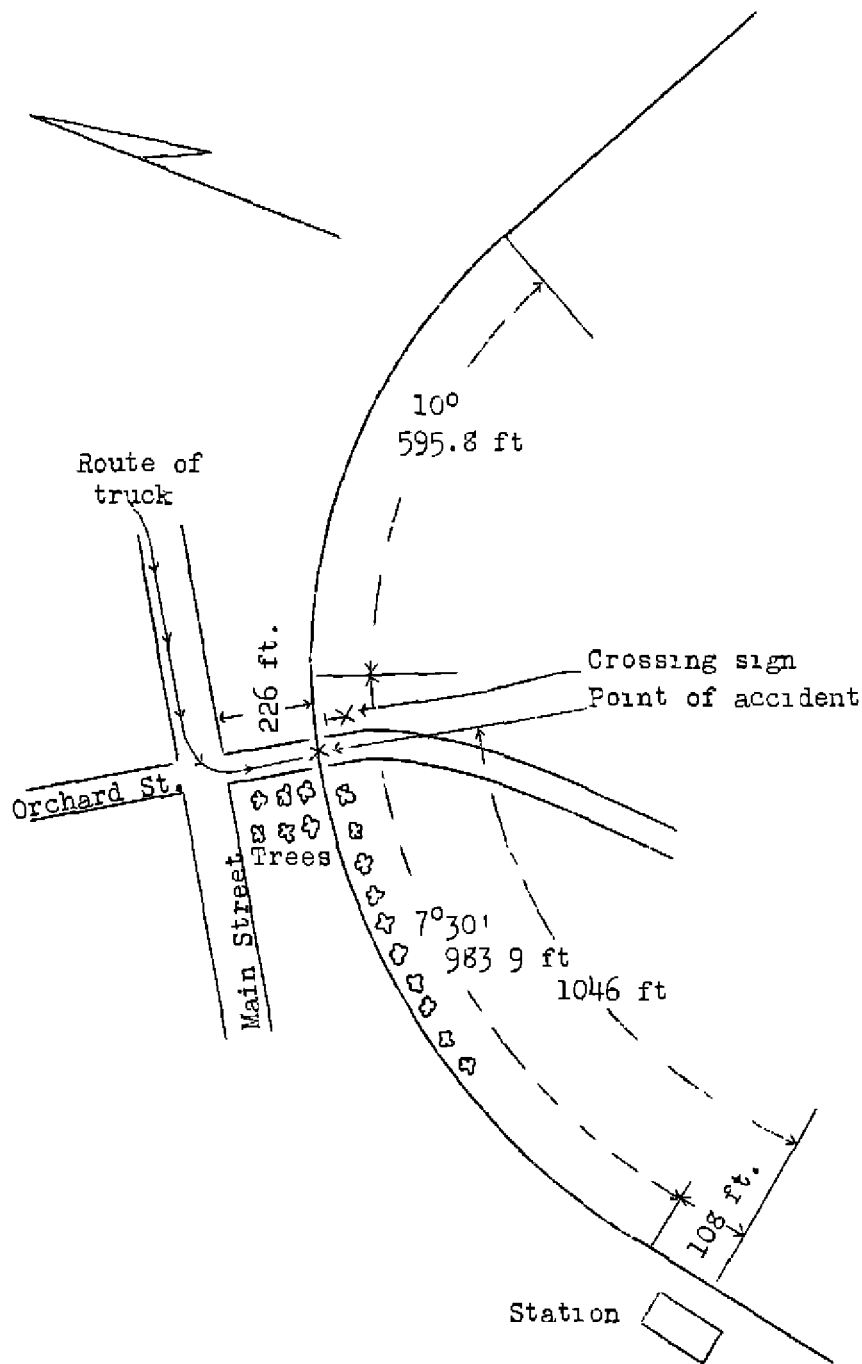
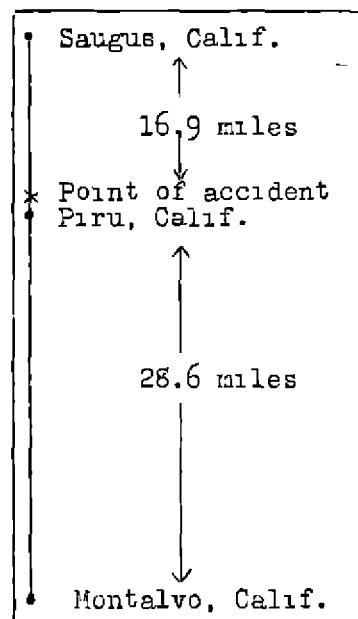
Inv. No 1810
Southern Pacific Co.,
Piru, Calif.
February 12, 1933

Due to an olive orchard situated on the northwest corner of the crossing the view to be had from Orchard Street of an approaching east-bound train is obstructed until a vehicle reaches a point 100 feet from the crossing, at which point a clear view of the track for a distance of 114 feet west of the crossing may be had. At a point 65 feet from the crossing the view is again obstructed by a tree, but at a point 55 feet from the crossing the track can be seen for a distance of 600 feet. There also are trees located on the south side of the track and on the inside of the curve, which reduce the range of vision, as a vehicle closely approaches the crossing, from 600 to 540 feet.
