INVESTIGATION NO. 2666
THE SOUTHERN PACIFIC COMPANY
REPORT IN RE ACCIDENT
NEAR SAN FRANCISCO, CALIF., ON
JANUARY 16, 1943

Railroad: Southern Pacific
Date: January 16, 1943
Location: San Francisco, Calif.
Kind of accident: Side collision
Trains involved: Light engine : Light engine
Train number: : Extra 2468 West
Engine numbers: 2434 : 2468
Speed: Practically stopped : 10-15 m. p. h.
Operation: Interlocking
Track: Double; 6° curve; 0.05 percent
descending grade westward
Weather: Clear
Time: 4:20 p. m.
Casualties: 1 killed; 2 injured
Cause: Accident caused by failure to obey
interlocking signal indication

Accident near San Francisco, Calif., on January 16, 1943,
caused by failure to obey an interlocking signal
indication.

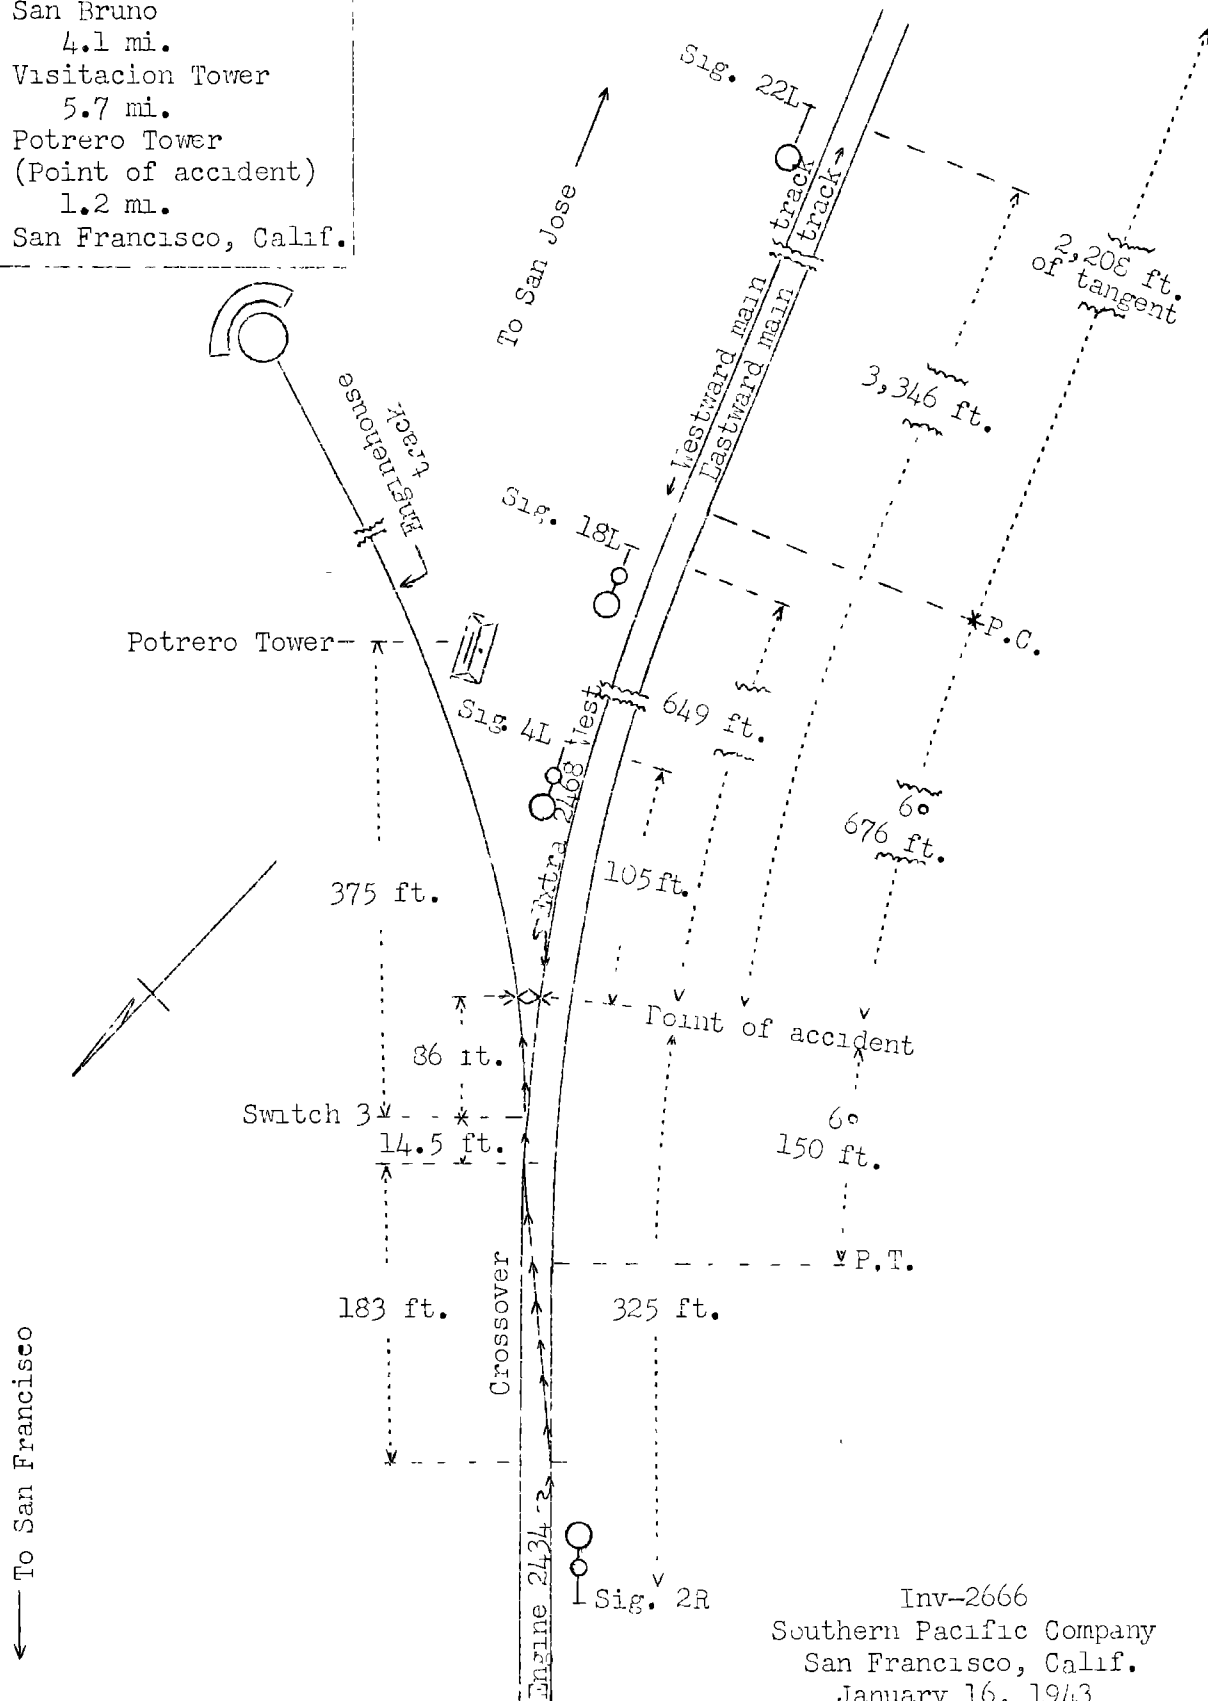
- San Jose, Calif.
35.9 mi.
- San Bruno
4.1 mi.
- Visitacion Tower
5.7 mi.
- X Potrero Tower
(Point of accident)
1.2 mi.
- San Francisco, Calif.

Engine 2434 departed from the station at San Francisco and moved eastward in backward motion on the eastward main track en route to the enginehouse near Potrero interlocking. This engine passed signal 2R, which displayed red-over-green, moved through the crossover, entered the enginehouse track at switch 3 and was practically stopped when the rear end of the tender was struck by Extra 2468 West at a point 100.5 feet east of switch 3.

Extra 2468 West consisted of engine 2468. This train passed Visitation Tower, 5.7 miles east of Potrero Tower and the last open office, at 4:03 p. m., passed signal 22L, which displayed yellow, passed signal 18L, which displayed yellow, passed signal 4L, which displayed red-over-red, and while moving at an estimated speed of 10 to 15 miles per hour it collided with engine 2434 at a point 105 feet west of signal 4L.

From the left side of a west-bound engine the view of signal 4L is restricted to about 775 feet, and from the right side, to about 100 feet, because of buildings adjacent to the track and track curvature.
