INVESTIGATION NO. 2502  
THE SOUTHERN PACIFIC COMPANY  
REPORT IN RE ACCIDENT  
AT TRUCKEE, CALIF., ON  
MAY 10, 1941.

Railroad: Southern Pacific  
Date: May 10, 1941  
Location: Truckee, Calif.  
Kind of accident: Derailment  
Train involved: Freight  
Train number: Extra 4132 East  
Engine number: 4132  
Consist: 71 cars, caboose  
Speed: 18-22 m.p.h.  
Operation: Timetable, train orders and  
automatic block-signal and  
automatic train-stop system  
Track: Double; 3°55' curve; 1.72 percent  
descending grade eastward  
Weather: Clear  
Time: About 2:55 a.m.  
Casualties: 1 killed; 1 injured  
Cause: Accident caused by broken wheel

Accident at Truckee, Calif., on May 10, 1941, caused by broken  
wheel.

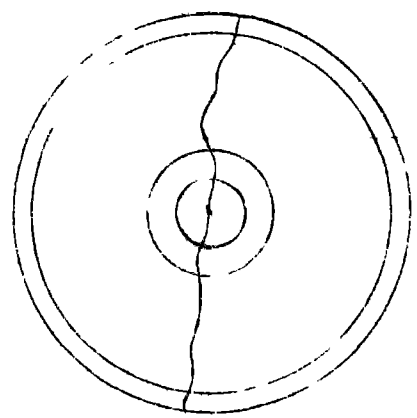
Sketch showing location of rupture.

The Commission's inspectors observed that the first mark of derailment was a flange mark on a tie about 14 inches inside the north rail. The car involved was of steel underframe and wooden superstructure construction equipped with Bettendorf U-section trucks, Universal geared hand-brake and K-2 triple valve. The triple was last cleaned on March 19, 1940. The car was built in 1926 and was reconditioned in March 1941. The inspectors observed an old fracture which covered about 35 percent of the cross-sectional area of the hub and appeared to be in the line of the failure.

at this point was in proper gage, surface and alinement. Examination made soon after the accident occurred disclosed that the right front wheel of the rear truck of the eleventh car was broken into two almost equal portions, one of which was found between the rails of the eastward main track at a point about 60 feet east of the first mark of derailment and the other was between the two main tracks a short distance east of the first portion. The companion wheel remained on the axle but was dragged on the ties to the point where the general derailment occurred.
