ACCIDENT ON THE
SOUTHERN PACIFIC RAILROAD

TURLOCK, CALIF.

OCTOBER 23, 1937.

INVESTIGATION NO. 2211

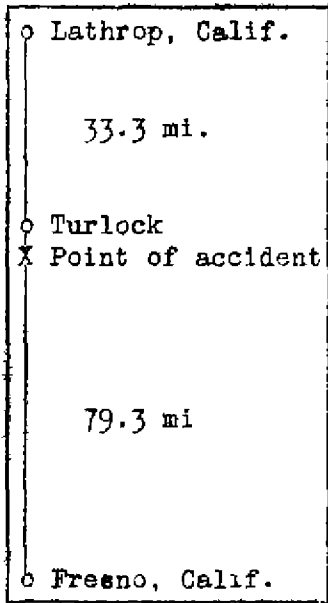
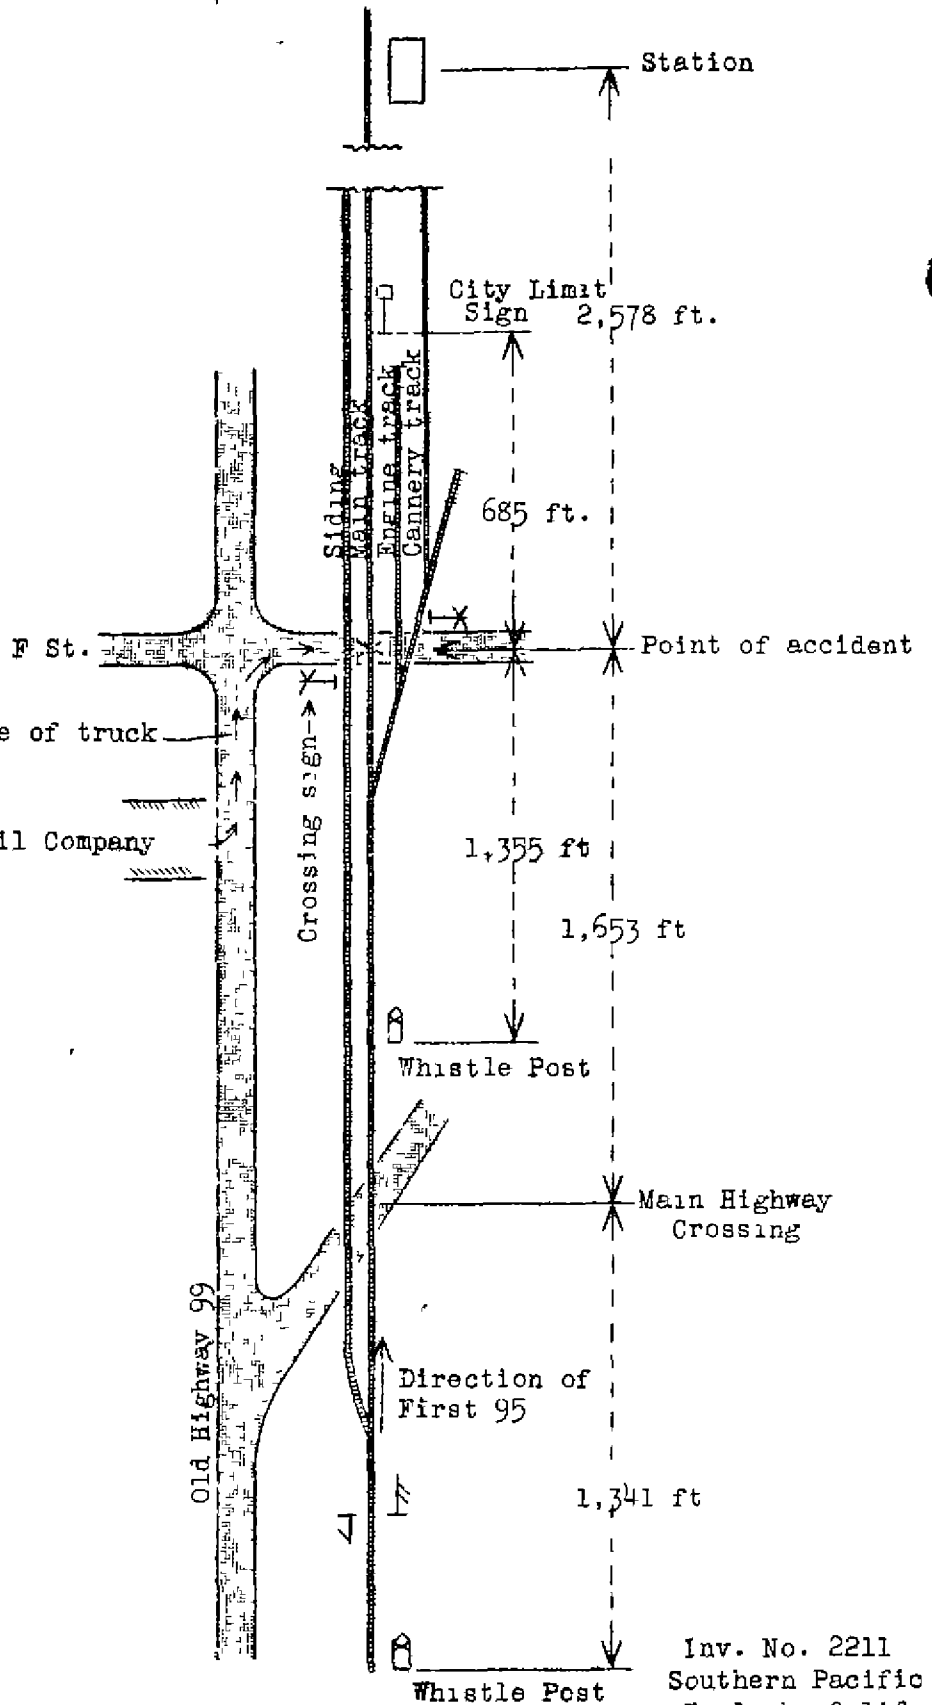
Inv. No. 2211
 Southern Pacific
 Turlock, Calif
 October 23, 1937

F Street extends north and south and crosses the tracks at right angles and intersects Old Highway 99 which parallels the tracks approximately 45 feet on the south. The crossing is 30 feet in width and constructed of an asphalt compound, with planks on each side of each rail. The street is level. Standard cross-bar signs are located on each side of this crossing; the sign governing north-bound traffic is located to the right of the highway and 27 feet from the center line of the siding, the first track encountered, or 40 feet from the center line of the main track. There are no crossing signals to indicate the approach of trains.

A row of trees and two lines of telegraph poles are situated between the siding and Old Highway 99; however, a clear view can be had of a west-bound train by the driver of a north-bound vehicle at a point 25 feet from the south rail of the siding for a distance of 1,700 feet, and at a point 14 feet from the siding an unobstructed view can be had for several miles.

This accident was caused by a truck being driven upon a railroad crossing at grade directly in front of an approaching train.

In view of the amount of traffic, it is recommended that crossing signals be provided at this point to give warning when a train is approaching.
