REPORT OF THE DIRECTOR
BUREAU OF SAFETY

ACCIDENT ON THE
SOUTHERN PACIFIC RAILROAD

YAMSAI, OREG.

INVESTIGATION NO. 2190

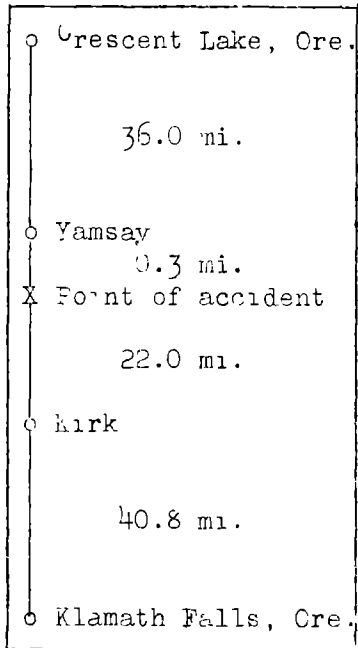
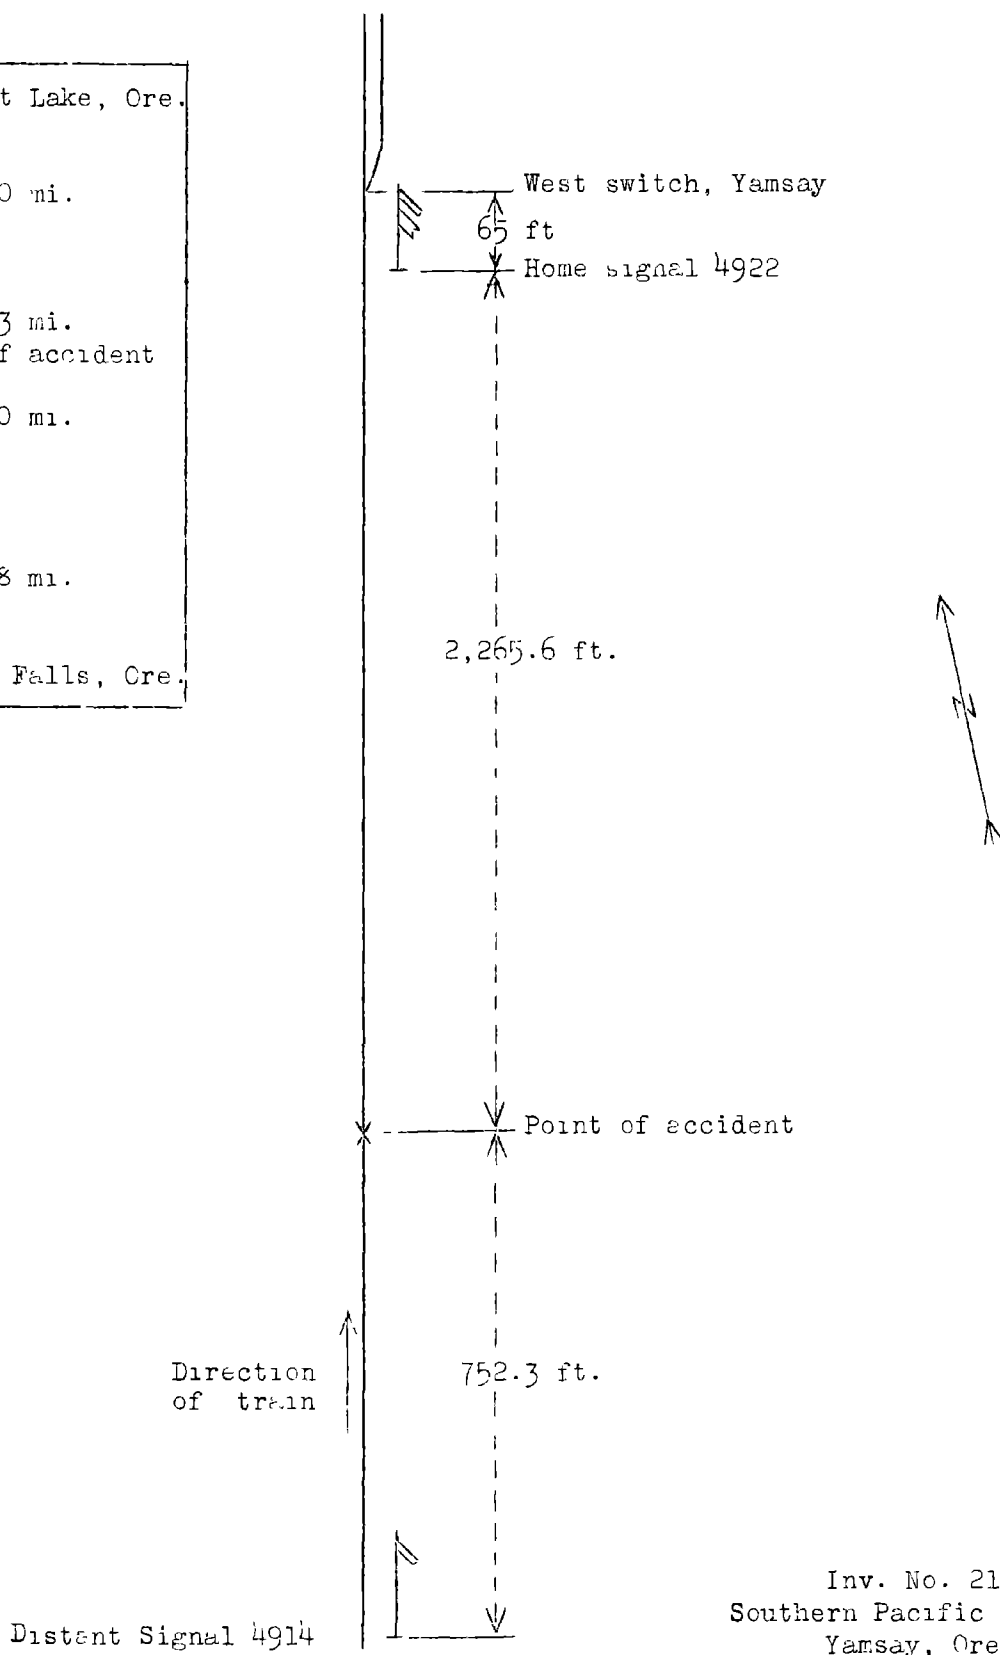
Inv. No. 2190
Southern Pacific Company
Yamsay, Oregon
Aug. 2, 1937

Roadmaster Parker, who arrived at the scene of the accident about 9:15 a.m., said that the first mark of derailment was a wheel mark on a tie just east of the broken end of the failed rail, which was on the right side of the track. This rail was a Bethlehem Steel, Maryland, open hearth, 39-foot, 110-pound rail, bearing heat number 64372-F-10, rolled in 1929 and laid in the track in the fall of that year. Approximately 30 feet 11 inches of the receiving end of this rail remained in the track, while the leaving end, measuring approximately 8 feet 1 inch, was broken into 11 pieces; pieces of the rail having the ball intact are listed consecutively from west to east, as follows:

Piece No.	Length
1	30' 11"
2	1' 2 3/4"
4	7 3/4"
5	2' 3 1/4"
6	10 3/4"
8	9 1/4"
9 1/2	4 1/2"
11	1' 11"

Transverse fissures between adjacent pieces, showing the percentage of the coverage of the ball of the rail and the relative locations of the fissures, were found by the roadmaster, as follows:

Fissures between	Percent	Location of fissures
Pieces 1 and 2	60	1/2" off center from gauge side
Pieces 2 and 4	30	5/8" off center from gauge side
Pieces 4 and 5	50	5/8" off center from gauge side
Pieces 5 and 6	25	1/2" off center from gauge side
Pieces 6 and 8	60	3/8" off center from gauge side.

All of the fissures were new, there being no indication that any of them had extended to the surface prior to the derailment. It was the roadmaster's opinion that a broken rail caused the derailment. He said a rail-detector car passed over this territory 16 months prior to the accident and some transverse fissures were found in the vicinity of the point of accident at that time. He thought the maintenance of the track was in keeping with the permissible speed of 60 miles and 40 miles per hour for passenger and freight trains, respectively. Section Foreman Collins had been in charge of the section on which the derailment occurred since July 14 and had not found it necessary to do any work on the track in this vicinity prior to the accident.

District Engineer Given, who arrived at the scene of the accident about 1:30 p.m., found the track destroyed for a distance of 671 feet. He saw the 30-foot 11-inch piece of the broken rail that remained in the track immediately behind the rear car and the fracture clearly showed a transverse fissure which covered about 60 percent of the ball area. There was no exterior sign to indicate that the rail was not all right. The track was inspected for a distance of one-fourth mile west of the broken rail and no indication of dragging equipment was found, and the track was regular in gauge and surface. During the time the failed rail had been in service, approximately 72,000,000 tons had passed over it. The district engineer said

that there had been six rail failures, due to transverse fissures, which had occurred in rails bearing the same heat number as the one involved in the derailment.
