RAILROAD ACCIDENT REPORT

SOUTHERN PACIFIC TRANSPORTATION CO.

FREIGHT TRAIN 2ND BSM 22 MUNITIONS EXPLOSION

BENSON, ARIZONA

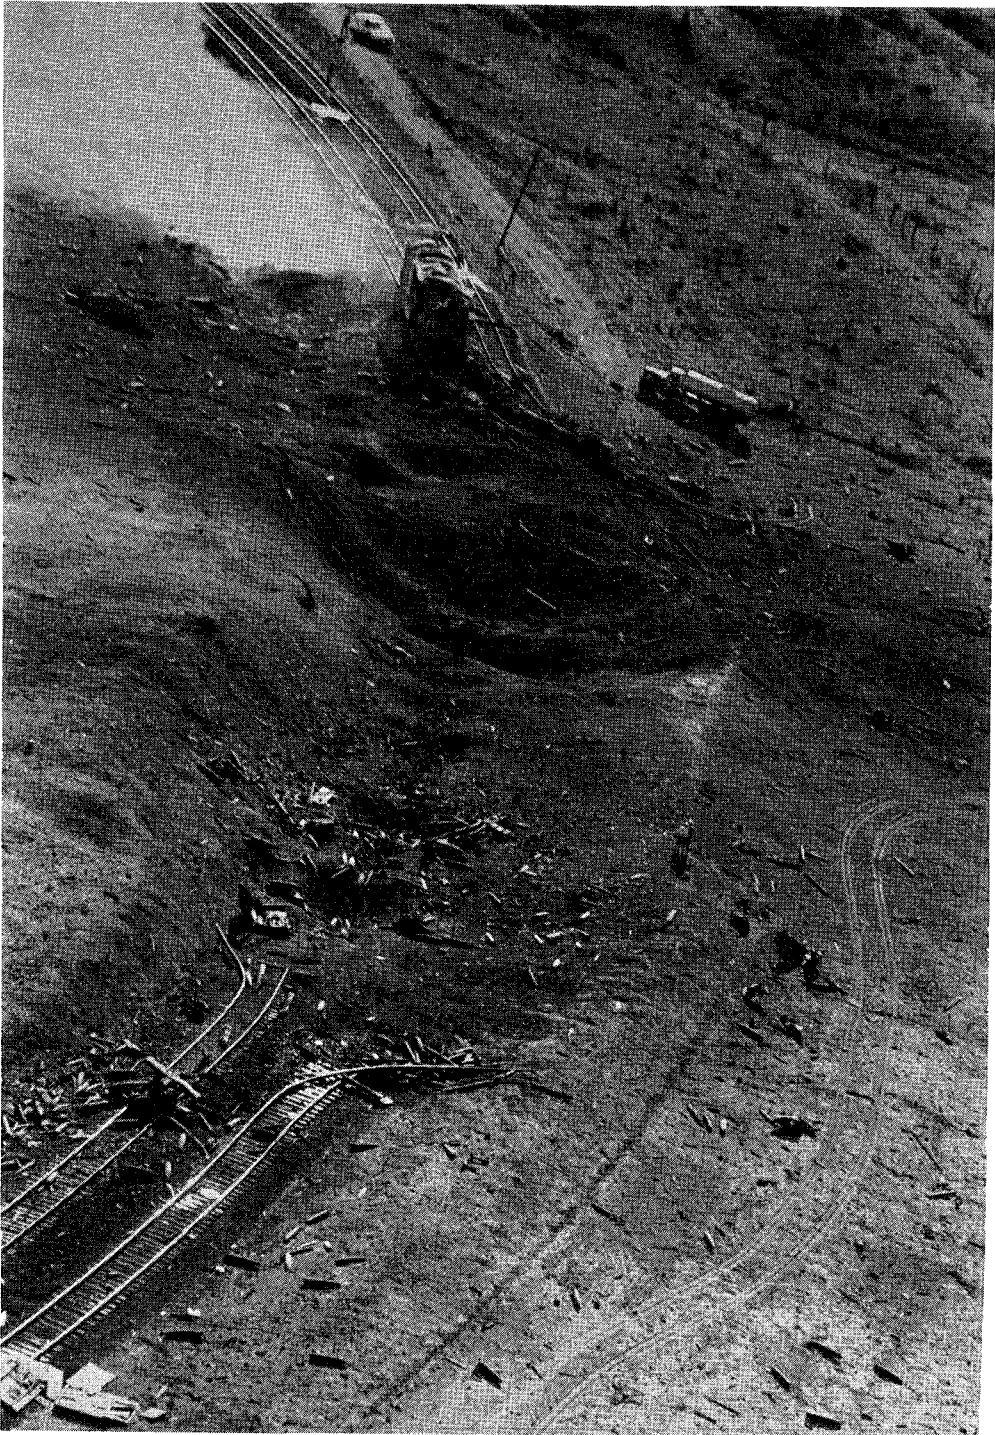
Figure 1. Main Crater Area.

As Car 98 passed MP 1048.4, a low-order explosion of one of the bombs that had been expelled from Car 38 produced a small crater and other damage. The train then separated between Car 35, the lead munitions car, and Car 34, a covered hopper car of starch (CCLX 80009). The force of the explosion blew starch from this car and debris from other cars onto the railroad right-of-way. Explosions of varying intensity continued until 1:15 a.m. on May 25, 1973.

The cars which followed the last car of bombs, containing zinc ash, clays, fiberboard, water heaters, auto tires, and asbestos, were severely damaged, and most of their cargoes spilled onto the right-of-way. The locomotives stopped at MP 1046.7; the caboose stopped at MP 1047.8. (See Figures 1 and 2.)

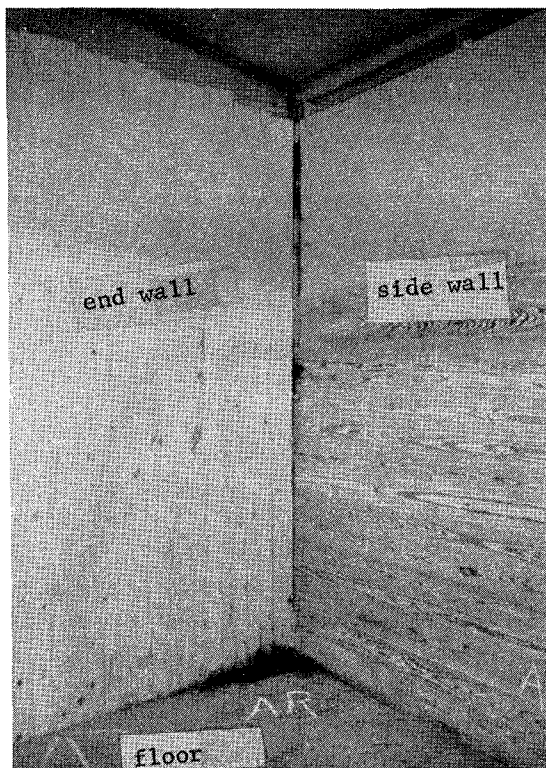
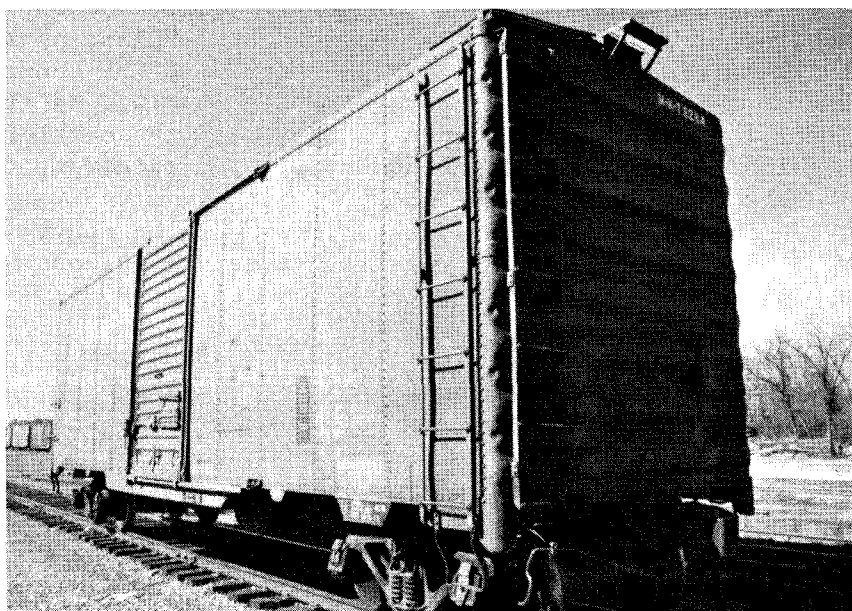
Figure 3. Interior and exterior views of a car similar in design to Car 38.

The cars -- Cars 35 through 46 were railroad-owned, general-purpose boxcars. Car 38 was built in 1950 by the American Car and Foundry Company for the MKT Railroad. The car was not equipped with spark shields to prevent sparks from the brakeshoes from contacting the car floor. It was equipped with friction bearings. Nineteen lining boards were replaced in its interior in 1970. (See Figure 3.)

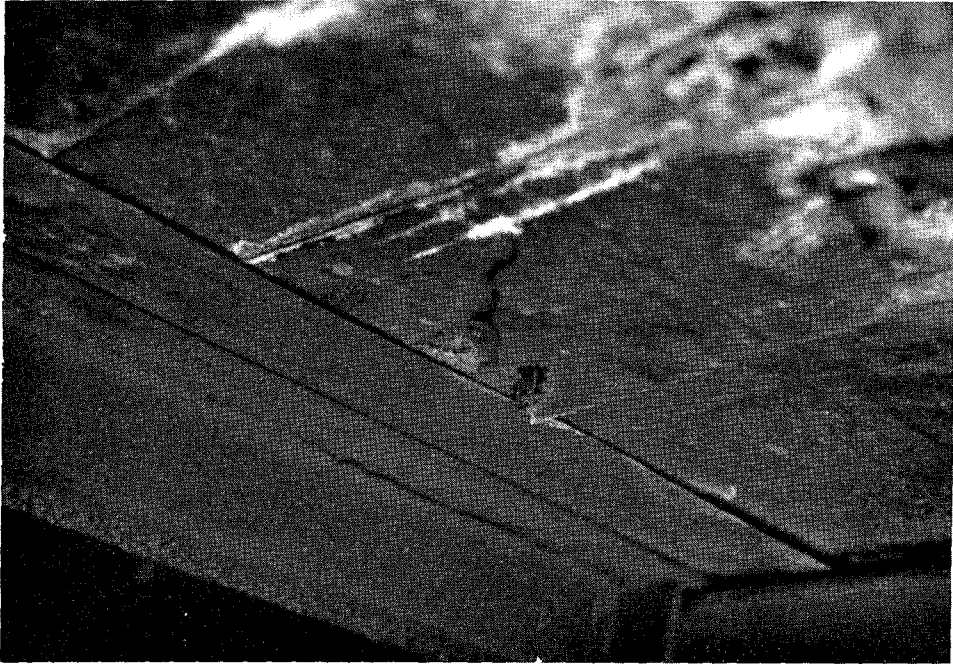
Figure 4. Broken floorboard of MKT 5394.

Another car, MKT 5394, which was not involved in this accident, was taken out of the train at Waco, Texas, for repairs. The car and its lading of bombs were examined at El Paso after the accident. Bracing in the car had shifted and was loose at one end wall, but the pallets were intact. Some of the plastic nose plugs were missing from bombs, and an exterior examination of the car disclosed a broken floor. (See Figure 4.)

Further examination of the load after the car had been returned to McAlester showed that the blocking and bracing were damaged and loosened. Some of the banding on the pallets was loosened and others had shifted. Several of the bombs had contacted one another.

The shifting of the lading in MKT 5394 resulted either from improper blocking or high-speed impacts. There was some indication that both had occurred. The maximum impact to be expected in normal rail transportation has never been defined. However, the Navy designed the blocking and bracing of munitions to withstand impacts of 8 mph. Either this standard was not met in MKT 5394, or the car was subjected to a potentially damaging impact which was not reported.

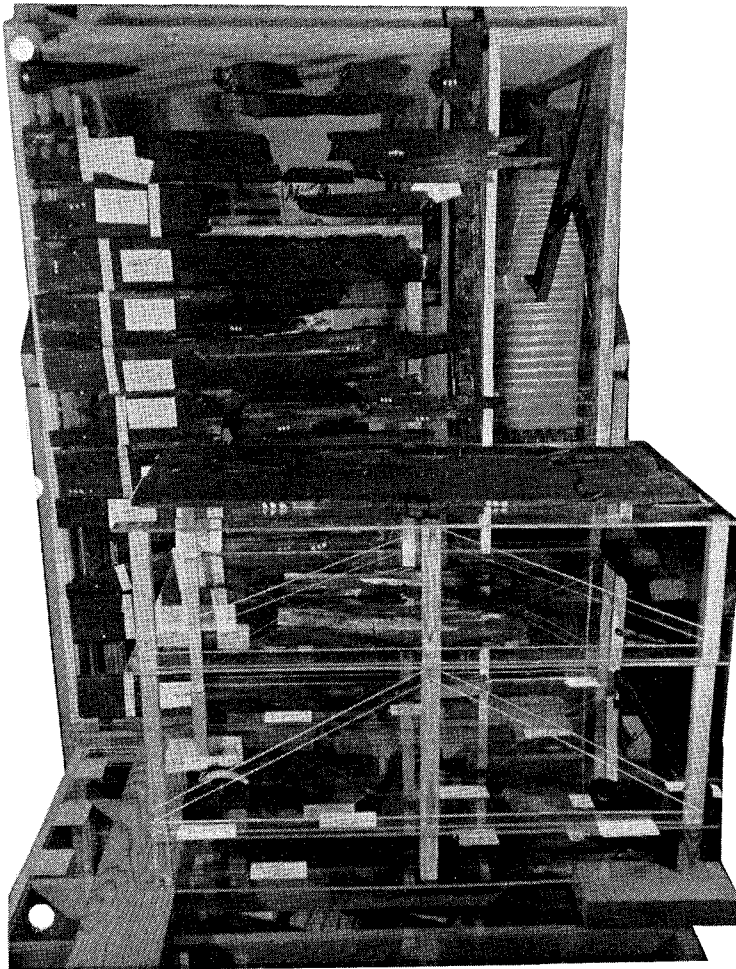
Figure 6. Interior view of reconstructed debris from the northwest corner of Car 38.

Car 38 -- All identifiable car debris recovered from MP 1052.6 and MP 1048 was assembled into a partial mockup which indicated that the car involved in the first explosion was Car 38; the events which occurred at MP 1052.6 were in the right forward corner of the car; the piece of board which was found at MP 1051 was from this corner of the car; and the explosion which occurred at MP 1048 was in the same location in Car 38. (See Figure 6.)

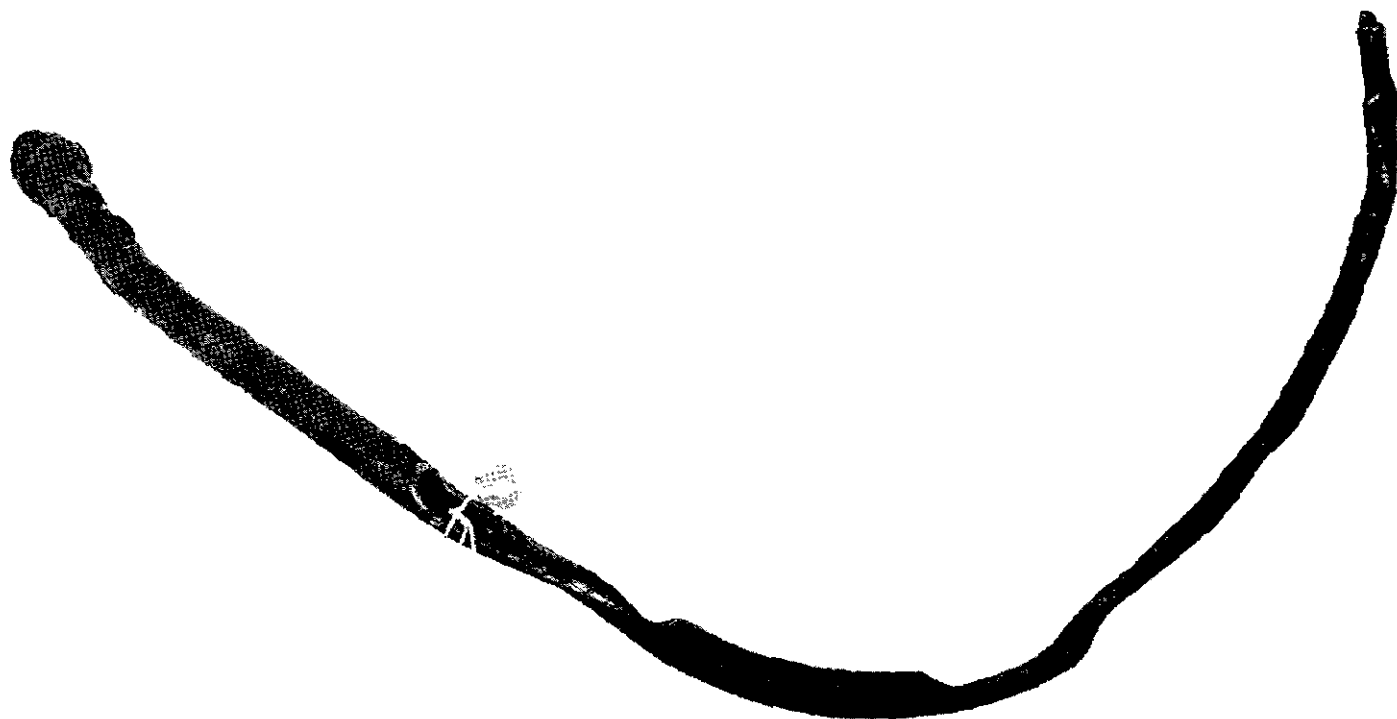
Figure 7. Charging Tube Found at MP 1052.6.

- . Crystals of TNT were found on the outside of the tube, especially in the collapsed portions of the tube. These crystals contained unreacted aluminum particles.
- . "Hot melt" coating was found on the outside surface, some of which appeared to have been affected by heat. One small piece of charred wood was embedded in the coating.
- . The collapsed portions of the tube appeared to have been heated above the melting point of the "hot melt" in several locations.
- . The tube was twisted along its longitudinal axis, but retained an approximation of its original contour.
- . The tube had been pulled out of its center and end connections.

The conditions of the charging tubes found at MP 1052.6 and those from the Navy's slow heating tests indicate that the bombs involved experienced similar heat exposures. Crushing and crumpling patterns were found on both tubes, and crystalline TNT was discovered on the exteriors of both.

The condition of the charging tube found at MP 1052.6 is significant. If an internal reaction spewed flames out of the nose or tail fuse liner over a 25-minute period, it would probably have overheated or consumed the charging tube in that bomb. The tube found at MP 1052.6 was not significantly overheated; in fact the conditions of the hot melt and the crystals indicate that the charging tube remained relatively cool during the explosion. The crystals on the tube indicated an exposure to vaporized tritonal, which would occur if the tritonal was overheated rather than reacting. The similarity between the appearance of the recovered tube and a tube recovered during the slow heating tests suggests that external overheating was more likely.

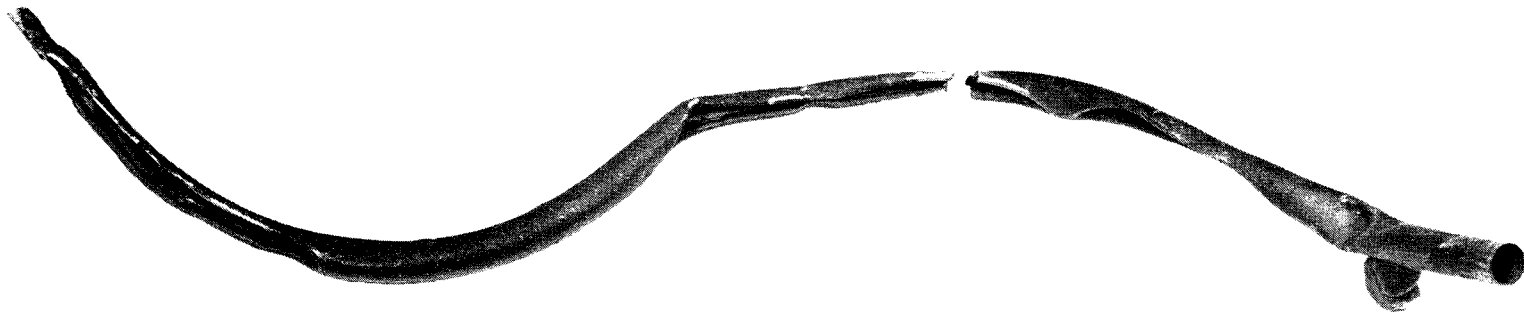
Figure 8. Charging Tubes Found at MP 1048.

Examination and tests disclosed that two of the fragments were similar in numerous details, and that external residues and appearances of both tubes were similar, except for the mass of "hot melt" at the straight end of the charging tube found in MP 1052.6.

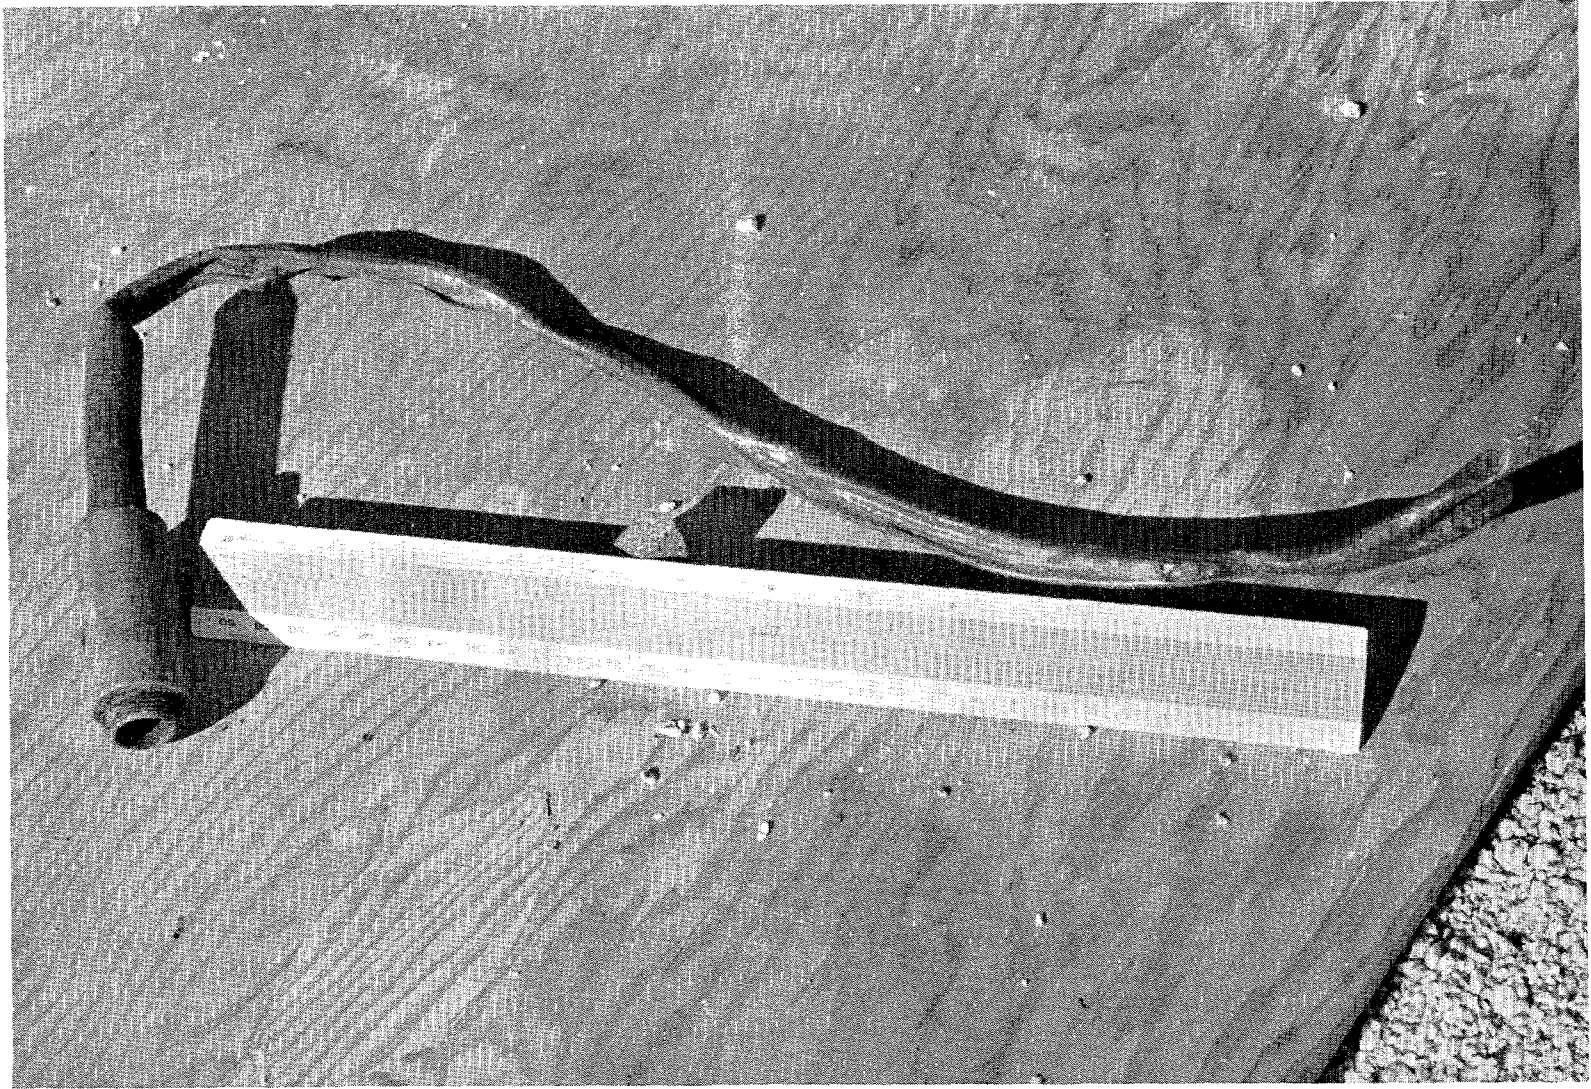
Figure 9. Debris Recovered from Externally Heated Test Bomb.

These tests resulted in the bursting of some of the test bombs, intensification of fire and smoke, and detonation of bombs. Resultant debris consisting of collapsed sections, hot melt, and crystal residues was similar to that found at the accident area. (See Figure 9.)

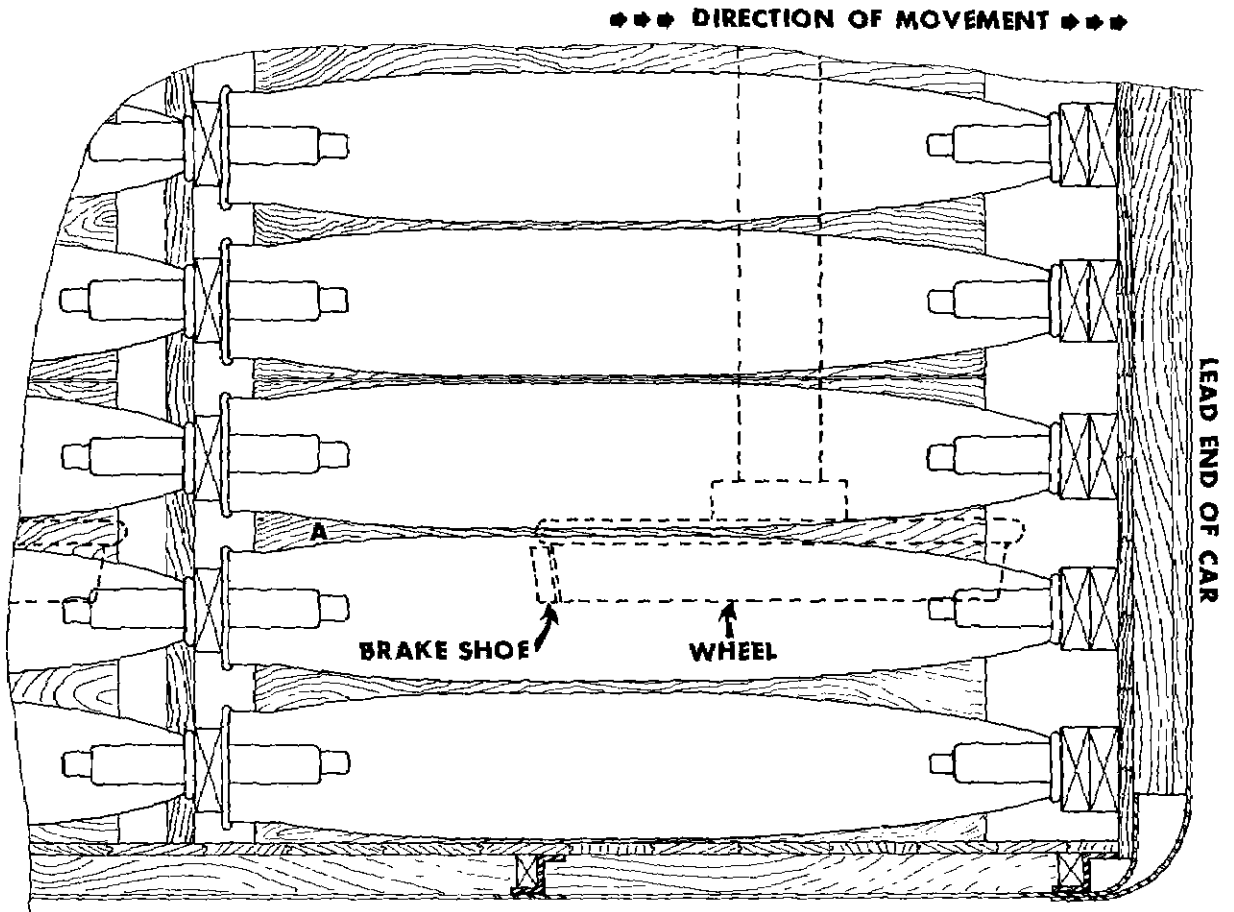
Figure 10.
CROSS SECTION PLAN VIEW AT NORTH WEST CORNER OF CAR
BOTTOM ROW OF MK 82 MOD I G.P. BOMBS ON PALLET SHOWN
AS LOADED ON BOX CAR MKT 6259

The location of the 25-minute char on the floorboard was in the vicinity of the tail of the center, bottom bomb on the pallet in the right forward corner of Car 38 (see Figure 10), and under and slightly ahead of the nose of the bottom, center bomb on the adjacent pallet. If either of these bombs had experienced an internal chemical reaction, the hot reaction products would have had to escape from the nose or tail fuse liner area of one of the bombs to have burned the floor in this area. A flame of this type would be accompanied by dense black smoke. No such smoke was observed until the train was well beyond MP 1052.6.

An examination of the charring on the recovered floorboards, on the pallet components, and on the other recovered fragments disclosed that the fire was most intense at floor level in the body bolster area and burned toward the end wall. In addition, the condition of the pallet parts indicates that the center bomb on the bottom row of the pallet in the right forward corner of the car split open at MP 1052.6. The Safety Board believes that the initial fire was localized between the floor and the bottom surface of the pallet in the vicinity of the center bomb. (See Figure 10.)

The debris pattern indicated that the center bomb in the bottom row of the corner pallet in Car 38 burst at MP 1052.6. It was probably exposed to the fire for the longest time. Therefore, the fire must have been most intense at, or near, the floor of the car in the area of the rear pallet chocks and the car body bolster. The location was almost directly above the leading wheel of the lead truck. The rear of the pallet was above the area where sparks from the brakeshoes could impinge the sodium-nitrate impregnated floor. While none of the floorboards recovered showed conclusive evidence of burning through from the bottom of the floor, the location of the bomb which first reacted, the location of the impingement area for brakeshoe sparks, and the location of the most extensively charred car floor and pallet all coincide.

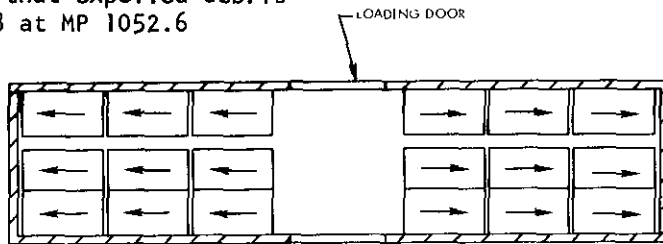
Location of pallet containing first bomb that expelled debris from car 38 at MP 1052.6
