RAILROAD ACCIDENT REPORT

HAZARDOUS MATERIALS ACCIDENT AT THE
SOUTHERN PACIFIC TRANSPORTATION COMPANY'S
ENGLEWOOD YARD
HOUSTON, TEXAS
SEPTEMBER 21, 1974

NATIONAL TRANSPORTATION SAFETY BOARD
Washington, D.C. 20594
REPORT NUMBER: NTSB-RAR-75-7

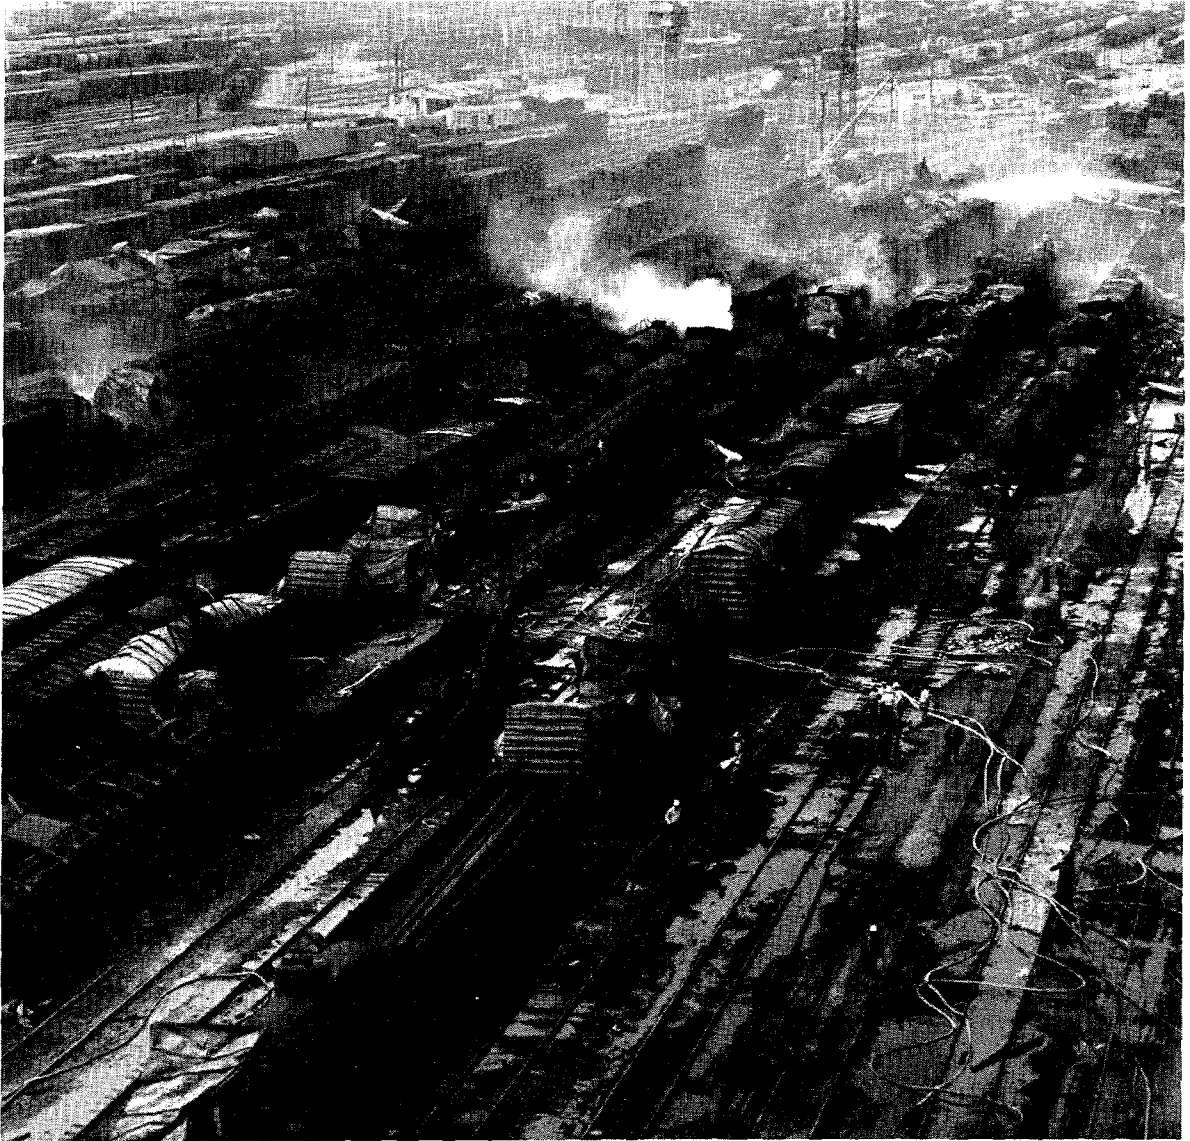
The explosion and fire destroyed 231 railroad cars and substantially damaged 282 others. (See Figure 1.) Considerable fixed railroad property also was destroyed or damaged.

Figure 1. Some of the wreckage on the day following the accident.

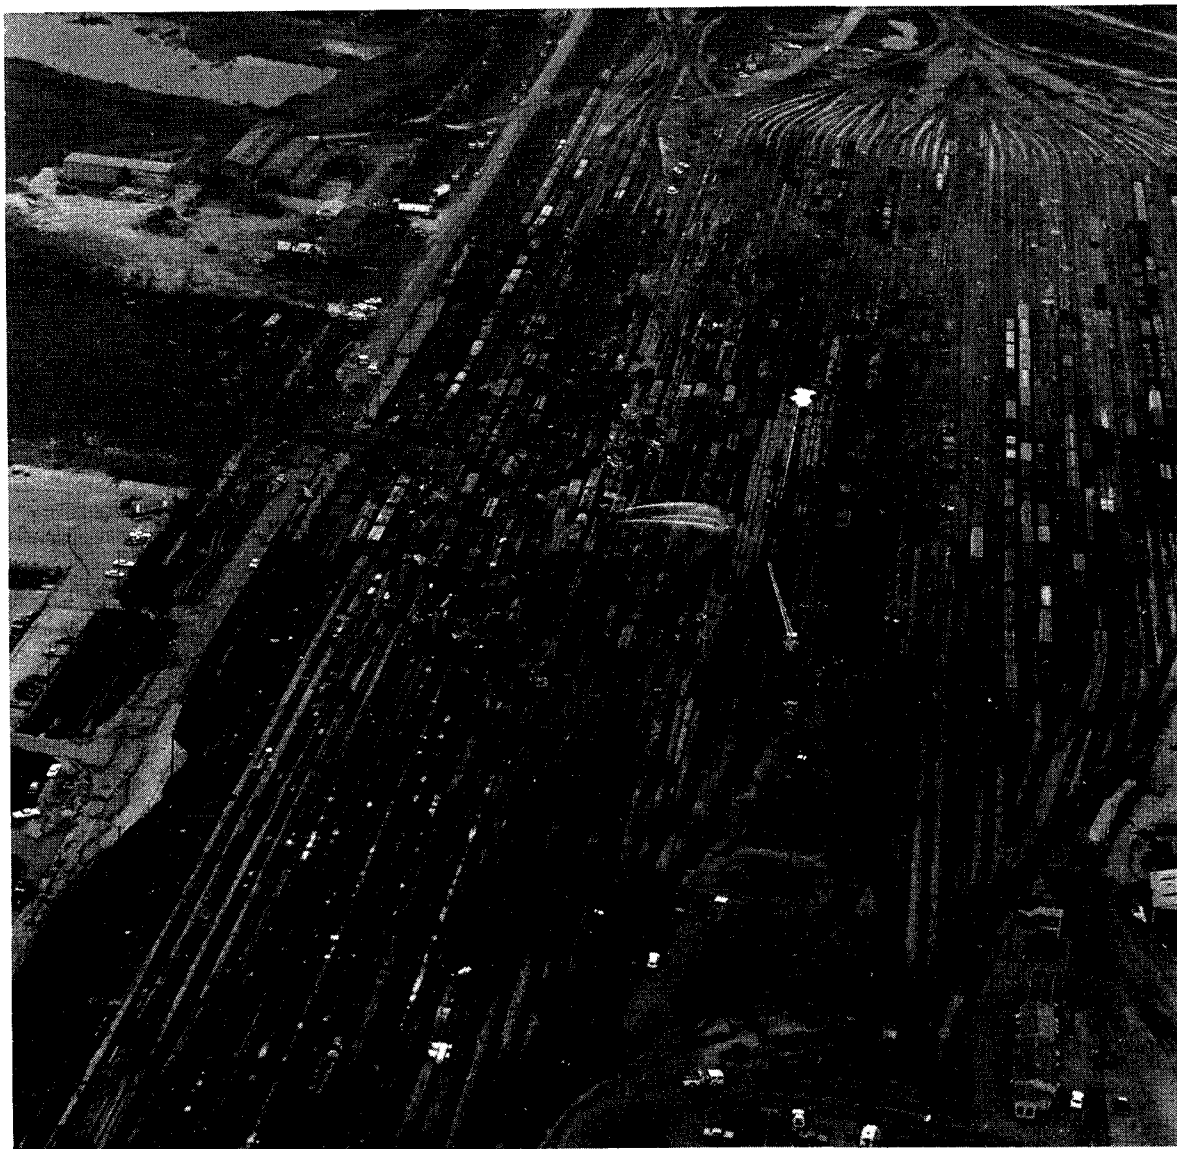
Figure 2. Aerial view of Englewood Yard on day after accident looking east toward the hump.

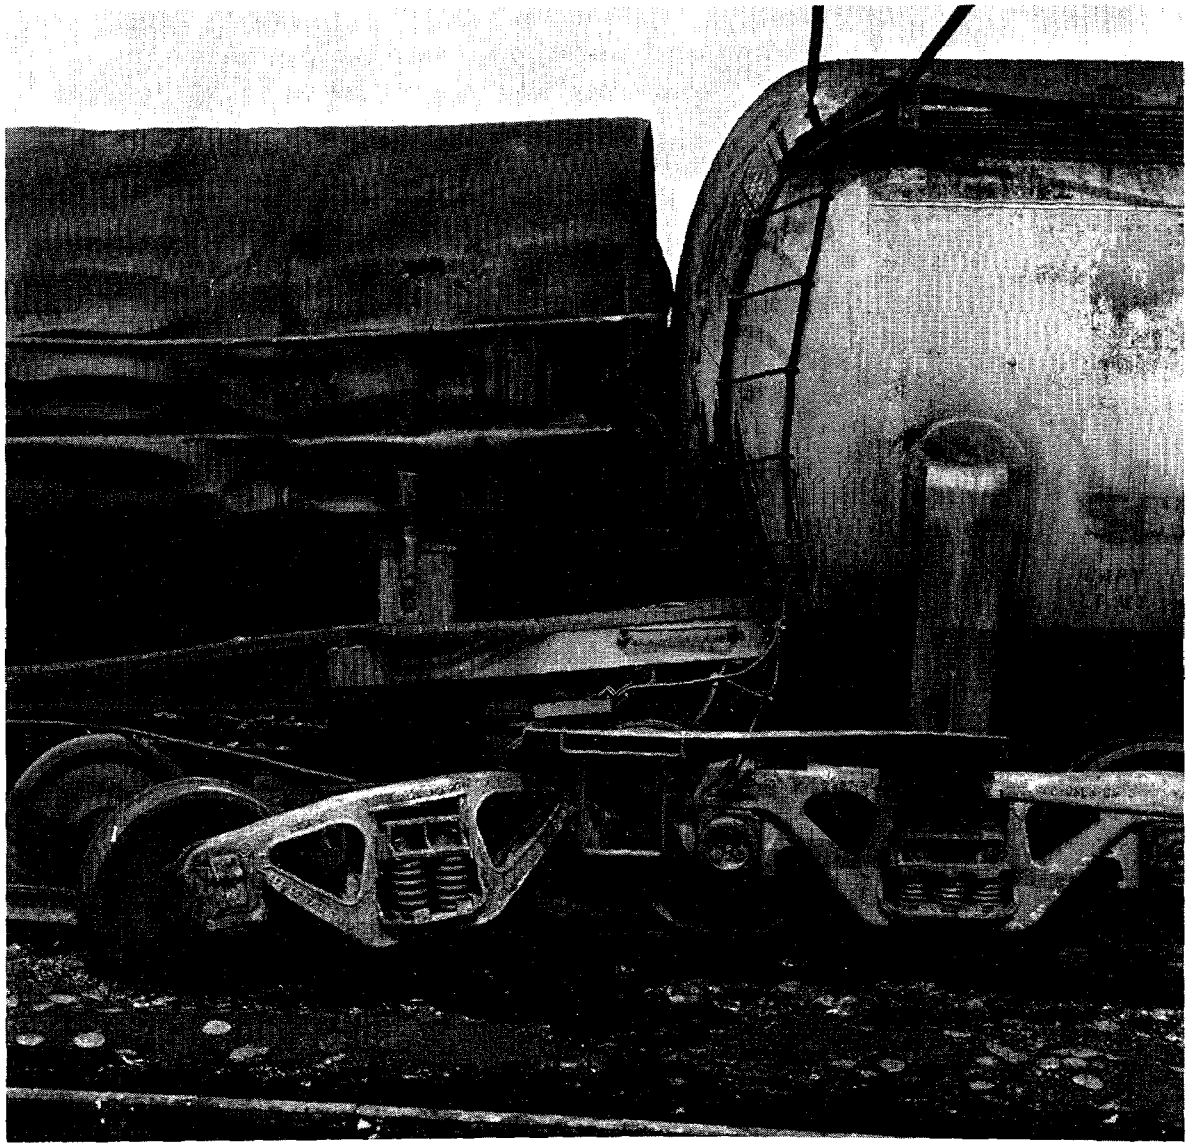
Description and damages -- The first car in this switching cut which, subsequent to the accident, showed evidence of being involved in an overspeed collision was car 10. Table 1 describes the general circumstances of car 10 and those cars which followed it through the retarders. Car 10 weighed 67,000 pounds and was equipped with a type E, 6 1/4" x 8" straight shank coupler on the end that was impacted by car 17. This coupler was broken off at the shank and the lower coupler's front face was split vertically. The east trucks had been derailed. (See Figure 3.)

Figure 3. Car 10 (the empty tank car) on the left and car 17 (the punctured car which contained butadiene) on the right.

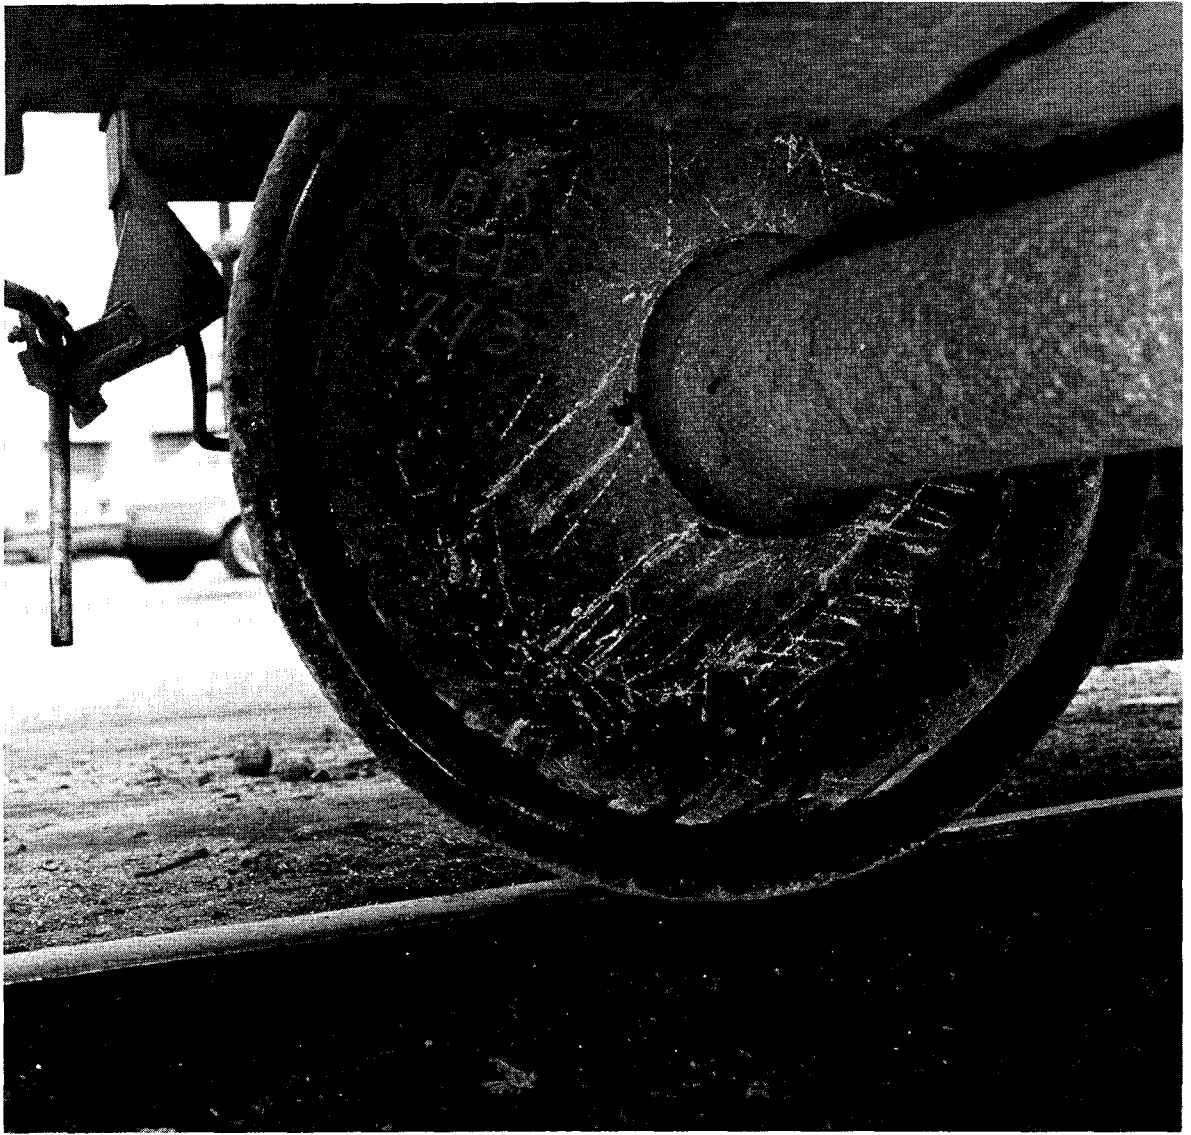
of all their wheel rims were coated with a dark gummy substance. (See Figure 4.) The coating of foreign substance on the wheels of car 19 was considerably less than that on the wheels of cars 15 and 16.

Figure 4. Inside face of one of the wheels of the 15th car.

The foreign substance was found on all three of the retarders' brakeshoes. The material also was identified in substantial quantities on the wheel rim faces of cars 15 and 16, and there were traces of resin on the wheels of car 19. Car 15 was the first car in the switching cut on which this material was observed.
