REAR-END COLLISION OF TWO  
SOUTHERN PACIFIC TRANSPORTATION COMPANY  
FREIGHT TRAINS

INDIO, CALIFORNIA  
JUNE 25, 1973

REPORT NUMBER: NTSB-RAR-74-1

ADOPTED: March 20, 1974

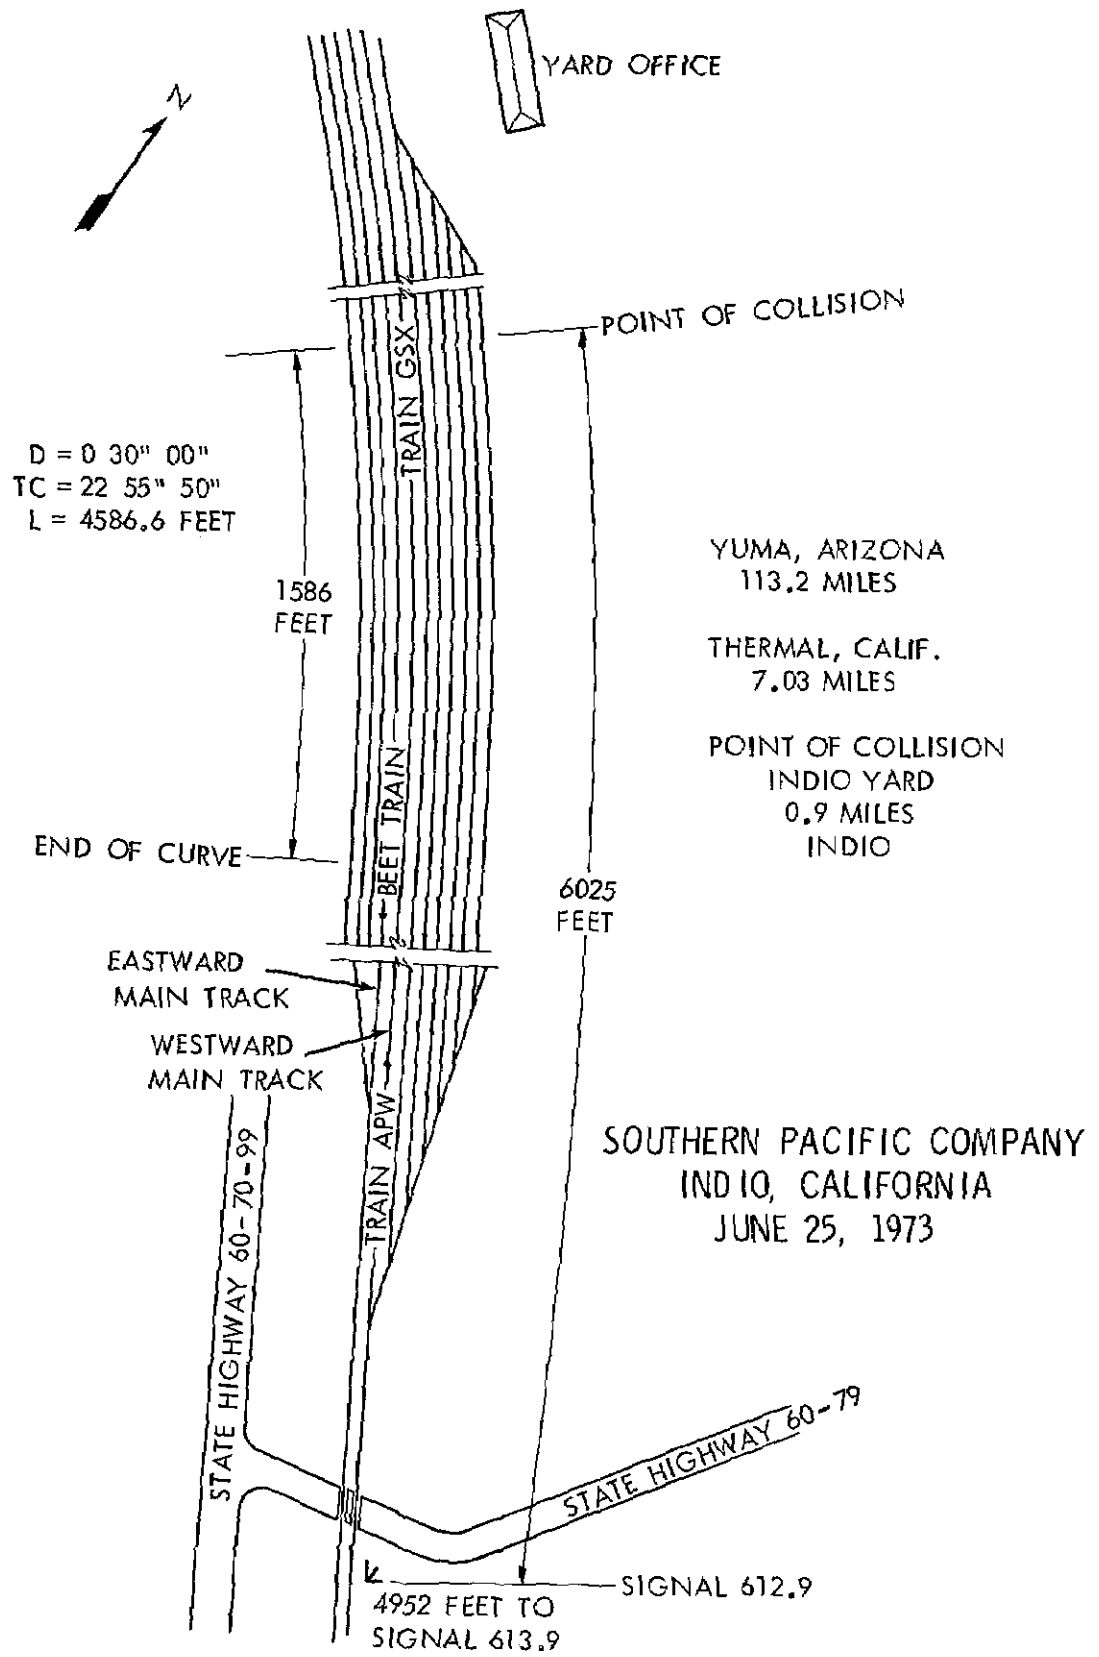
Figure 1. Accident site.

on each side. Westbound trains approached Indio on straight tracks until they reached a point 4,439 feet west of signal 612.9. From this point, they traversed a 0° 30' curve to the left for a distance of 4,586 feet. Westbound trains approaching the collision point on the westbound main track ascended a 0.2-percent grade. A yard office was located along the north side of the yard about 2,680 feet west of the collision point. (See Figure 1.)

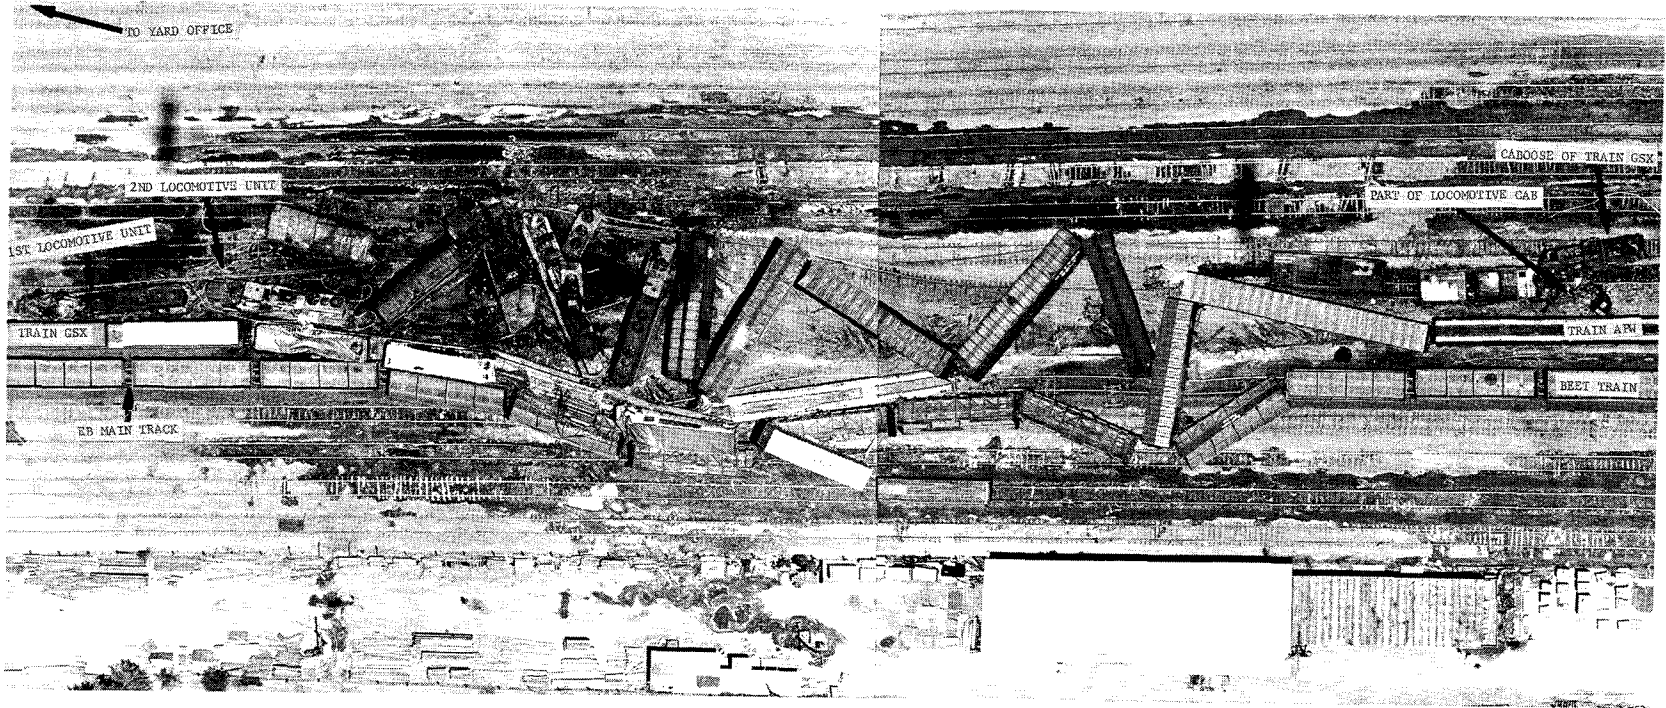
Figure 3. Aerial view of wreckage after the collision.

A portion of the control compartment was torn from the first locomotive of train APW and was thrown along the north side of the track near the caboose. As train APW continued northward after the collision, the locomotive plowed through the seven rear cars of train GSX. The fuel tanks of several of the locomotive units were punctured; diesel fuel sprayed over the wreckage and ignited. All five locomotive units and the first seven cars on train APW were derailed and destroyed. In addition, the 31st car and the 10 cars in back of the 31st car were derailed and heavily damaged as a result of the impact.

Eight cars of Extra 9214 East on the adjacent track were derailed and damaged when they were struck by the derailing equipment of the colliding trains. (See Figure 3.)
