RAILROAD ACCIDENT INVESTIGATION,

✓
REPORT NO. 4187,

SOUTHERN PACIFIC TRANSPORTATION COMPANY

APRIL 28, 1973

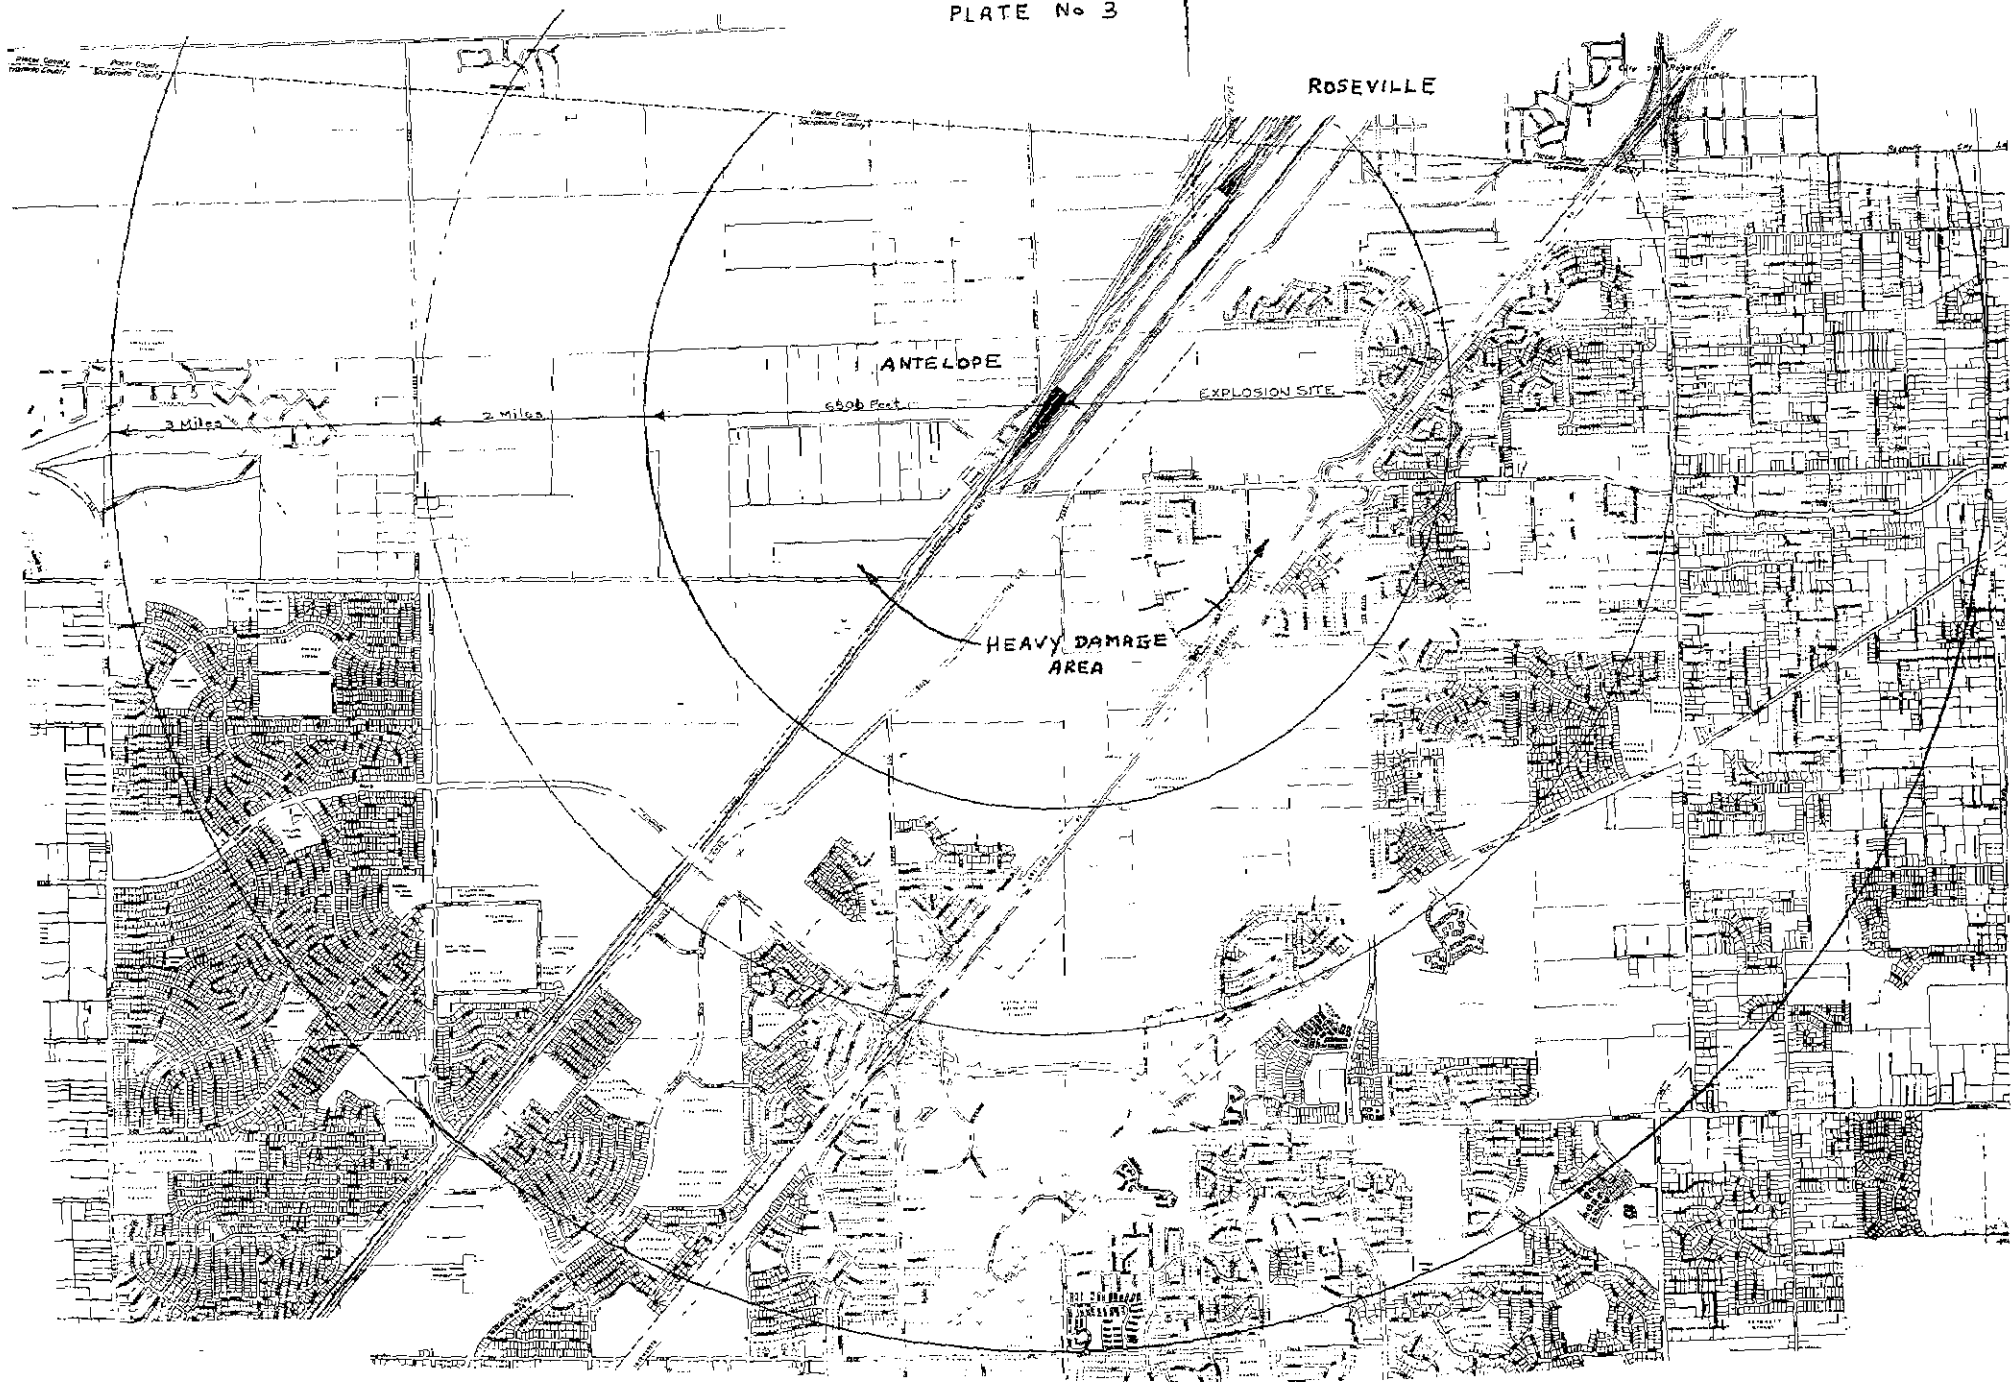
PLATE No 3

Of the 32 structures in Antelope, 9 were destroyed, 11 heavily damaged, and 12 slightly damaged.

In all, approximately 5,500 buildings, mostly residential, were damaged by the explosions. The area of heavy damage or destruction was within a radius of 6,800 feet from the explosion site (See Plate 3). Slight damage to structures occurred up to three miles from the site of the explosions.

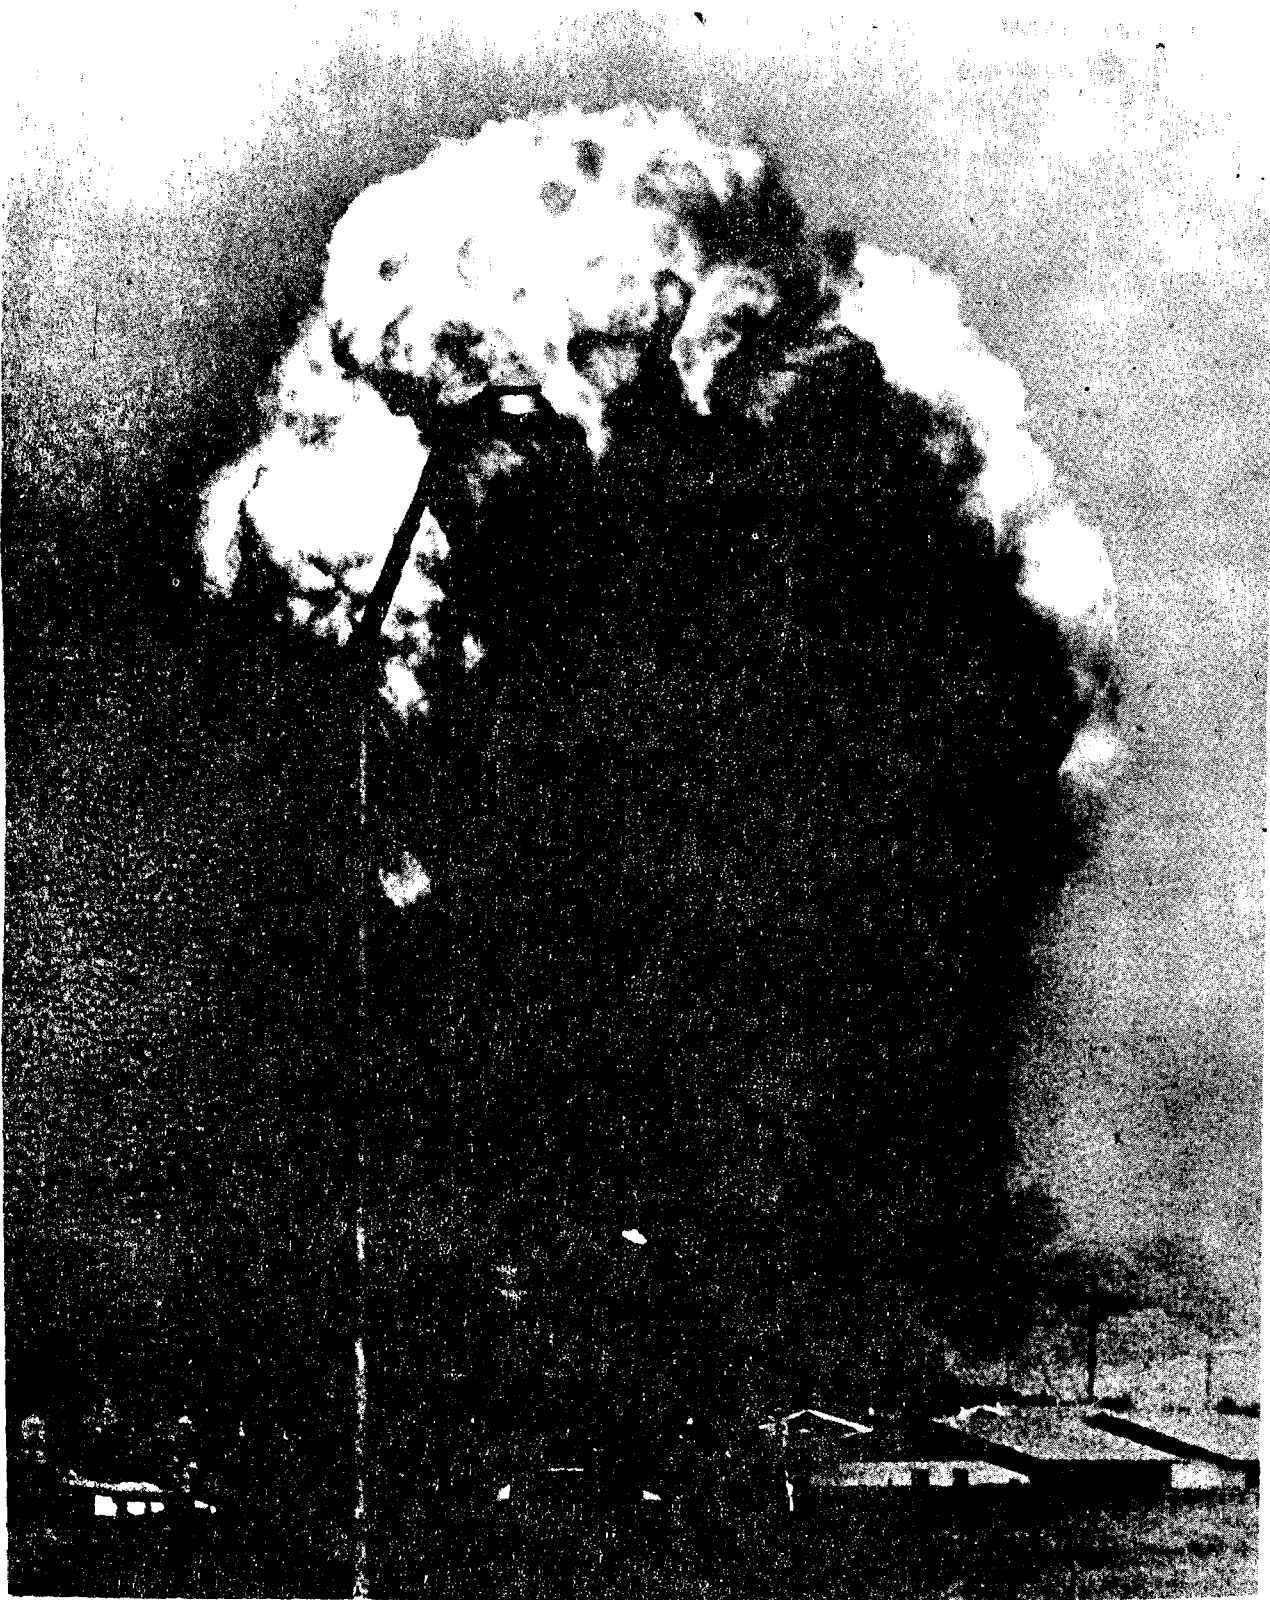
PLATE NO. 4

Bomb explosion at Roseville

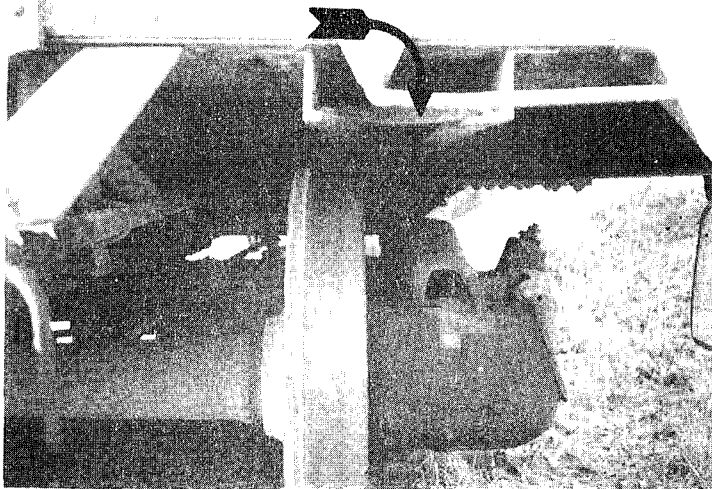
A metal spark shield was above each wheel as shown in the following photo.

The heavy application of the brake shoe against the glowing wheel of the DODX car could have caused very heavy sparks to be thrown upward against the underside of the spark shield above that wheel. All train braking causes some sparking, which looks dangerous but is actually not unusual. Since tests have revealed composition brake shoes infrequently catch on fire when heavily applied against a rotating wheel for a prolonged period, there is a possibility that fire from a burning brake shoe was also directed toward the aforesaid spark shield. Assuming that braking action caused fire and/or sparks to be thrown upward toward a spark shield on a DODX car in the train of Extra 9117 West, there is a possibility such fire and/or sparks was not blocked by the spark shield because of its location and size. In this event, unblocked fire or sparks from the brake shoe and wheel area would have been directed to the

underside of the car floor and could have ignited the floor, causing it to smolder. Thus, a possibility exists that the wooden floor of a DODX car was smoldering when Extra 9117 West entered the Roseville receiving yard approximately one hour before the initial explosion. A possibility also exists that the smoldering floor produced little or no smoke. There is a conflict in this theory between sparks causing a fire in an oil and greased coated floor and no smoke. In such fires, especially when smoldering, are usually very smoky. But, this could account for the fact that no one observed smoke emanating from the DODX car until approximately 15 or 20 minutes before the initial explosion, or presumably, under this hypothesis, about the time the smoldering portion of the car floor burst into flames and produced readily visible quantities of smoke.

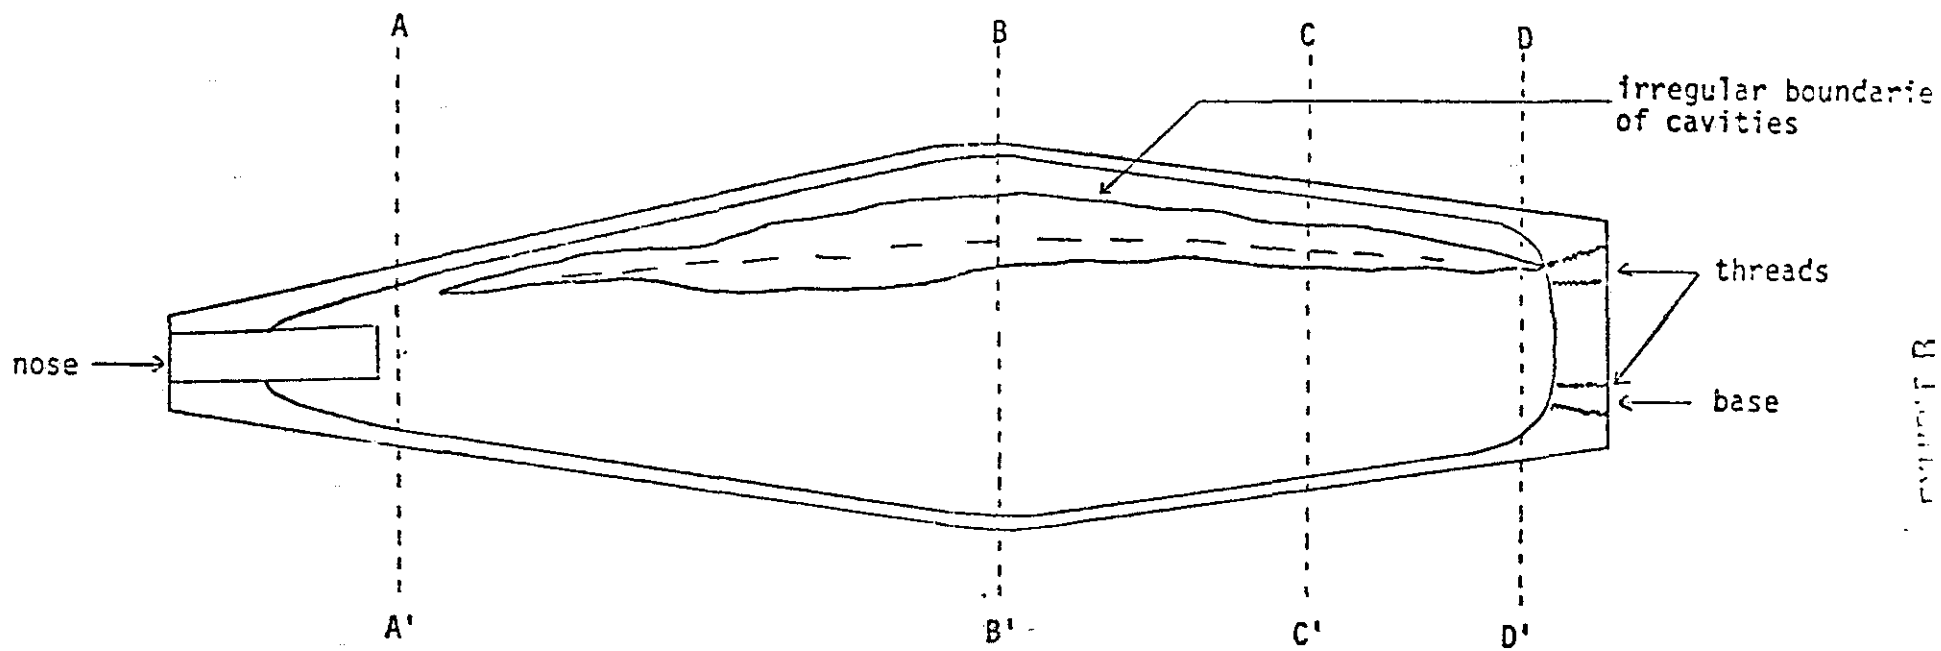
Figure 1. Diametrical Cross-Section Showing Cavities of a Tritonal Bomb.

There was good evidence for the situation I suggested at Mr. Bonner's meeting last Tuesday that unconsolidation of HE would occur in and surrounding the large cavities especially near the base of the charge, i.e., the threaded base end of the bombs. Moreover, the cavities were lined with pure, honeycombed, recrystallized TNT obviously in a much more sensitive condition than in a proper cast by reason of the porosity and partial unconsolidation of the TNT in these regions. The volume of pure, recrystallized TNT was comparable to that of the cavities which theoretically should amount to around 8% of the inside volume of the bomb.

3. Since the cavitation in the bomb extended right into this most hazardous threaded end plate region, there exists a potential, in fact very likely, ignition source as well as a ready channel for explosion buildup right from the region of this corrodible and potentially friction-initiated section of the bomb.

examine all facets of the problem in order to prevent a recurrence prompts us to recommend that the Navy reexamine its manufacturing and loading procedures at Hawthorne and McAlester, where the tritonal bombs are produced.
