# NATIONAL TRANSPORTATION SAFETY BOARD

## RAILROAD ACCIDENT REPORT

DERAILMENT OF SOUTHERN PACIFIC  
TRANSPORTATION COMPANY  
TRAIN NO. 01-BSMFF-05  
CARRYING RADIOACTIVE MATERIAL  
AT THERMAL, CALIFORNIA  
JANUARY 7, 1982

NTSB-RAR-83-1

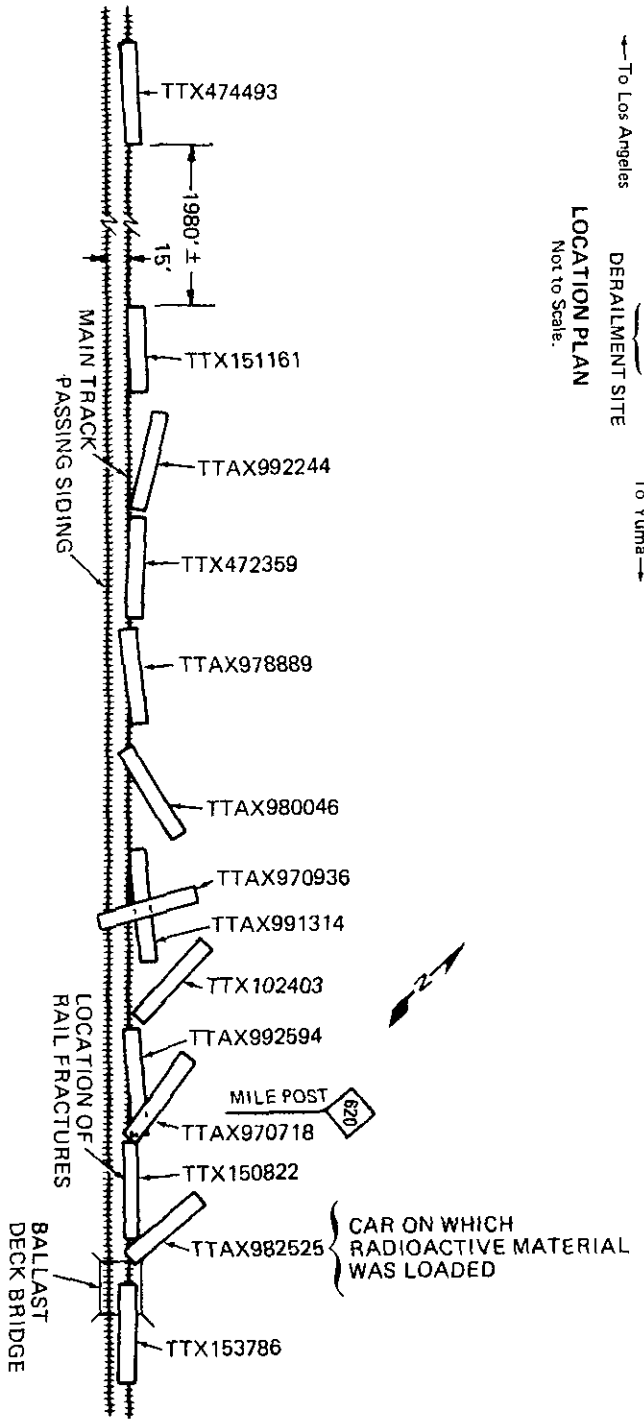
Figure 2.—Sketch of derailment site.

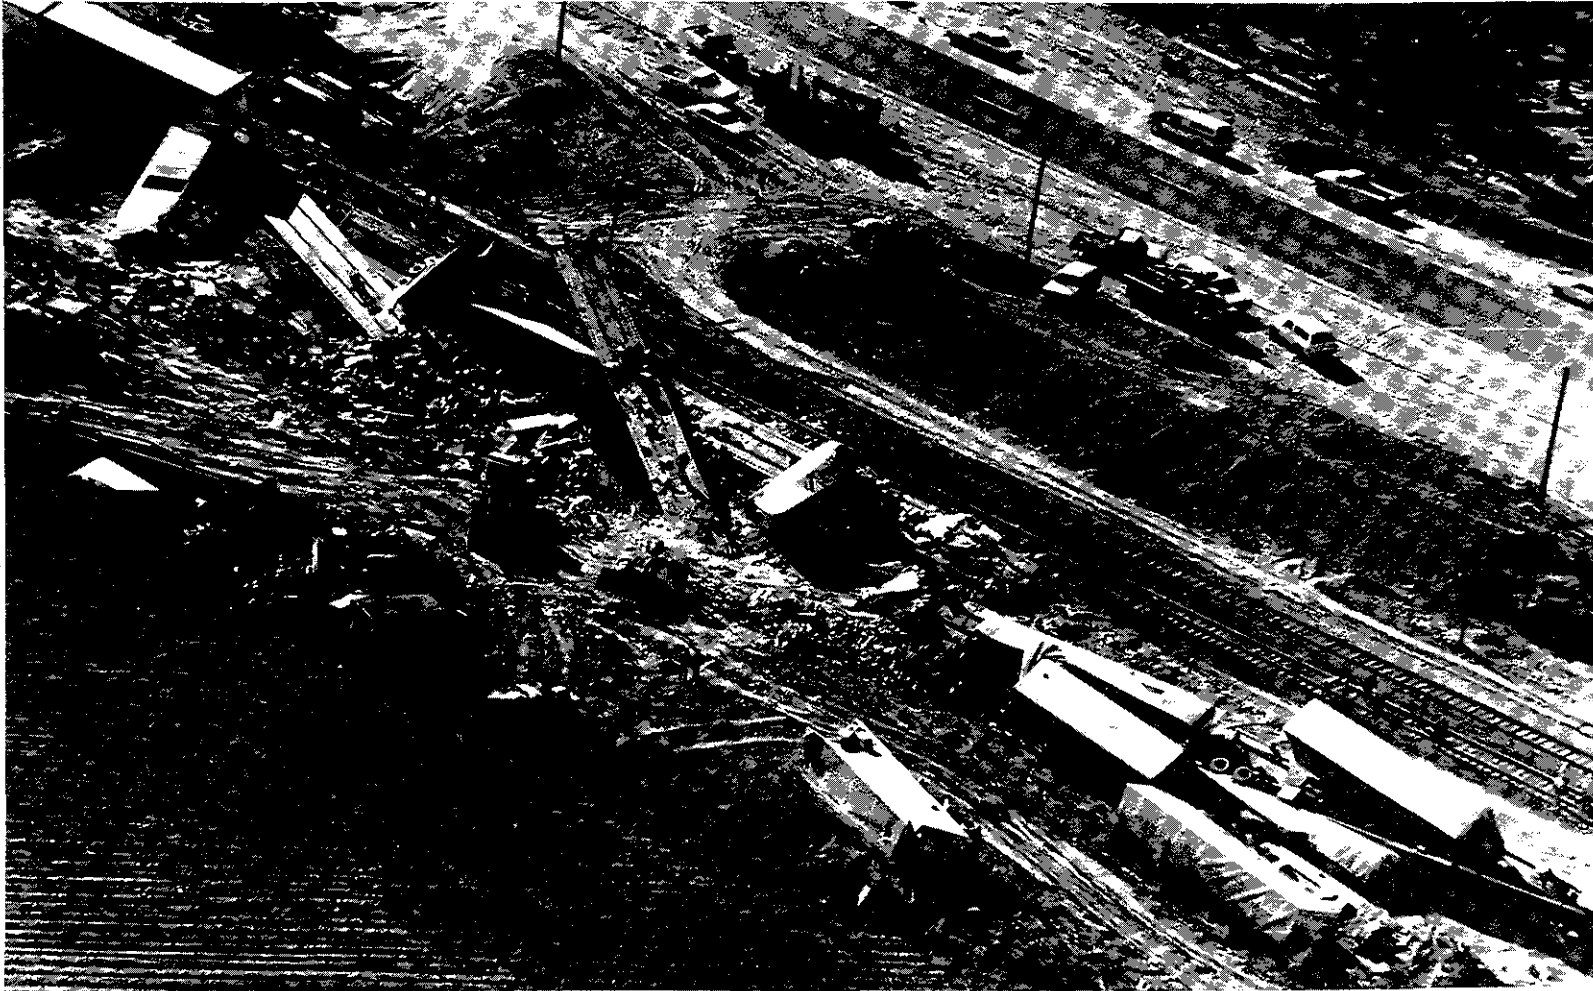
Figure 3.—Aerial view of accident site.

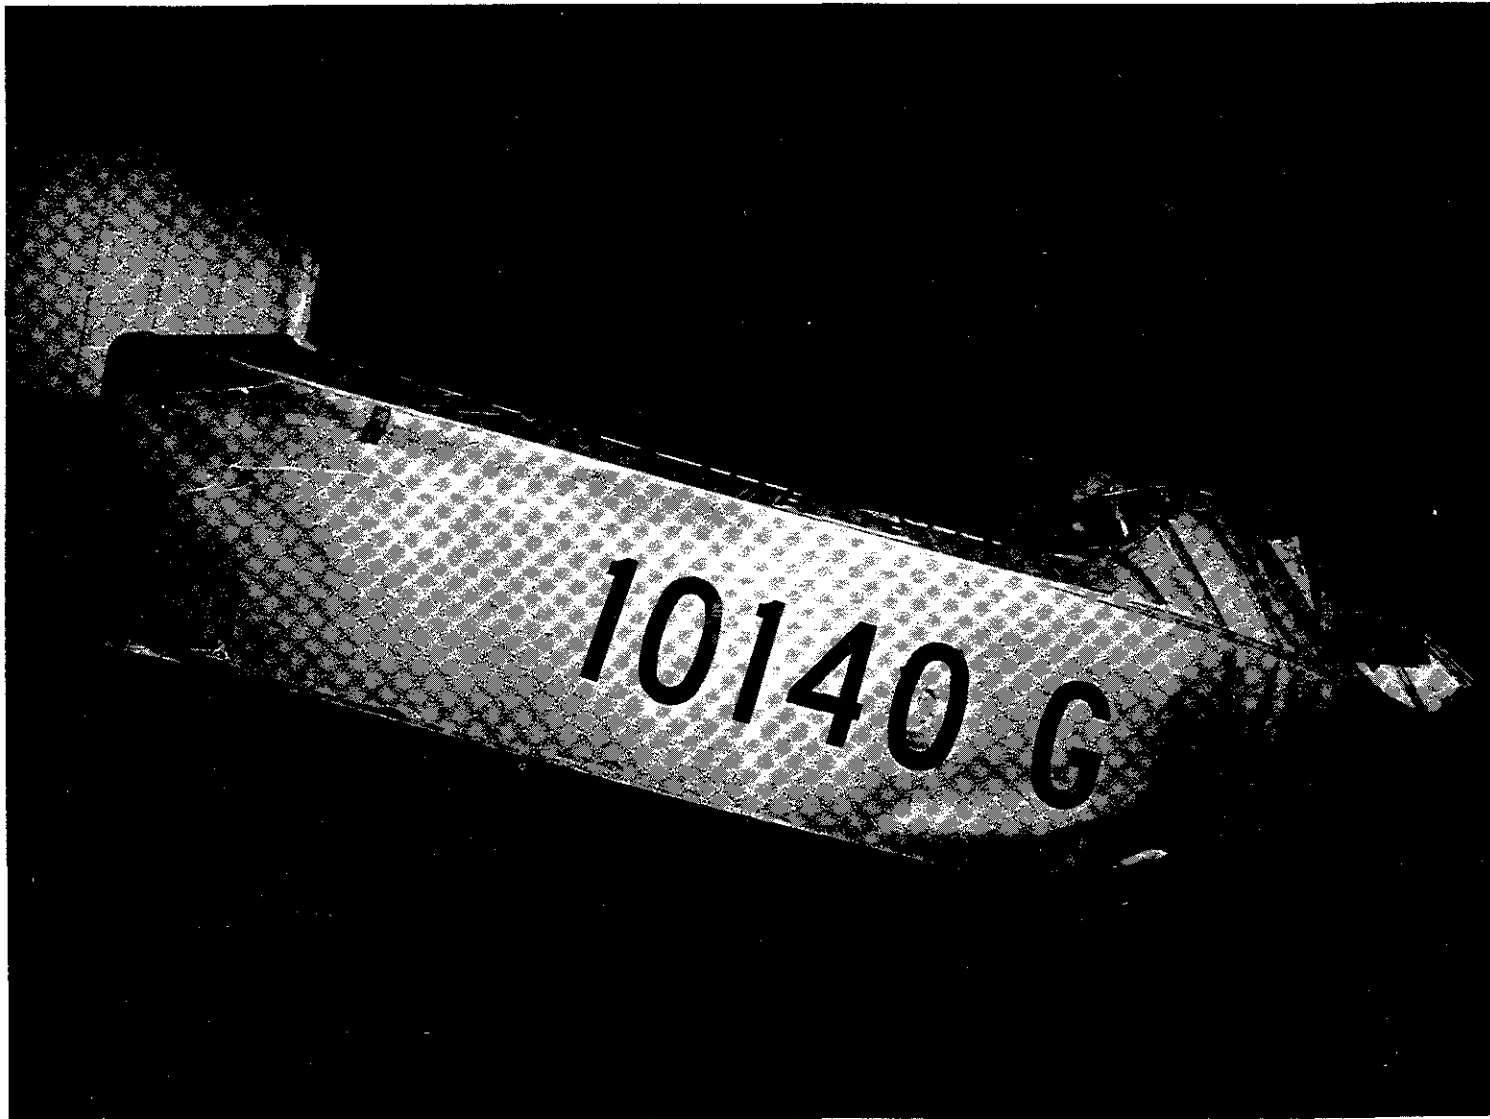
and destroyed (see figure 4). The 49th car of the train derailed, but also remained upright and in line with the track structure. The trailers on this car remained attached and were not damaged in the derailment, but were damaged during wreckage clearing. All other truck trailers involved in the derailment were destroyed, and their lading were badly damaged or destroyed.

Figure 4.—View of truck trailer No. GILFLEX 10140, containing radioactive material, as it came to rest after the derailment.

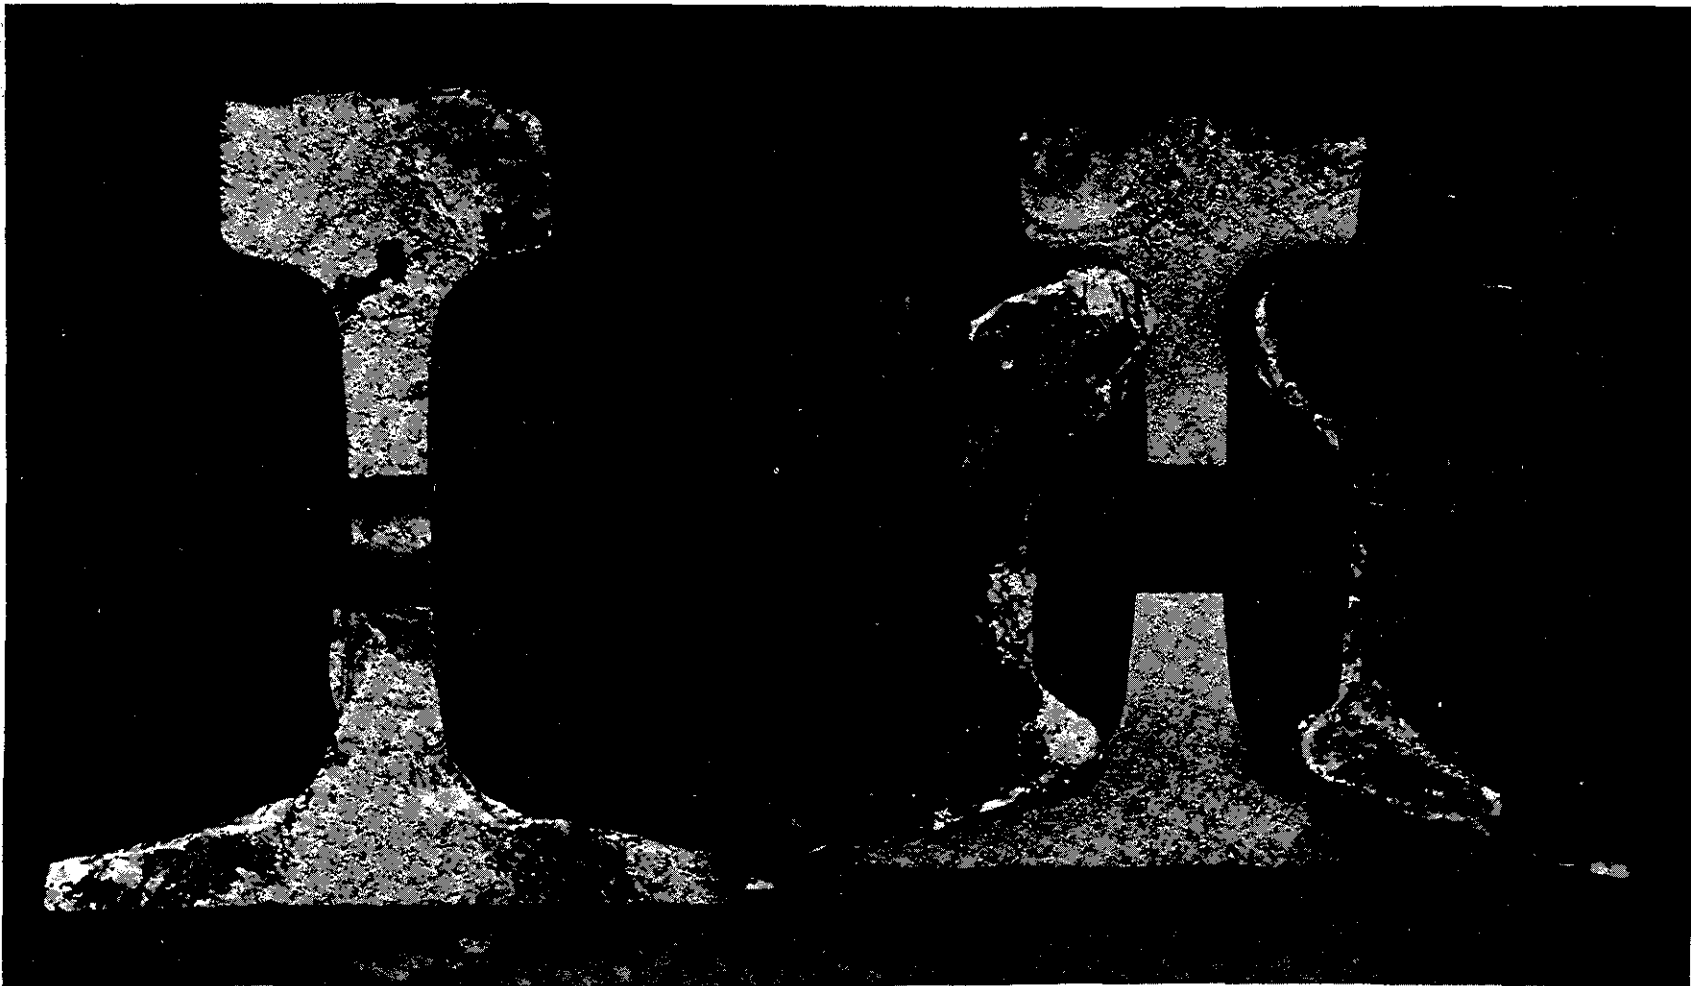
LAB. PHOTO 248-3. FAILED RAIL - THERMAL DERAILMENT 01SMFF-05, 1-7-82.

The fracture surfaces at A-A show a 35% derail fracture from shelling in the rail head gage side; remainder, rapid break. Arrows indicate origin.

Figure 7.—View of fracture at "A-A" showing detail fracture.

Metallurgical analysis of the broken rail indicated that two of the fractures were detail fractures which originated from shelling. Shelling is a condition which occurs when contact stresses between wheels and the railhead exceed the elastic limit of the steel, and can result in deformation and subsurface shear in the railhead. The subsurface shear normally originates in a longitudinal plane, but then turns downward to a transverse plane. Detail fractures are unique in contrast to other transverse defects because they are not the result of metallurgical factors such as inherent inclusions<sup>15/</sup> in the rail steel. Rather, they are the result of the excessive contact stresses of heavy wheel loads over an extended time frame, and as such are fatigue-related defects. The growth of a detail

fracture from shelling occurs rapidly in contrast to other transverse fissures. The remaining rail fractures were caused by instantaneous overstress, which probably occurred during the derailment. The fact that the rail fracture surfaces displaying detail fractures were battered also indicated that the detail fractures preceded the instantaneous overstress fractures. Although the precise moment of the rail failure could not be established, the signal's momentary flash from green (clear) to red (stop) to green (clear) as train No. 01-BSMFF-05 approached, indicated a momentary disruption of the signal circuit, which was conveyed through the rails. The dynamics imposed on the rails by the approaching train could have caused a slight longitudinal motion of the rails inducing the momentary disruption of the signal circuit. The Safety Board believes that the initial rail failure most likely occurred before the passage of train No. 01-BSMFF-05.

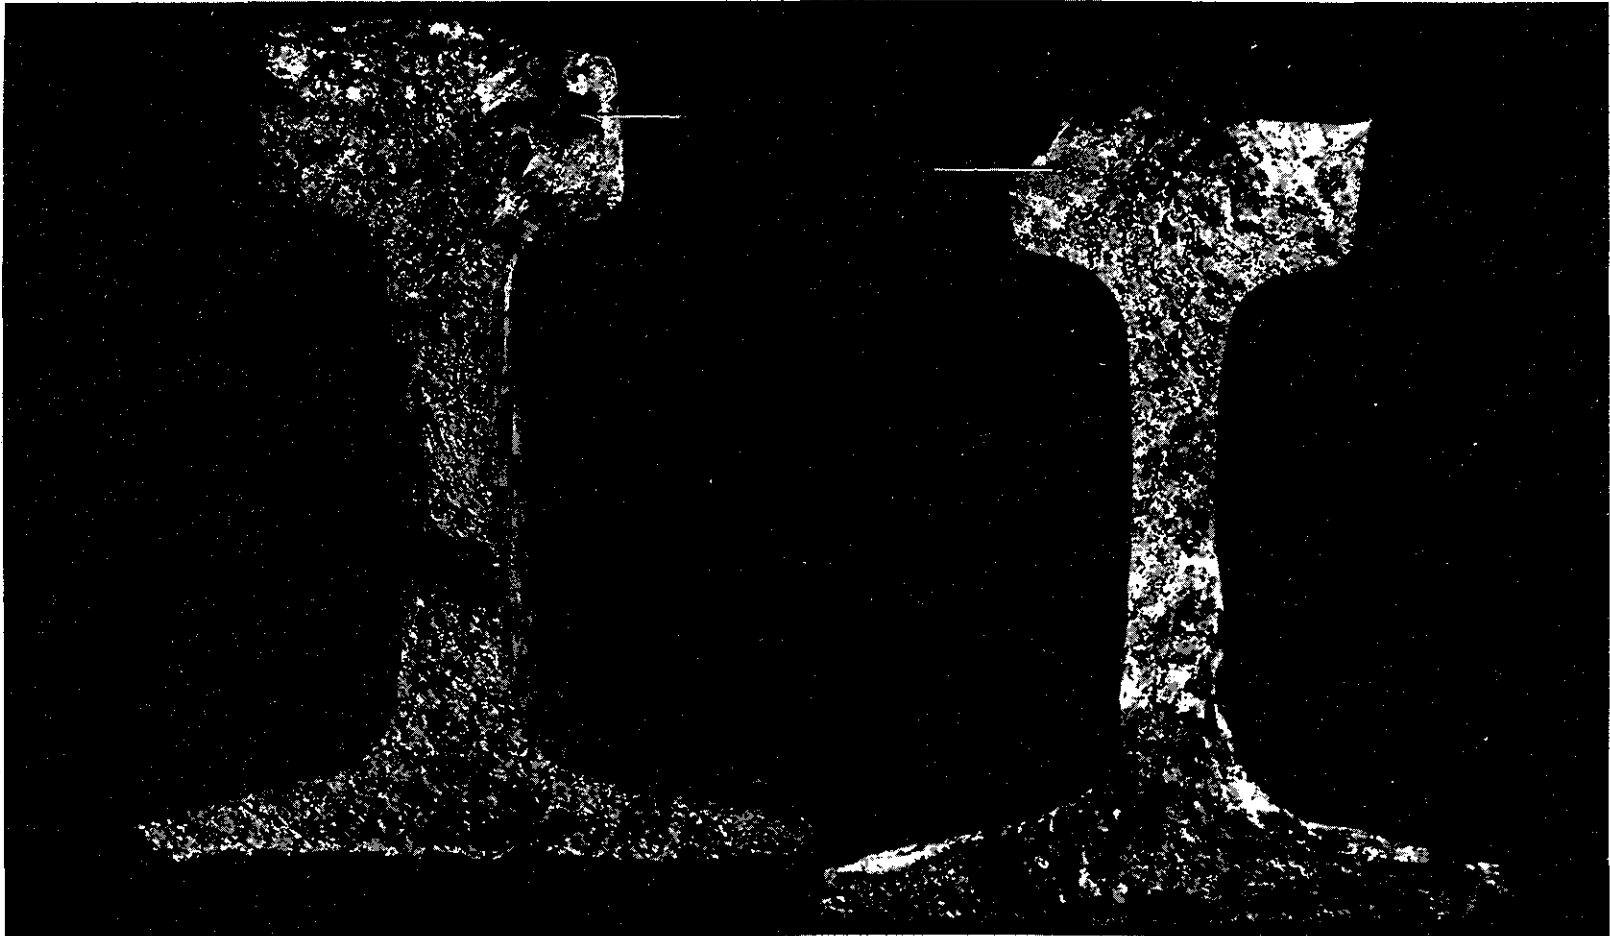
LAB PHOTO 248-4. FAILED RAIL - THERMAL DERAILMENT 01BSFF-05, 1-7-82

The fracture surfaces of the breck at B-B show a 15% derail fracture from shelling in the rail head on gage side, remainder, rapid breck with extensive battering.

Figure 8.—View of fracture at "B-B" showing detail fracture.

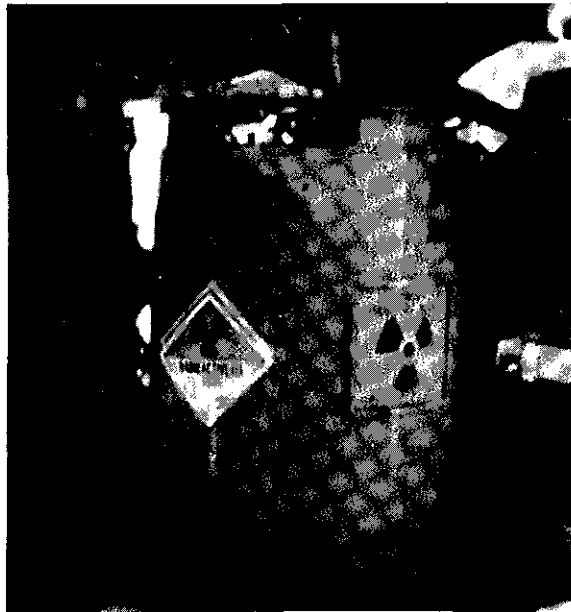
The outer container was visually examined after the accident and no apparent damage was noted (see figure 10). Radioactivity detection tests after the accident disclosed that the measured radioactivity from the container was at the same level as when the container had been prepared for shipment.

Figure 10.--View of RAM container after derailment.
