RAILROAD ACCIDENT REPORT

REAR END COLLISION OF SOUTHERN PACIFIC
TRANSPORTATION COMPANY FREIGHT TRAINS
02-HOLAT-21 AND 01-BSMFK-20
THOUSAND PALMS, CALIFORNIA
JULY 24, 1979

NTSB-RAR-80-1

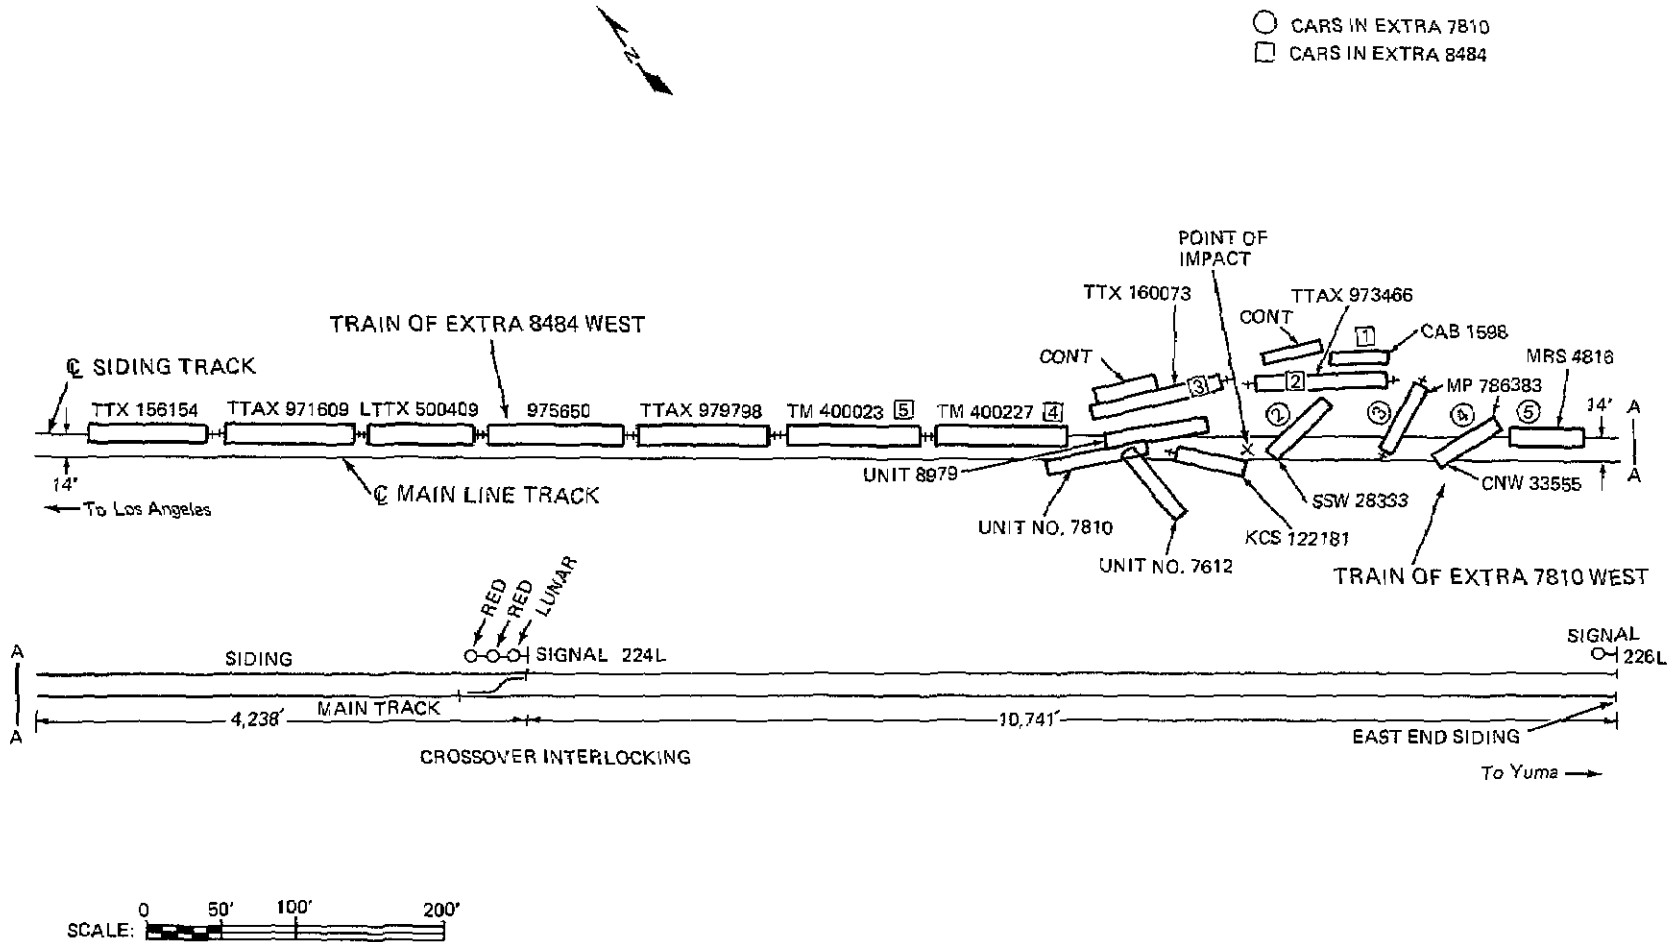
West of the crossover interlocking, the head brakeman remembered seeing the door open on the caboose of Extra 8484. He did not see any persons and he did not remember seeing a red marker light. He was not sure whether or not he operated the emergency brake valve on the fireman's side, but he thought he did. He did not call the aspect of signal 224L at the crossover interlocking to the engineer, but he recalled the engineer telling him that the train ahead was moving out and "we will follow it down to the west end." He said he did not question this logic. Shortly thereafter, about 4:03 a.m., while moving at approximately 20 mph, Extra 7810 West struck the rear of Extra 8484 West about 4,238 feet west of the crossover interlocking signal. (See figure 1.)

Figure 1. Thousand Palms derailment.

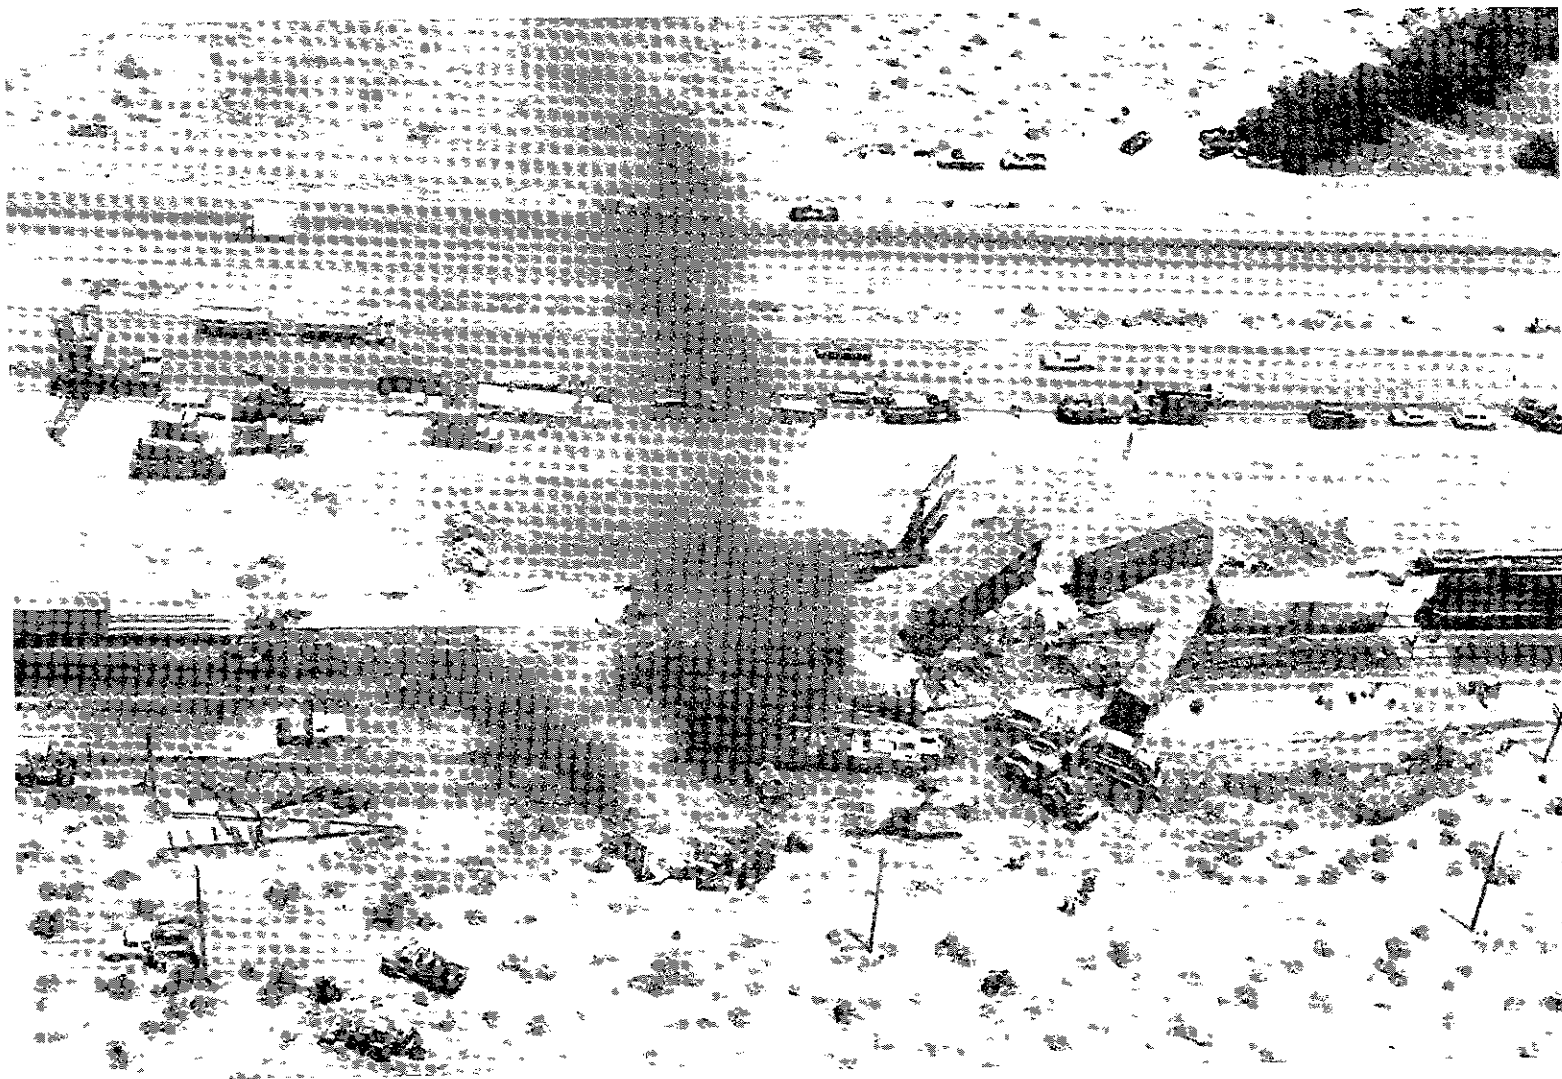
The caboose of Extra 8484 West was heavily damaged. The second, third, fourth, eighth, and ninth cars from the rear sustained minor to heavy damage. The three locomotive units of Extra 7810 West were destroyed and the first, second, third, fourth, and fifth cars from the head sustained minor to heavy damage. (See figure 2.) The track was damaged slightly.

Figure 2. Wreckage at point of impact.

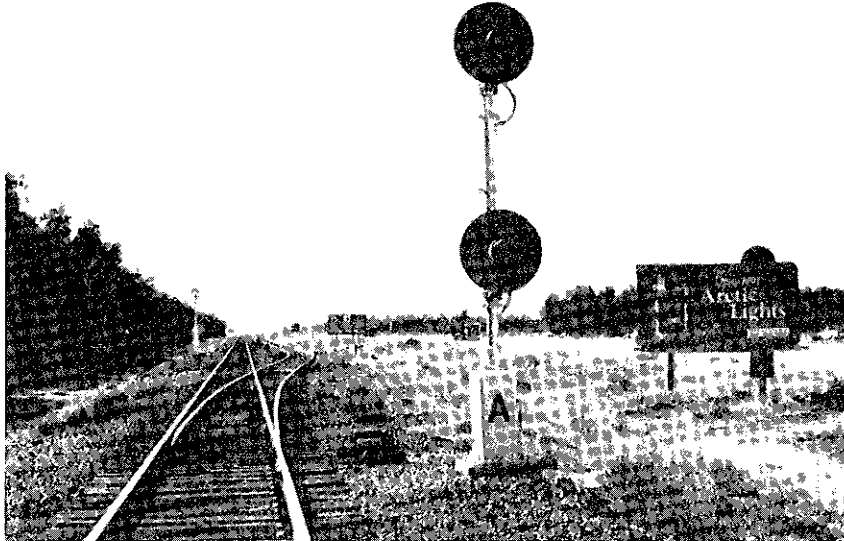
The head brakeman of Extra 7810 West said that he remembered a red over yellow signal aspect at the east entrance to the siding at Thousand Palms, which permitted the train to proceed at a restricted speed, but that he did not call it to the engineer as required by operating rule 34. He did not recall the signal aspect displayed by the crossover interlocking home signal, signal 224L, at the midway point of the siding, but he said that he saw a flashing white light at that point. He did not take any action in either instance.

The track at Thousand Palms is tangent with a grade averaging about 1.13 percent ascending westward from Myoma and continuing westward. A siding 21,620 ft in length parallels the main track on the north. A crossover connecting the siding with the main track is located 10,471 ft from the east end of the siding. (See figures 3 and 4.)

Figure 3. Signal 226L east entrance to Thousand Palms siding and view west.

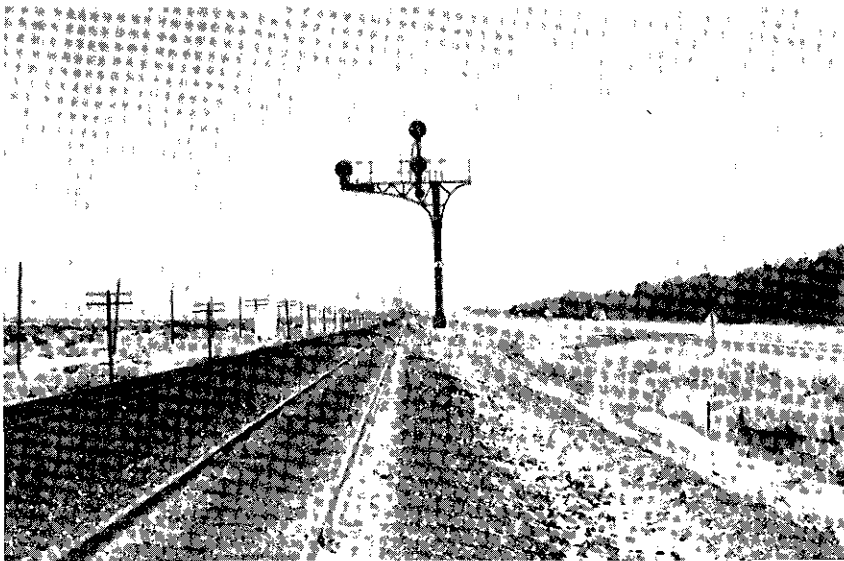
Figure 4. Signal 224L at crossover interlocking and Thousand Palms siding and view west.

5. Signal 224L displayed a stop aspect when Extra 7810 West passed.
6. Extra 7810 West passed the stop aspect of the signal at the crossover interlocking without stopping.
