RAILROAD ACCIDENT INVESTIGATION

REPORT NO 4096

SOUTHERN PACIFIC COMPANY

CLOTHO, CALIF

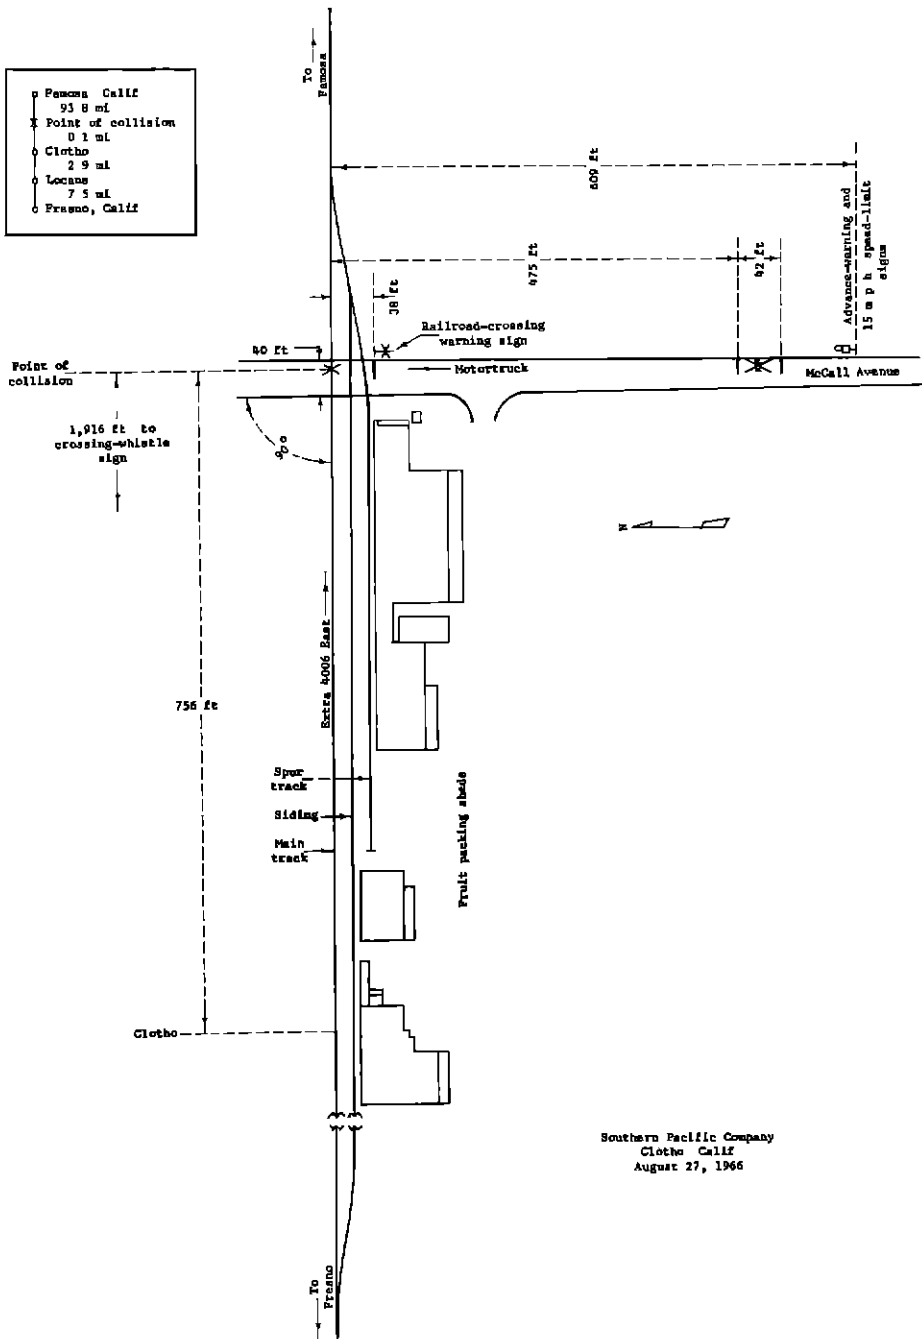
The accident occurred on that part of the San Joaquin Division extending between Fresno and Famosa, Calif., a distance of 104.3 miles. In the accident area this is a single-track line over which trains operate by timetable and train orders. There is no block-signal system in use. In the accident area, a siding and a spur track parallel the main track on the south as shown in the sketch appended to this report.

As a northbound vehicle on McCall Avenue approaches the crossing, the driver's view of the main track westward is obstructed by fruit packing sheds along the south side of the siding.

and spur track and by trees in the southwest quadrant of the crossing. However, as the vehicle approaches the crossing within 36 feet, the driver has an unrestricted view of the main track westward for a distance of about 700 feet.

As the motortruck approached the crossing during the last 100 feet, the driver's view of the main track westward was restricted by fruit packing sheds to less than 400 feet until his vehicle reached a point about 36 feet from the main track. Under these circumstances, a provision of the California State Vehicle Code restricted the motortruck from traversing the crossing at a speed in excess of 15 miles per hour. In addition, the highway speed-limit sign posted 609 feet south of the crossing restricted the motortruck to a speed not exceeding 15 miles per hour as it neared the crossing. It is apparent that the driver did not reduce speed as required while approaching the crossing and that the motortruck was moving at 43 miles per hour, considerably faster than its maximum authorized speed, when it entered the crossing and struck the train. Had the driver exercised due caution and properly controlled the speed of his vehicle while nearing the track, he could have seen or heard Extra 4006 East approaching in sufficient time to stop short of the crossing and the accident probably would have been averted.

It is recommended that the Southern Pacific Company, and/or California State or local authorities, immediately take such action as is necessary to provide adequate protection for rail and highway movements over the Clotho rail-highway grade crossing.
