RAILROAD ACCIDENT INVESTIGATION

Report No 3814

SOUTHERN PACIFIC COMPANY

JULY 26, 1958

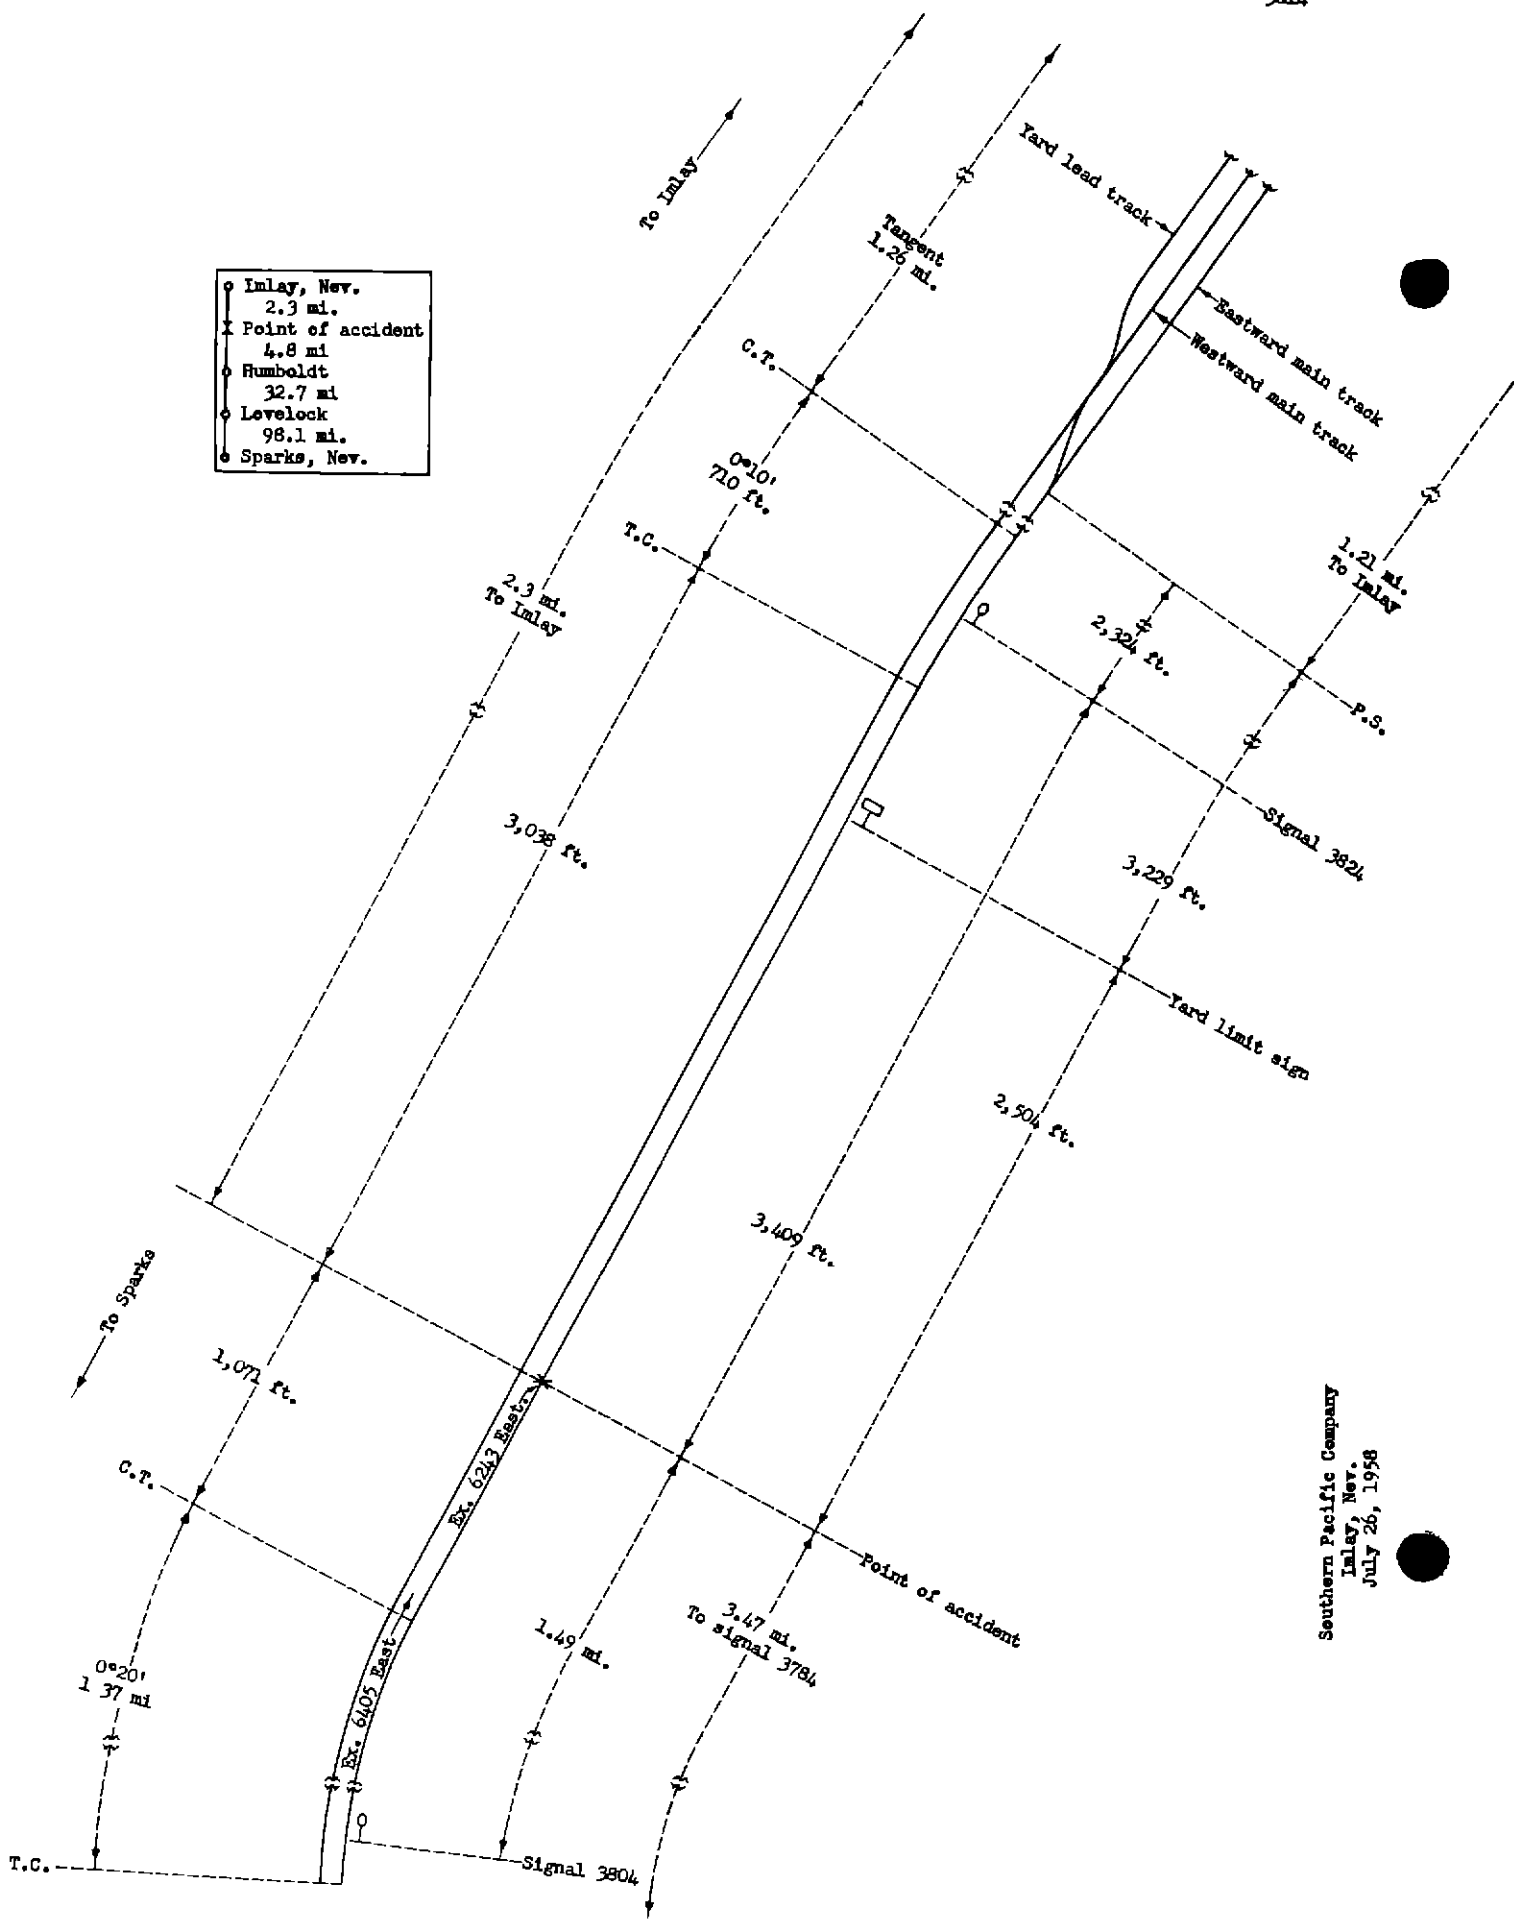
Location of Accident and Method of Operation

- Inlay, Nev.
2.3 mi.
- ⊥ Point of accident
4.8 mi
- Humboldt
32.7 mi
- Lovelock
98.1 mi.
- Sparks, Nev.

This accident occurred on that part of the Salt Lake Division extending between Sparks and Imlay, Nev., 137.1 miles. In the vicinity of the point of accident this is a double-track line over which trains are operated by timetable, train orders, and an automatic block-signal system. At Imlay a facing-point crossover connects the main tracks. The west switch of this crossover is located 1.21 miles west of the station. A yard lead track diverges to the north from the westward main track. The switch of this track, which is facing-point for eastbound movements on the westward main track, is located immediately east of the east switch of the crossover. The west yard-limit sign of Imlay yard is located 3,229 feet west of the west switch of the crossover. The accident occurred on the eastward main track at a point 2.3 miles west of the station and 2,504 feet west of the west yard-limit sign. From the west on the eastward main track there are, in succession, a 0°20' curve to the right 1.37 miles in length, a tangent 1,071 feet to the point of accident and 3,038 feet eastward, a 0°10' curve to the right 710 feet, and a tangent 1.26 miles. The grade for eastbound trains varies between 0.85 and 0.28 percent descending throughout a distance of 1 mile west of the point of accident, and it is 0.28 percent descending at the point of accident.

Automatic signals 3784, 3804 and 3824 are located, respectively, 3.47 miles west, 1.49 miles west, and 3,409 feet east of the point of accident. These signals are of the searchlight type and are approach lighted. Aspects applicable to this investigation, and the corresponding indications and names are as follows:
