RAILROAD ACCIDENT INVESTIGATION

Report No 3845

SOUTHERN PACIFIC COMPANY

MAY 10, 1959

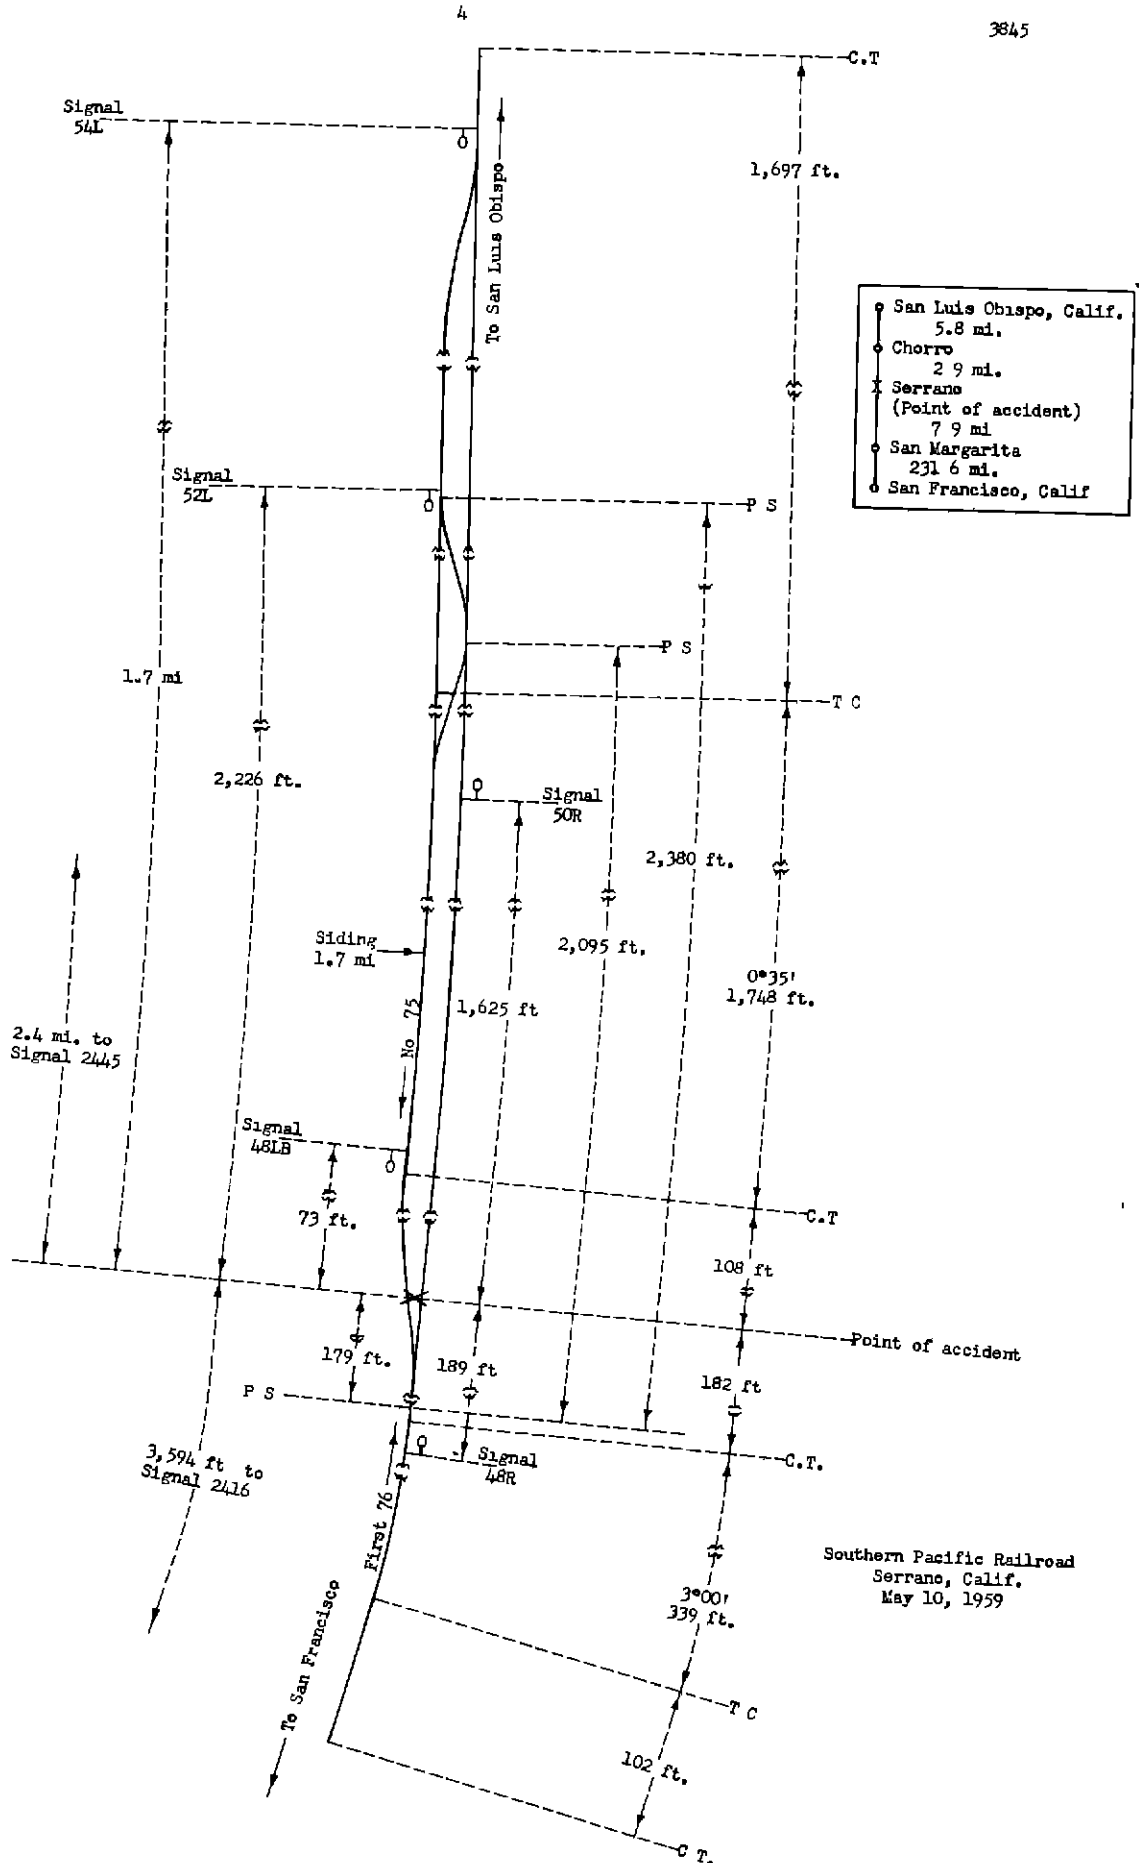
Southern Pacific Railroad
 Serrano, Calif.
 May 10, 1959

The 10th to 13th cars, inclusive, of First 76 were derailed and stopped upright in positions as shown in the sketch. A separation occurred between the 10th and 11th cars. The 10th car was somewhat damaged and the 11th to 13th cars, inclusive, were considerably damaged.

No. 75 stopped with the front end approximately 260 feet west of the point of accident and about 15 feet north of the main track. The four diesel-electric units were derailed and stopped upright in positions as shown in the sketch. The 1st diesel-electric unit was considerably damaged, and the other three units were somewhat damaged.
