DEPARTMENT OF TRANSPORTATION
FEDERAL RAILROAD ADMINISTRATION
RAILROAD SAFETY BOARD

RAILROAD ACCIDENT INVESTIGATION
REPORT NO. 4114

SOUTHERN RAILWAY COMPANY
MARCH 3, 1967

Southern Railway
 East Spartanburg, S. C.
 March 3, 1967

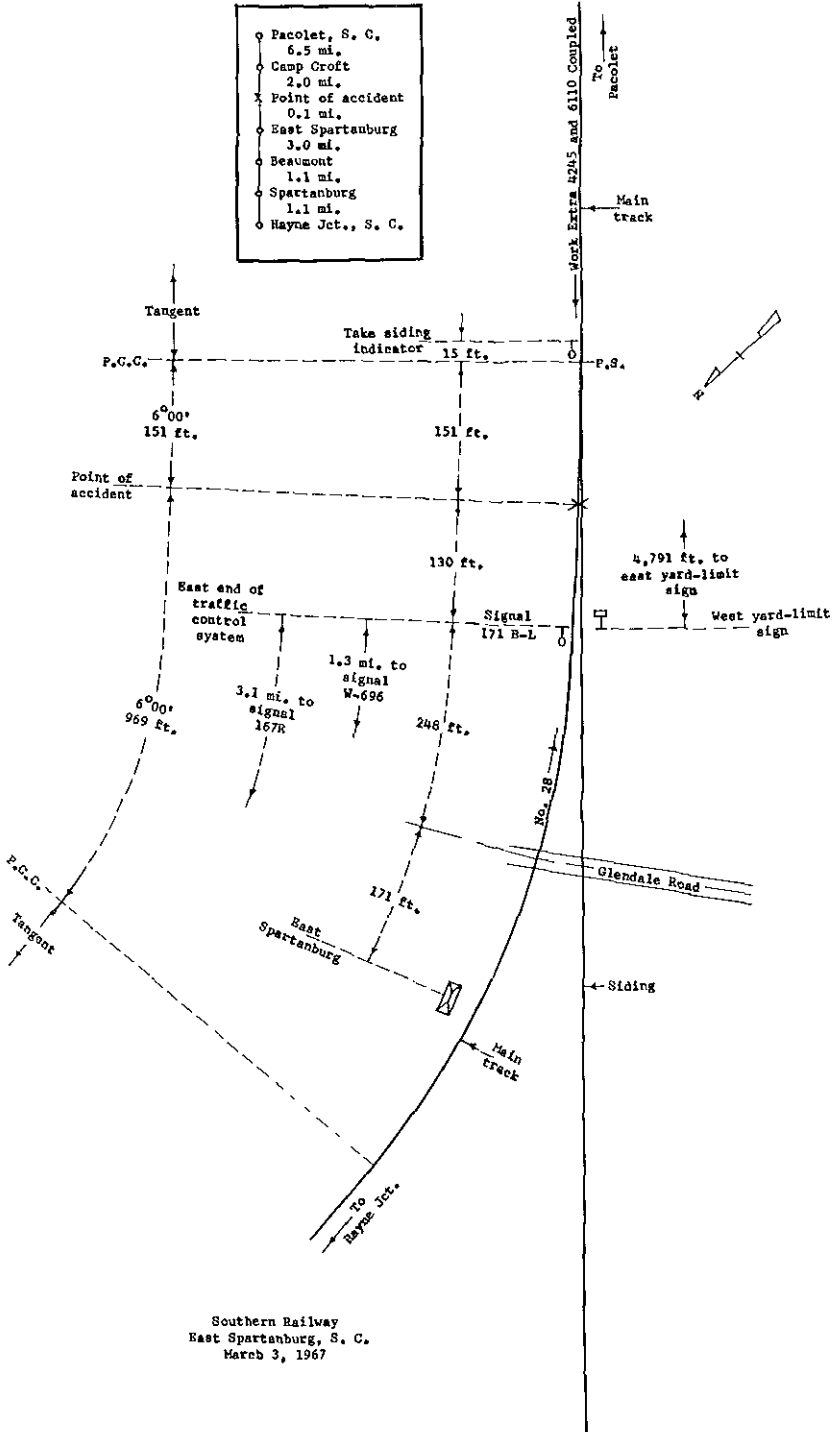
The collision occurred on the main track, within yard

limits, 549 feet east of the East Spartanburg station and 130 feet east of the east end of the traffic control system

A spur track, which is designated as a siding, diverges from the main track at East Spartanburg as indicated in the sketch appended to this report. The siding-switch is facing point for westbound movements on the main track and is 151 feet east of the collision point. A take siding indicator for westbound trains is 15 feet east of the siding-switch. It is controlled by the train dispatcher. When the take siding indicator is illuminated, it indicates TAKE SIDING.
