# NATIONAL TRANSPORTATION SAFETY BOARD

## RAILROAD ACCIDENT REPORT

DERAILMENT OF SOUTHERN RAILWAY COMPANY  
TRAIN NO. 2, THE CRESCENT  
ELMA, VIRGINIA  
DECEMBER 3, 1978

NTSB-RAR-79-4

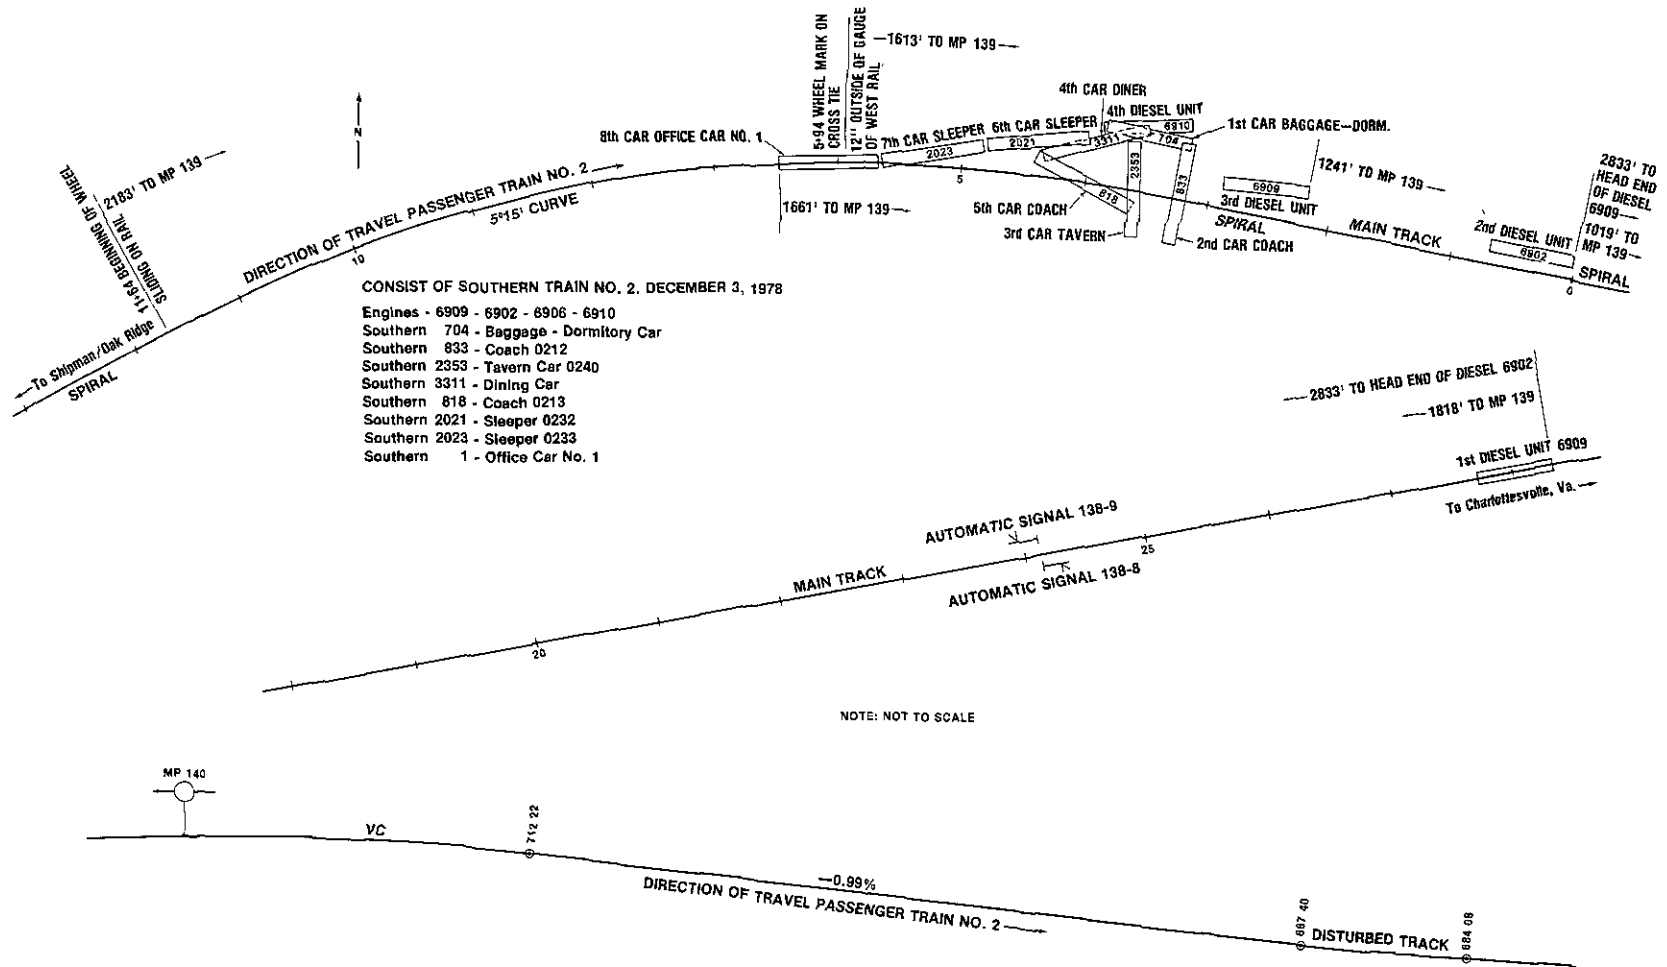
Figure 1. Plan of accident site.

The engineer continued to probe the shunt field contactor, and when he turned to observe the track to determine his location he saw that he was approaching a 5°15' curve which had a 45-mph speed limit. He knew that the train's speed was too fast to move around the curve, and he immediately made a service brake application, followed almost in a continuing move by an emergency application. The train derailed after moving about 570 feet into the 800-foot curve. (See figure 1.)

The lead unit separated from the other three locomotive units and continued northward 3,427 feet. The second and third units turned on their sides and stopped 594 feet and 372 feet respectively, from the point of the derailment along the west side of the track. The fourth unit buried itself in a dirt embankment at the end of a ravine, 285 feet

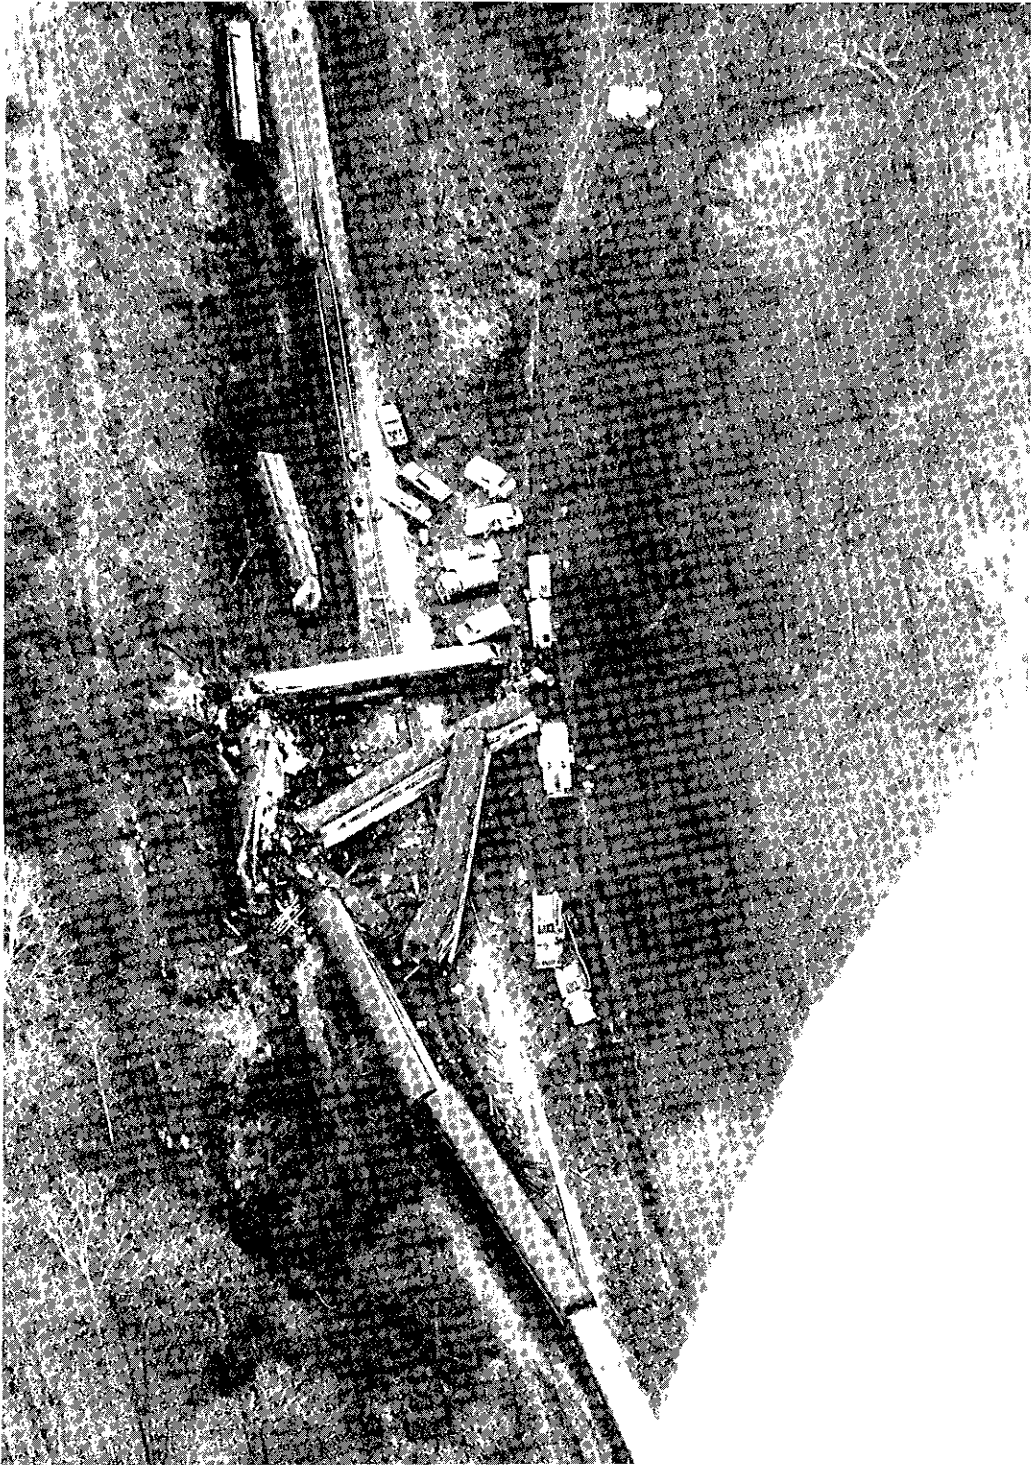
Figure 2. Aerial view of accident site.

The fourth locomotive unit and seven cars were contained in a 250-foot distance. Some cars overrode each other, while others jackknifed across the track. The first, a baggage car, was overturned and stopped on top of the fourth unit. The second car, a coach, was turned on its right side and was lying across the track. The third, a tavern car, jackknifed and stopped across the track. The fourth car, a diner, went into the ravine and was partially overridden by other cars. The fifth car, a coach, stopped across the track. The sixth and seventh, sleeping cars, were stopped on the side of the fill headed into the ravine, and the eighth, a business car, stopped on the track structure. (See figure 2.)

The manner in which the equipment came to rest on the west side of the curve, as opposed to the cars staying in line on the track structure, also was indicative of a high-speed derailment on a curve. The cars that jackknifed and stopped at varying angles, some nearly perpendicular to the track, were violently forced to those positions by the sharp decelerating forces caused by the application of brakes and the derailment. On most of the cars the tightlock couplers did not become uncoupled but as the cars were forced into a jackknife position at least one coupler shank broke on each car.

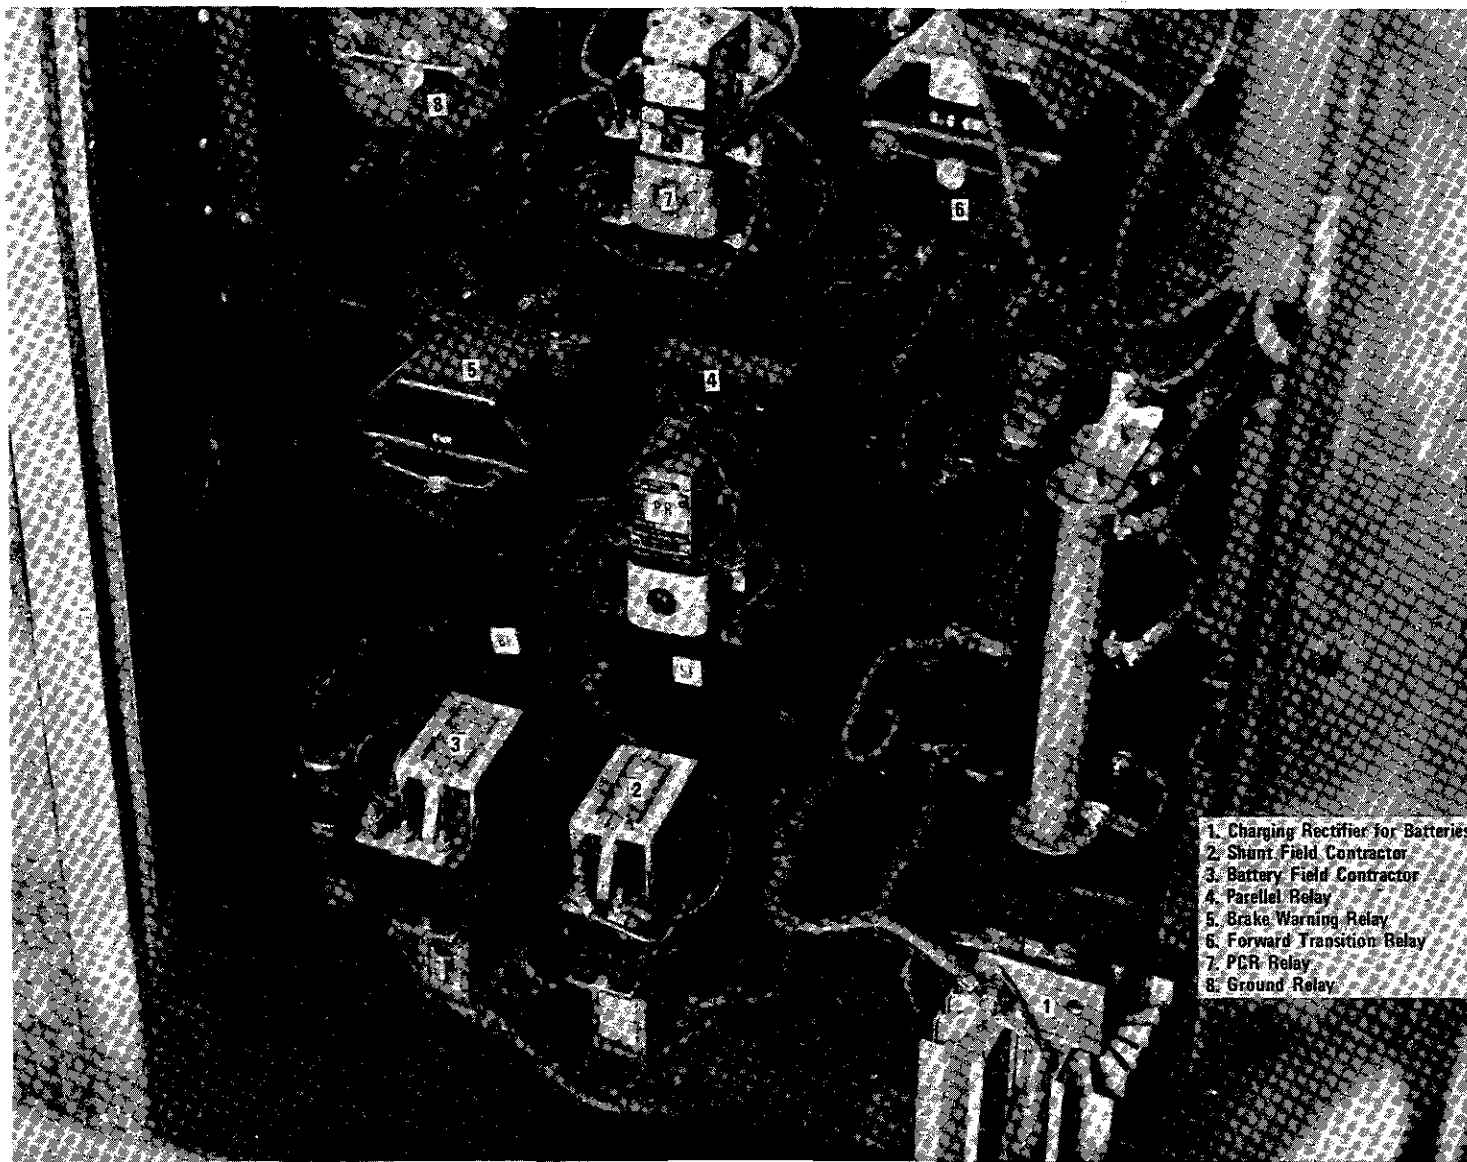
Figure 3. Interior view of low voltage cabinet.

The engineer had experienced a transition problem before, so he thought that tapping the shunt field contactor might eliminate the problem. He asked the fireman to use the wooden staff of a signal flag to close the contacts of the shunt field contactor, located in an electrical cabinet to the rear of the locomotive cab, to see if holding the contactor in an energized position would cause the transition to be completed. This action also failed, so he instructed the fireman to take the engine off the line. <sup>2/</sup> To do this, the fireman had to move from the operating cab to the engineroom, where he operated the controls to take the engine off line temporarily. Taking the engine off line also failed to complete the transition.

Two cabinets which contained electrical components were located in the rear of the operating compartment. One, a high voltage cabinet, was kept locked. The other, a low voltage cabinet, was not locked and contained fuses and other equipment for use of the enginecrew. The low voltage cabinet also contained the shunt field and the battery field contactors, and other relays associated with transition. (See figure 3.)

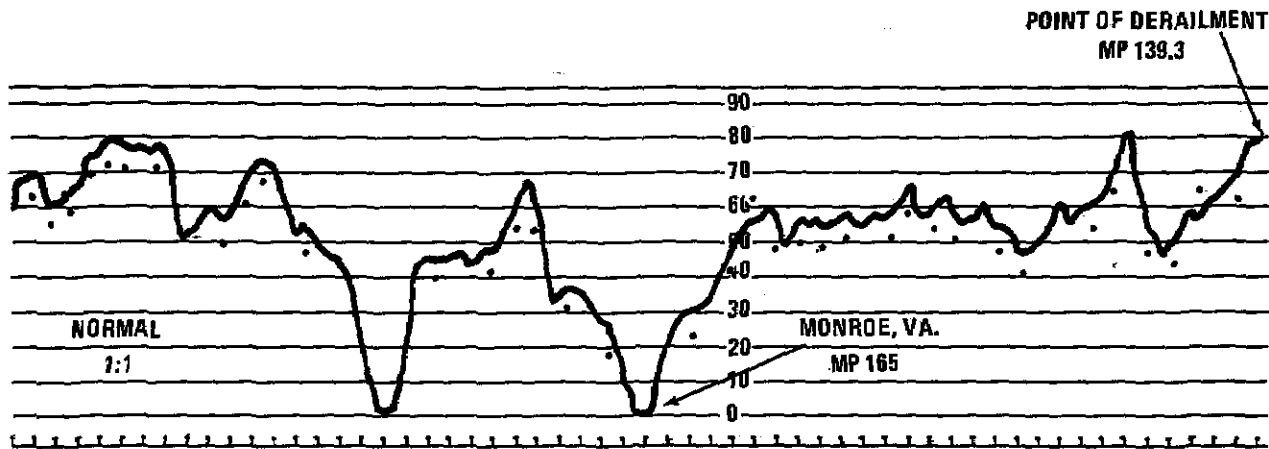
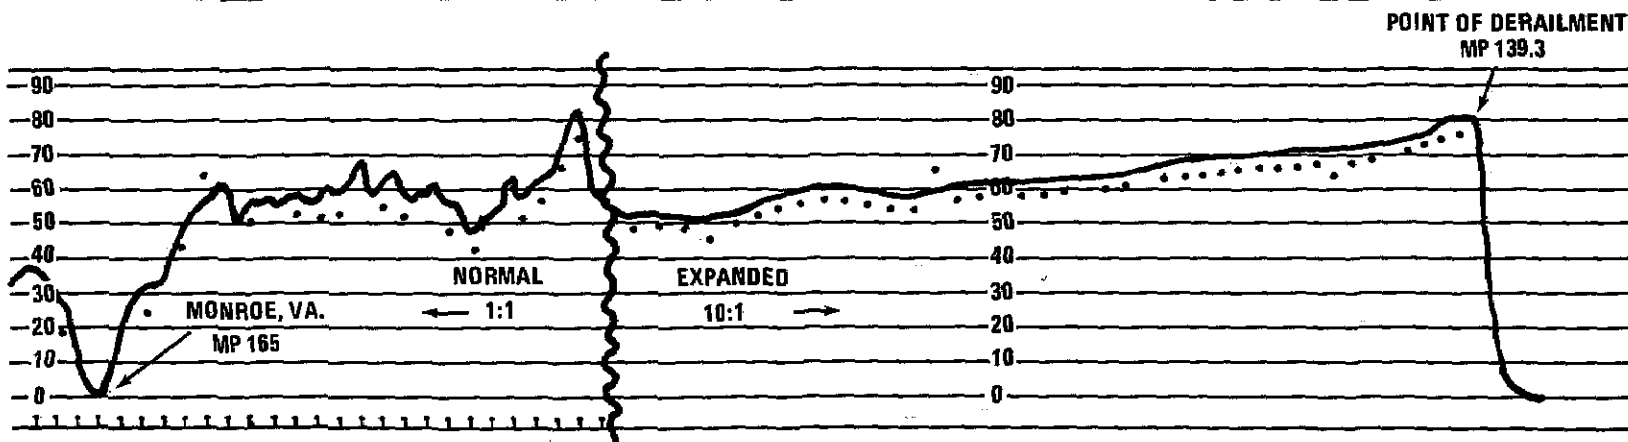
LOCOMOTIVE NO. 6902

The four locomotive units were provided with speed recorder units. The recorder uses a standard 8-track tape cassette. The first locomotive unit had a defective recorder and no speed data was recorded. The three cassettes from the other locomotive units were processed and a tape produced. All three units recorded similar data. They showed stops at Lynchburg, Virginia and Monroe; they showed the slow speed of 50 mph required at Tye River and Oakridge for the equilateral turnouts; they showed the reduction in throttle made by the engineer when he was attempting to clear the locomotive's failure to make transition; and they showed a gradual acceleration from Oakridge to 80 mph at the point of derailment. There was no data recorded following the derailment. (See Appendix D.)

AREA OF DERAILMENT  
CARTRIDGE OUT OF RECORDER  
LAST SPEED DATA LOST
