RAILROAD ACCIDENT REPORT .

SOUTHERN RAILWAY COMPANY
TRAIN 154
DERAILMENT WITH FIRE AND EXPLOSION
LAUREL, MISSISSIPPI
JANUARY 25, 1969,

ADOPTED OCTOBER 6, 1969

U.S. NATIONAL TRANSPORTATION SAFETY BOARD,
DEPARTMENT OF TRANSPORTATION
WASHINGTON, D. C. 20591

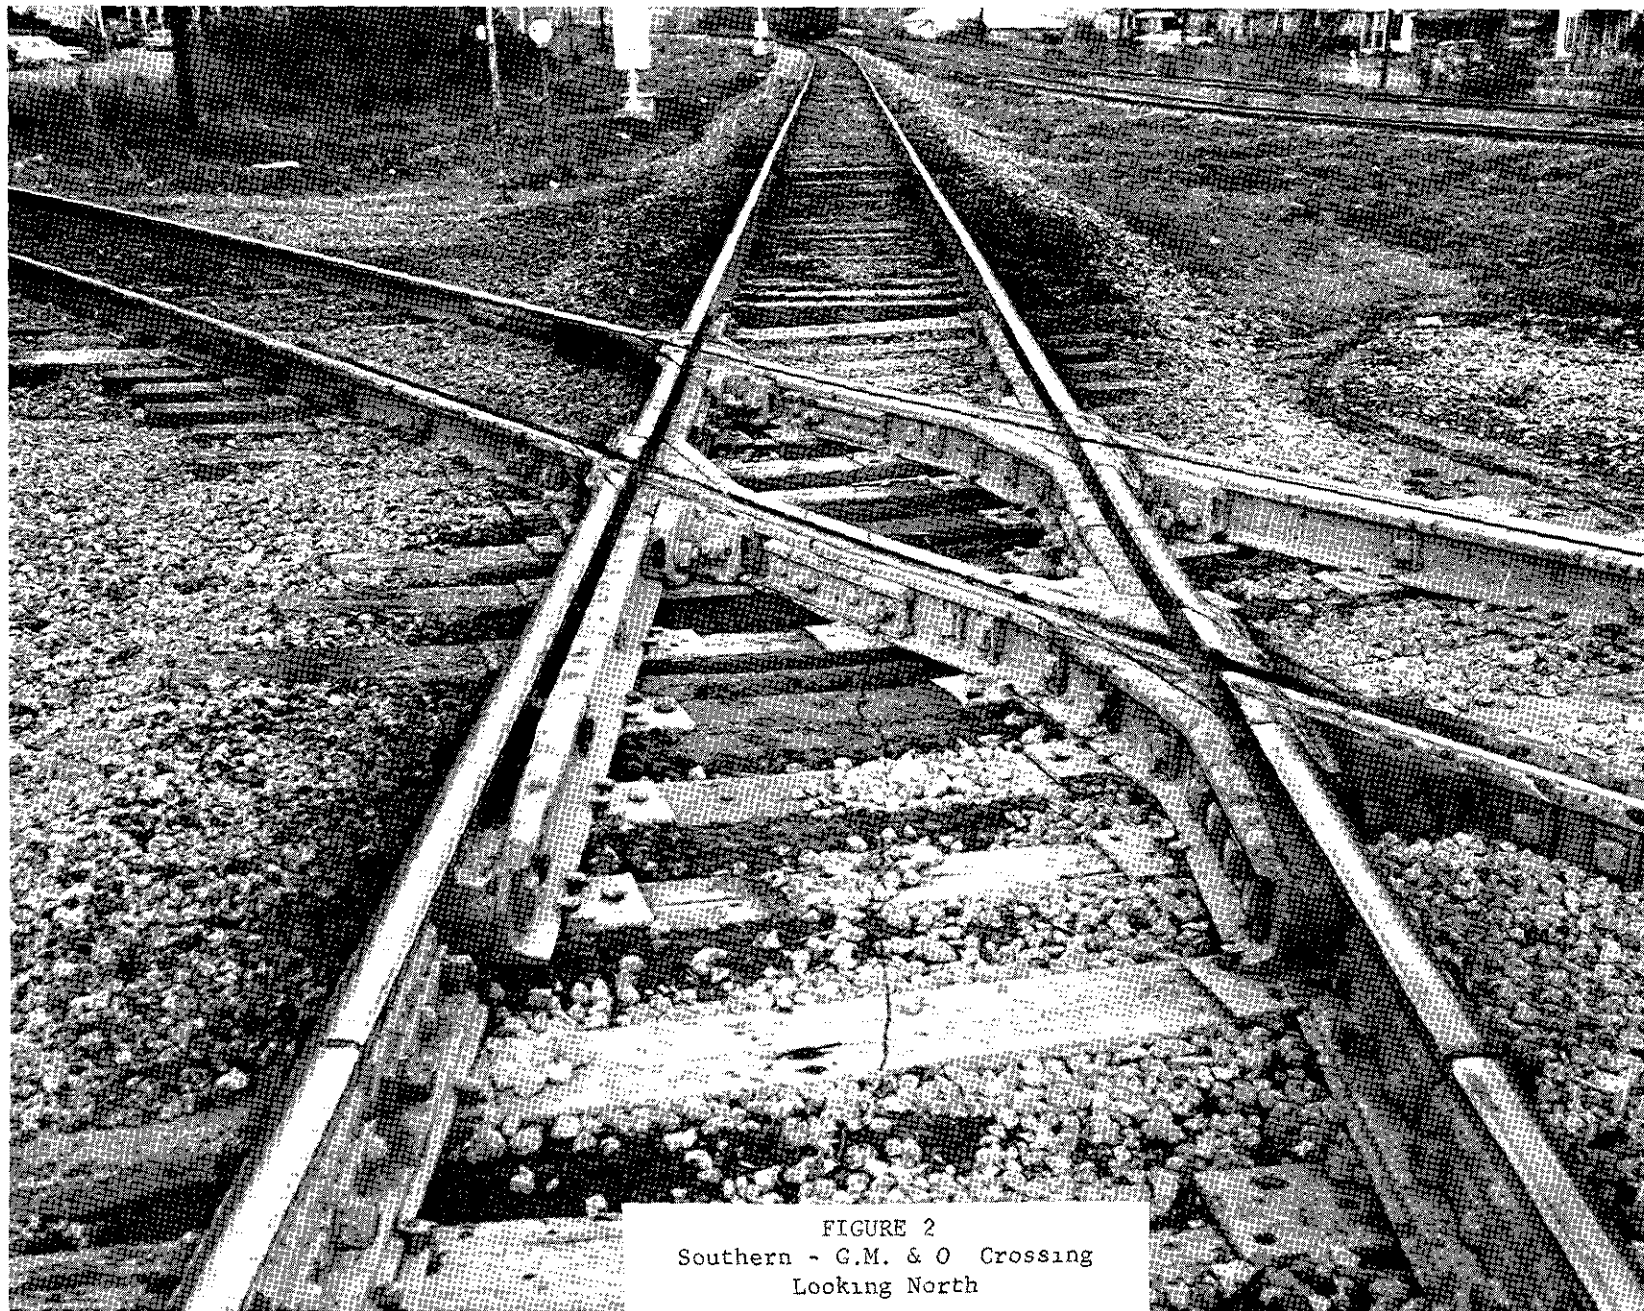
FIGURE 2
Southern - G.M. & O Crossing
Looking North

It appears that the condition of maintenance of the G. M. & O. crossing probably contributed to these lateral forces. Since the east rail approaching and passing over the crossing was substantially lower than the west rail when under load, the L-3 wheel would have been bearing hard against the left-hand guardrail. This would have introduced lateral

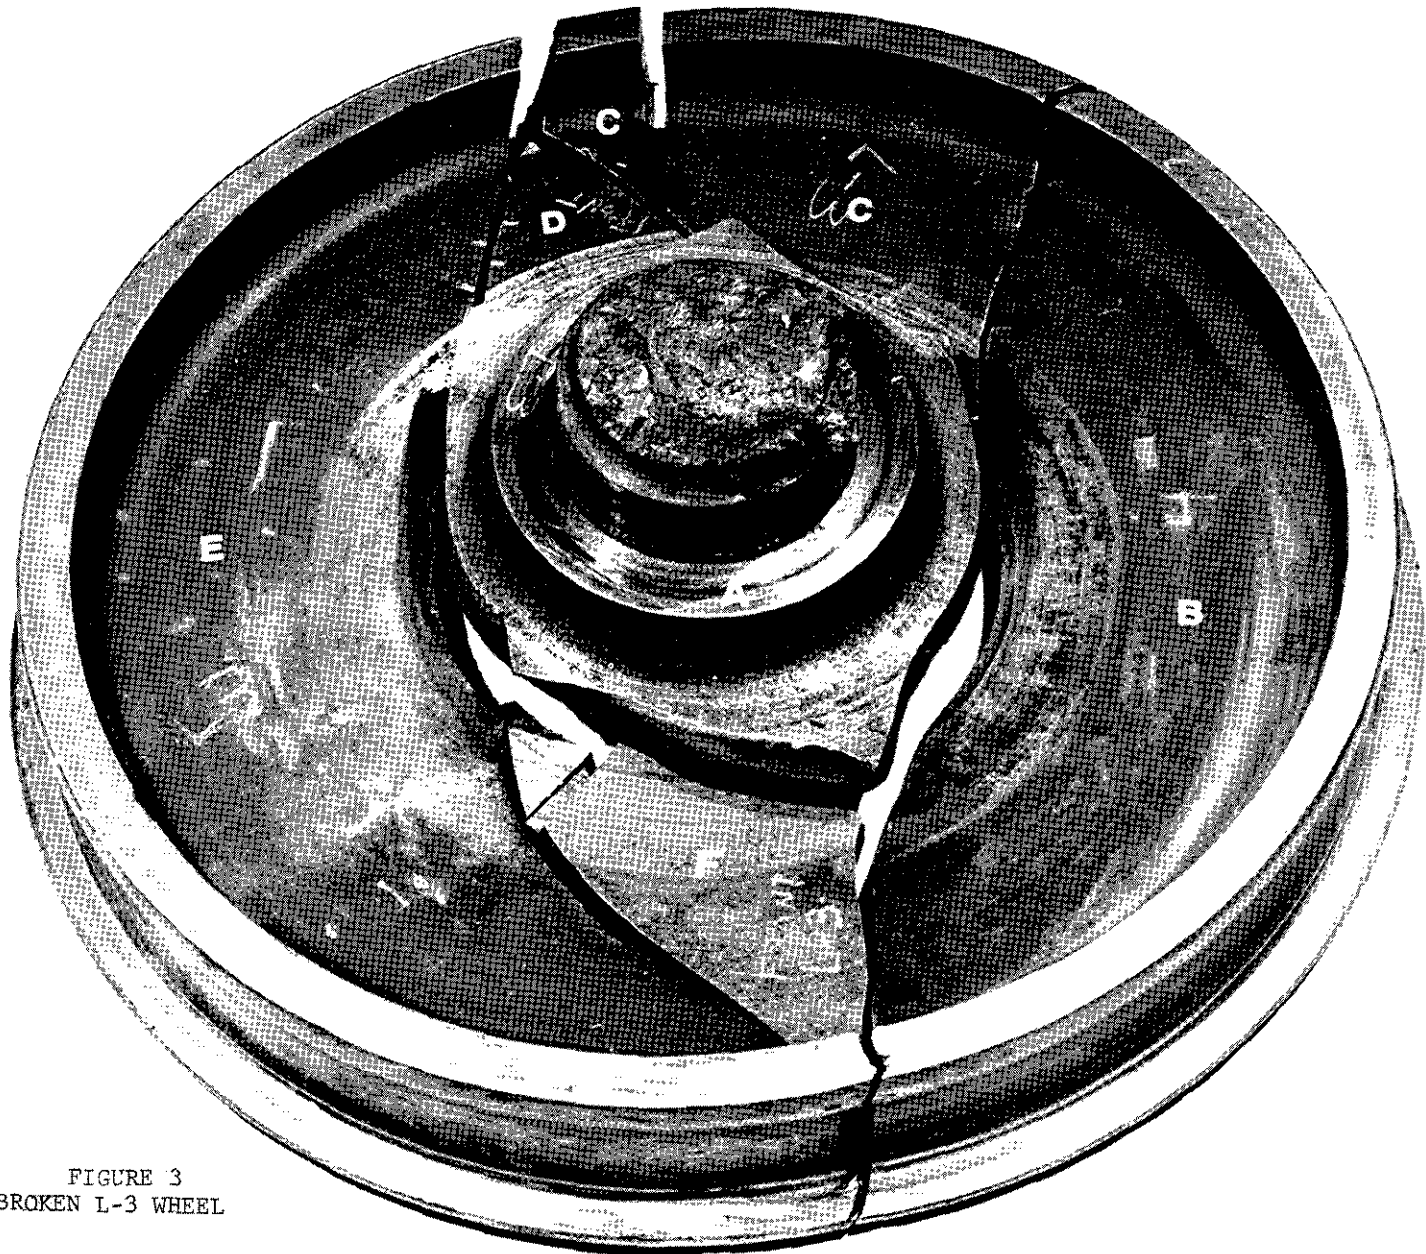
FIGURE 3
BROKEN L-3 WHEEL

The broken wheel which initiated the derailment was manufactured by Armco Steel Corporation at Butler, Pennsylvania, in June 1962 and had been in service since that time. The break was a brittle fracture which originated in the back of the plate in a roughly machined area. The fracture was initiated by a concentration of stresses in the back of the plate, resulting from sudden lateral loading as the wheel traversed the G.M.&O. Railroad crossing. The tread-worn-hollow condition of the wheel and the out-of-level condition of the crossing contributed to the lateral loading of the wheel.

The noise and sparks observed by the operator were the results of a piece breaking out of the trailing wheel of the lead truck on the west side (L-3 position) of the 62nd car in the train, ACSX car 932003. (See Figure 3.) The piece of wheel marked "B" broke as it was traversing the crossing and came to rest near the tower, pieces "C" and "E" were found on the east side of the track about 250 to 255 feet north of the crossing. When these three major pieces were assembled, it was apparent that they came from the same wheel, and other smaller pieces fitted inside these as shown in Figure 3. North of the trailing-point switch, parts of a second wheel were found, and it was later determined that they came from the east side of the lead pair of wheels on the same car (R-4 position). The pieces of the two wheels were marked, crated, and sent by railroad baggage to the Southern Railway's testing laboratory at Alexandria, Virginia. The analysis of the tests made by Southern Railway, Armco Steel Corporation, and the Illinois Institute of Technology Research Institute appears in the section entitled "Analysis of the Broken L-3 Wheel" on page 33.

Marks on the east rail indicated the broken L-3 wheel continued for 256 feet before derailing the mate wheel. This derailed wheel continued northward on the ties inside and adjacent to the east rail until it struck the curved closure rail of the trailing-point switch, bounced over the closure rail, and continued northward to the point of switch where the lead pair of wheels of the same truck derailed. The R-4 wheel on the east side of the lead axle broke at about this point. It is not known which occurred first, the breaking of the R-4 wheel or derailment of the lead pair

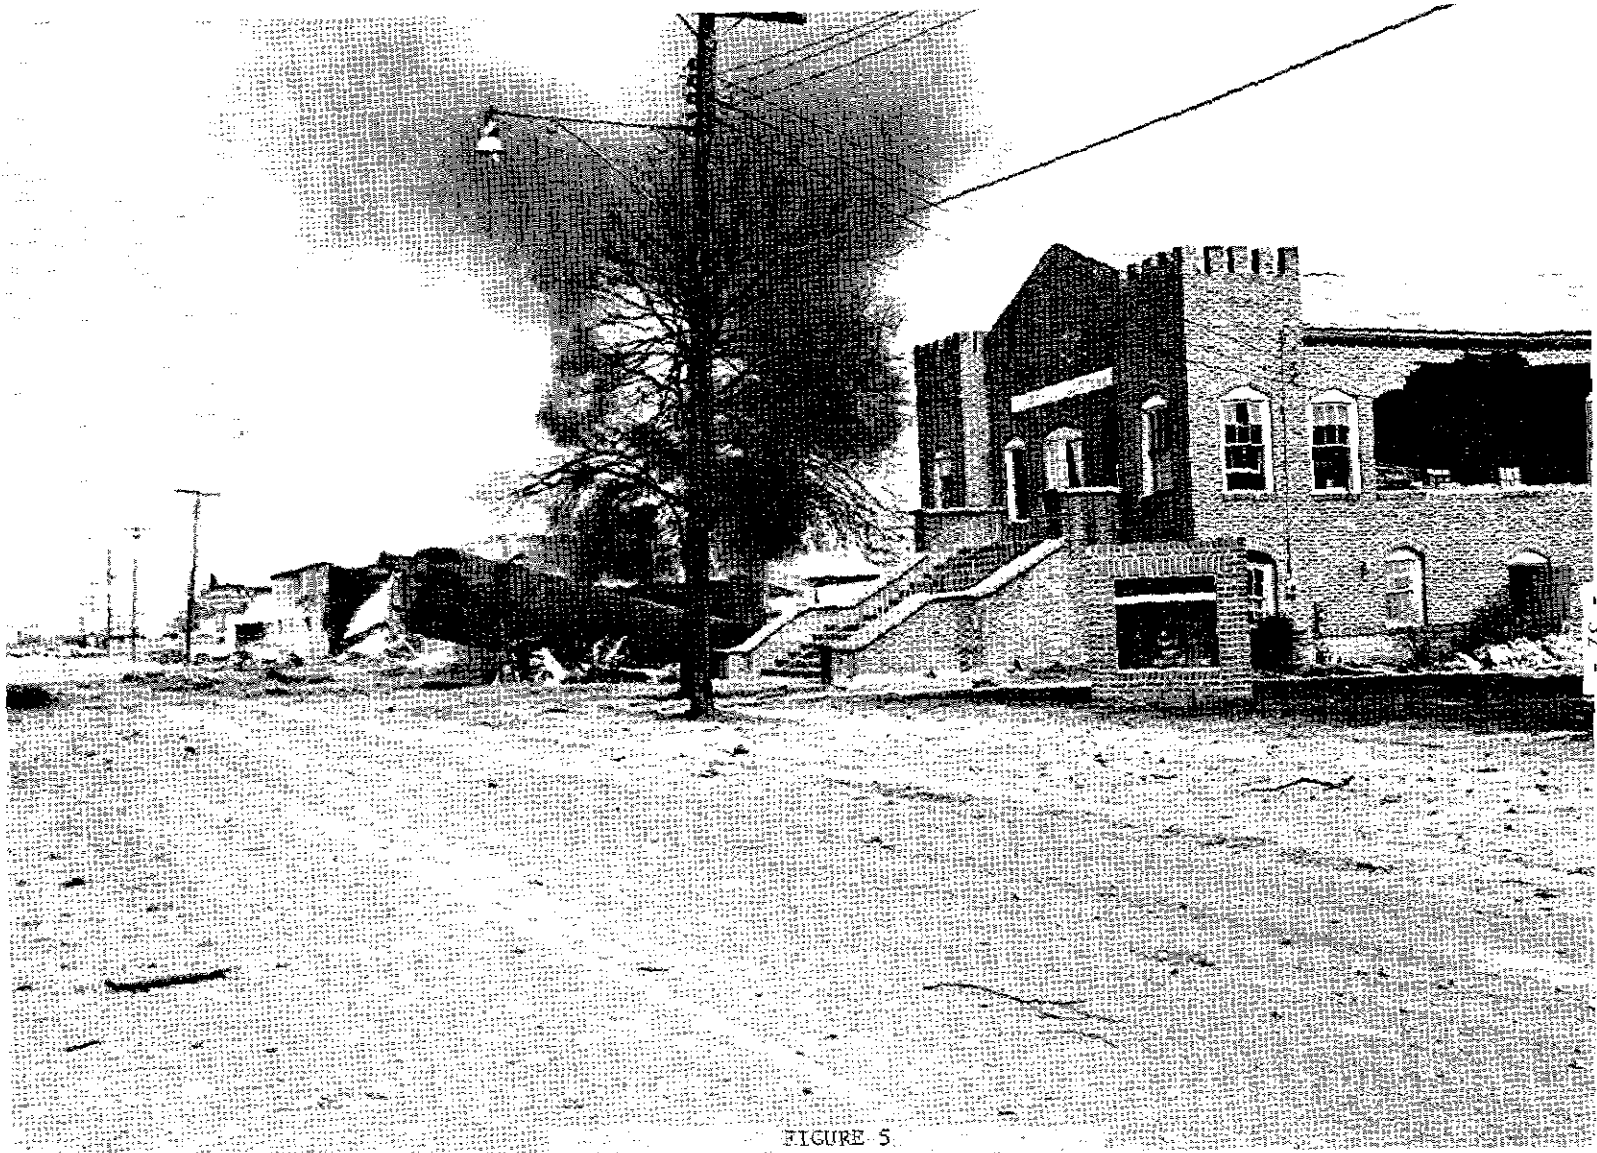
FIGURE 5
A Part of One Tank Shell and
Damage to Church and Business
East Side of Meridian Avenue,
Laurel, Mississippi

The fire and explosions which followed the derailment immediately set fire to those buildings, primarily residences, between the wreck and Meridian Avenue. The concussion from the explosions caused structural damage to buildings in the vicinity, and broken windows were numerous and widespread. The Fire Chief testified that broken windows were reported as far as 3 miles west of Laurel. The majority of the broken glass was in the downtown area about 8 blocks away. The damage shown in the photograph on page 32, Figure 5, is on the east side of Meridian Avenue and illustrates the type of damage that resulted from concussion. The tank shown was the major part of UTLX car 88602, the 11th tank car that derailed.

Parts of the tank cars which were hurled through the area set fire to buildings in some instances as well as inflicting impact damage. Explosions spewed burning propane over a large area, setting fire to many buildings. A number of automobiles were destroyed by fire in the vicinity of the accident. There were 54 residences destroyed and over 1,350 residences suffered varying degrees of damage.

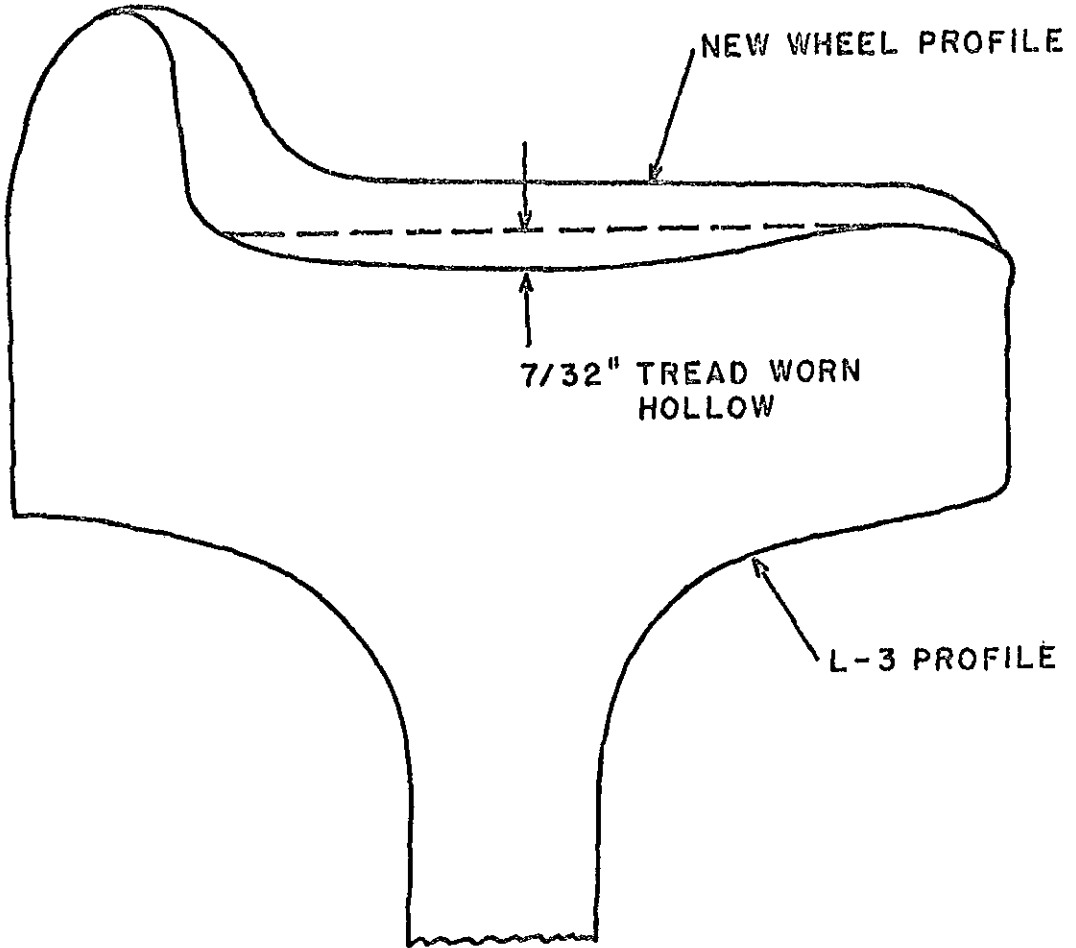
Fig. 8 - Rim Profile of the L-3 Wheel.

10. The tread-worn-hollow condition of the L-3 wheel did not require it to be condemned under the Rules of Interchange of the Association of American Railroads, which are based upon measurement of flange height. There is no A. A. R. gage to indicate a tread-worn-hollow contour for wrought steel freight car wheels, although the need for such a gage has been recognized by A. A. R. for many years. (Page 38)

It is obvious from the rim profile of the L-3 wheel, shown in Figure 8, that it has a substantial tread-worn-hollow condition. The relationship between a new wheel and the rail is quite different from that of the L-3 wheel when its flange is away from the rail or when traversing frogs, switches, or crossings. When the L-3 wheel was riding on its outer rim, the contact point moved outward from the plate, thus changing the stress pattern in the plate of the wheel. Under this condition, the point of maximum stress would have been near the hub on the back of the plate.

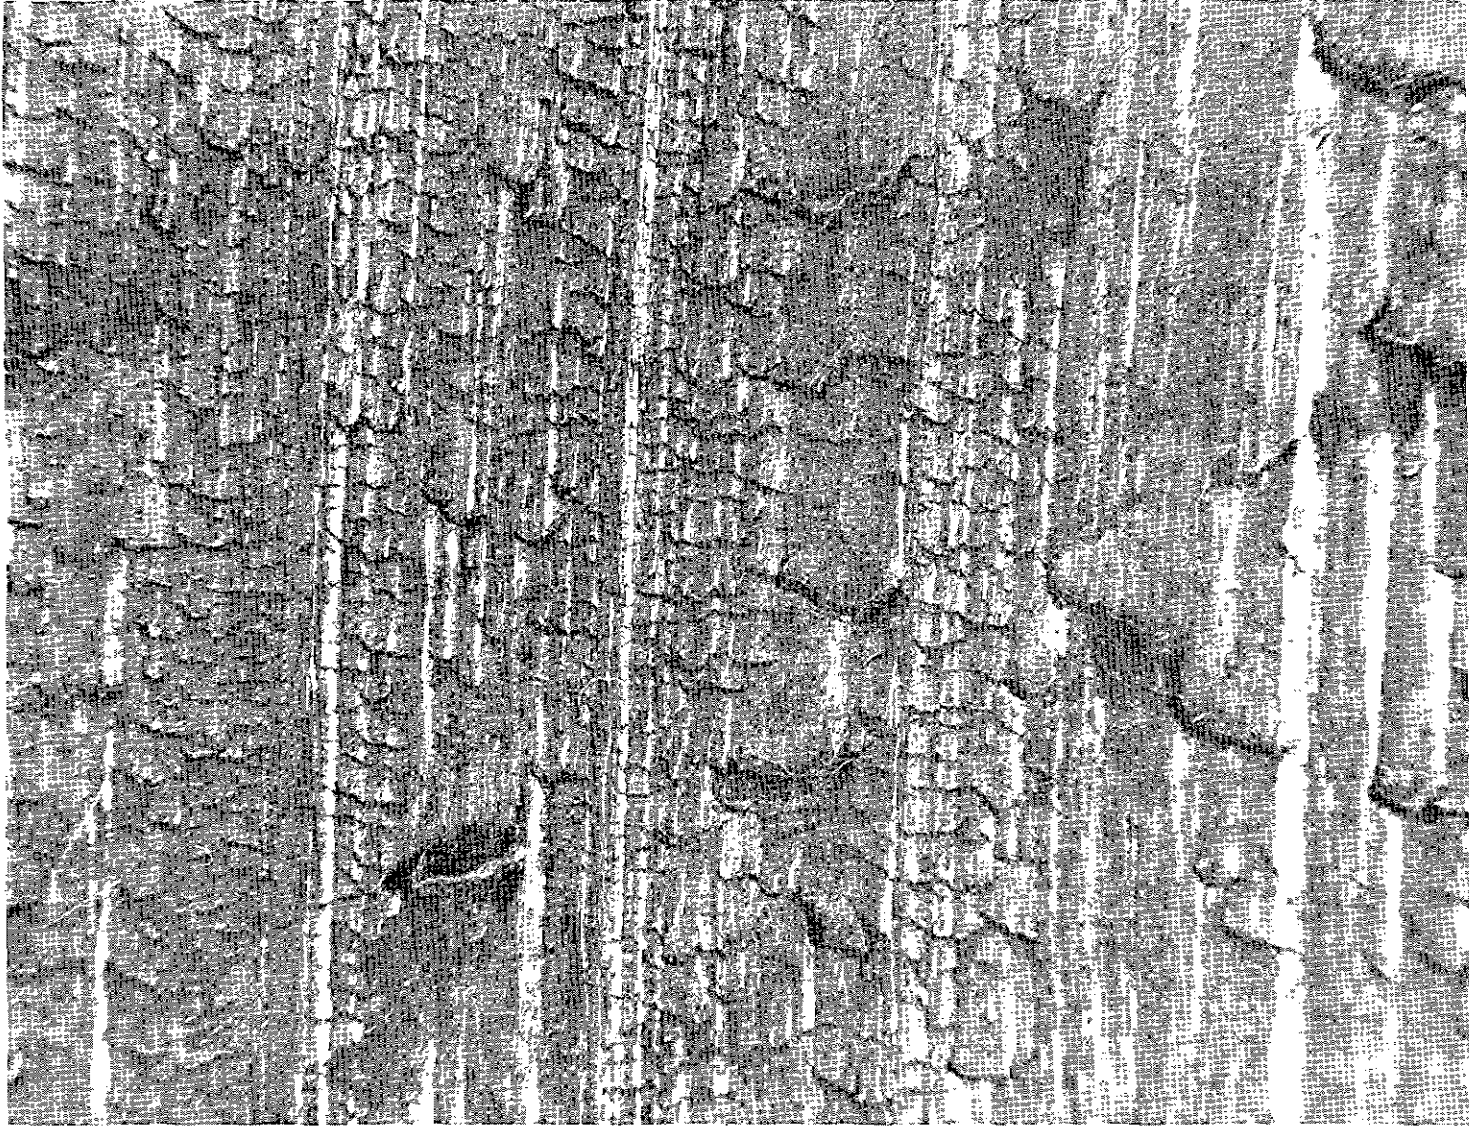
FIGURE 3
MICROGRAPH OF ROUGH MACHINING

15. The discontinuities in the machining of the plate of the L-3 wheel made the wheel more subject to impact fracture in the machined area at low metal temperatures similar to air temperatures existing on the day of the accident. (Page 40)

The L-3 wheel was a wrought steel wheel which was forged from open hearth steel ingots. After wheels are rolled, there is usually need for corrective machining, and in the case of the L-3 wheel, corrective machining was performed on the plate of the wheel. The machined area extended outwards 5-1/4 inches from the hub on the front face and 4-3/4 inches on the back face. The machined area was rough with chatter marks and surface discontinuities. The finish was too rough to be measured with conventional profile equipment where a scribe is drawn across the surface, however, it was found that the surface irregularities (peak to valley) varied from 5,000 to 10,000 microinches with tool gouges 0.035 inches deep. (See Figure 9, page 39.)

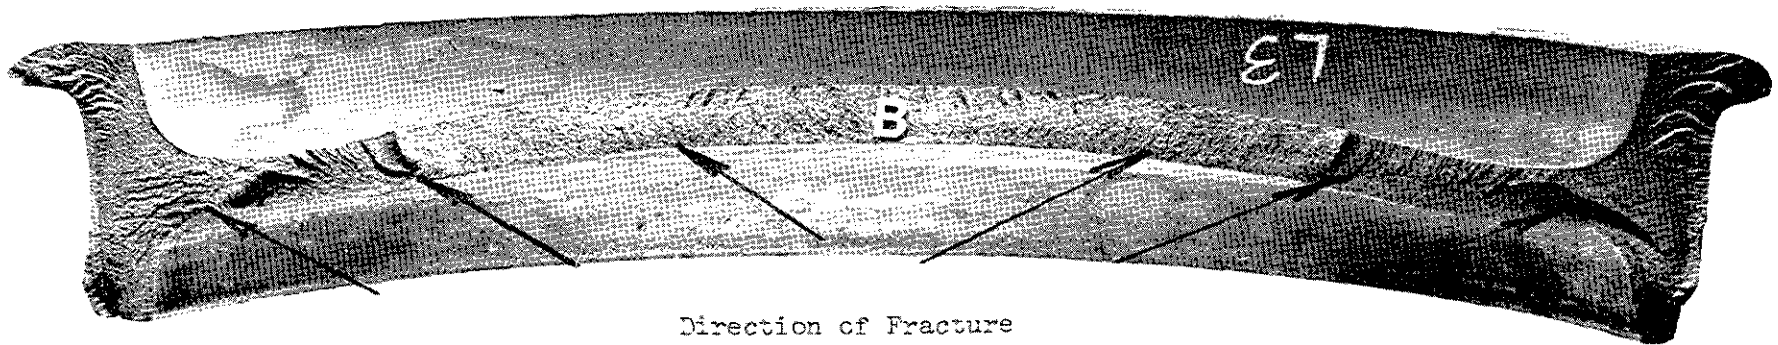
FIGURE 11
FRACTURE OF L - 3 WHEEL
SHOWING PROBABLE ORIGIN

16. The first fracture of the L-3 wheel originated near the hub in the area of rough machining on the back of the plate. (Page 42)
17. The L-3 wheel failed in the back plate near the hub because of suddenly applied lateral forces. The suddenly applied lateral forces came from the change in stress when the tread-worn-hollow wheel traversed the 35° 20' crossing frog, and from the pressure on the back of the flange by the guardrail because of the depressed east rail. The rough machining of the plate provided a notch effect and a stress concentration which reduced the ability of the wheel to withstand impact. The FRA reported the failure of a wheel for a similar reason in the accident at Cold Springs, Ohio, January 8, 1968, but has no authority to require any changes. (Page 44)

Direction of Fracture
as shown by
Chevron Pattern

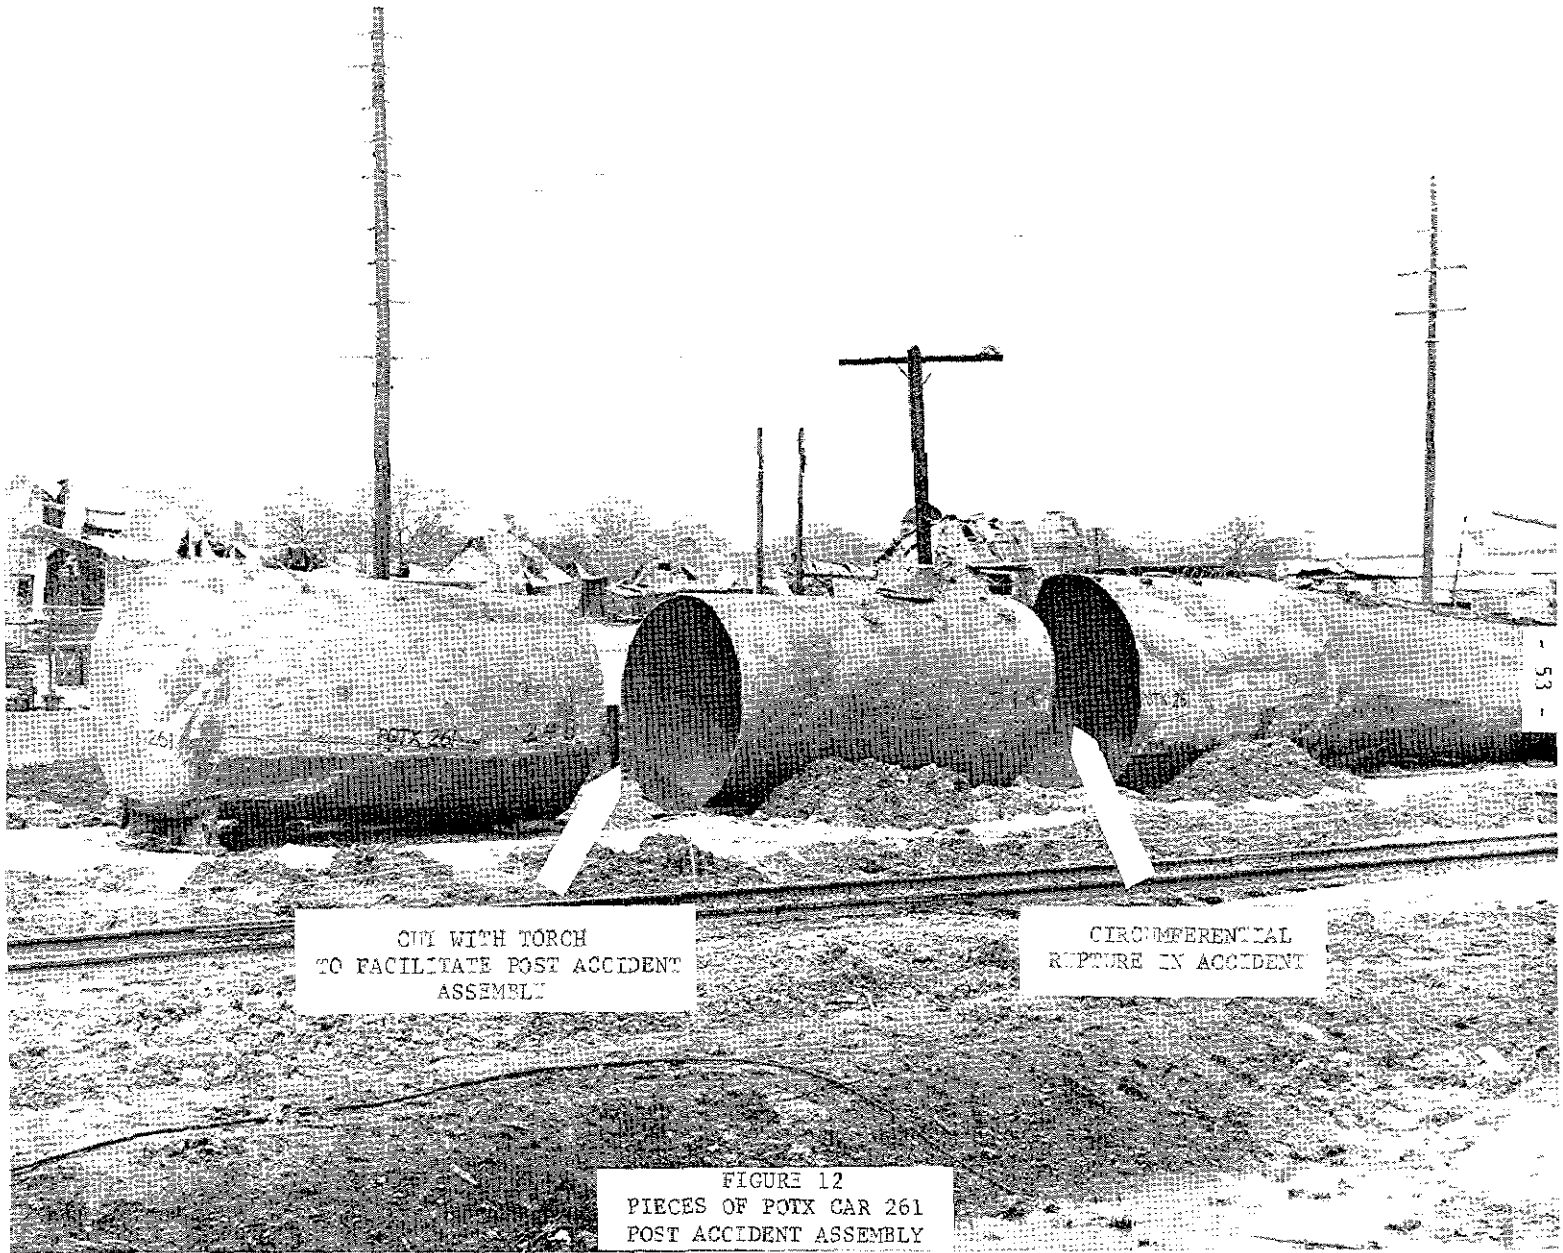
FIGURE 12
PIECES OF POTX CAR 261
POST ACCIDENT ASSEMBLY

The flight of these tanks was not observed by any trained witness. However, trajectories of these tanks suggests that a propulsive force other than that of blast forces at the location of the initial explosion was involved. In the first case, the flight through the air was 1,000 feet. The initial velocity necessary to sustain a flight of this length by inertia carry-through after a blast explosion would have been quite high, and the explosive pressure upon the tank shells necessary to develop a high velocity by a blast-like explosion would also have been quite high. The ability of tank shells to withstand external pressure without becoming distorted or destroyed is limited. Yet the shell of this tank, which is thin in comparison with its overall size, is relatively undistorted. It appears impossible that this tank was subjected to a short, severe external blast force as the means by which it was propelled to that great distance.

OWN WITH TORCH
TO FACILITATE POST ACCIDENT
ASSEMBLY

CIRCUMFERENTIAL
RUPTURE IN ACCIDENT

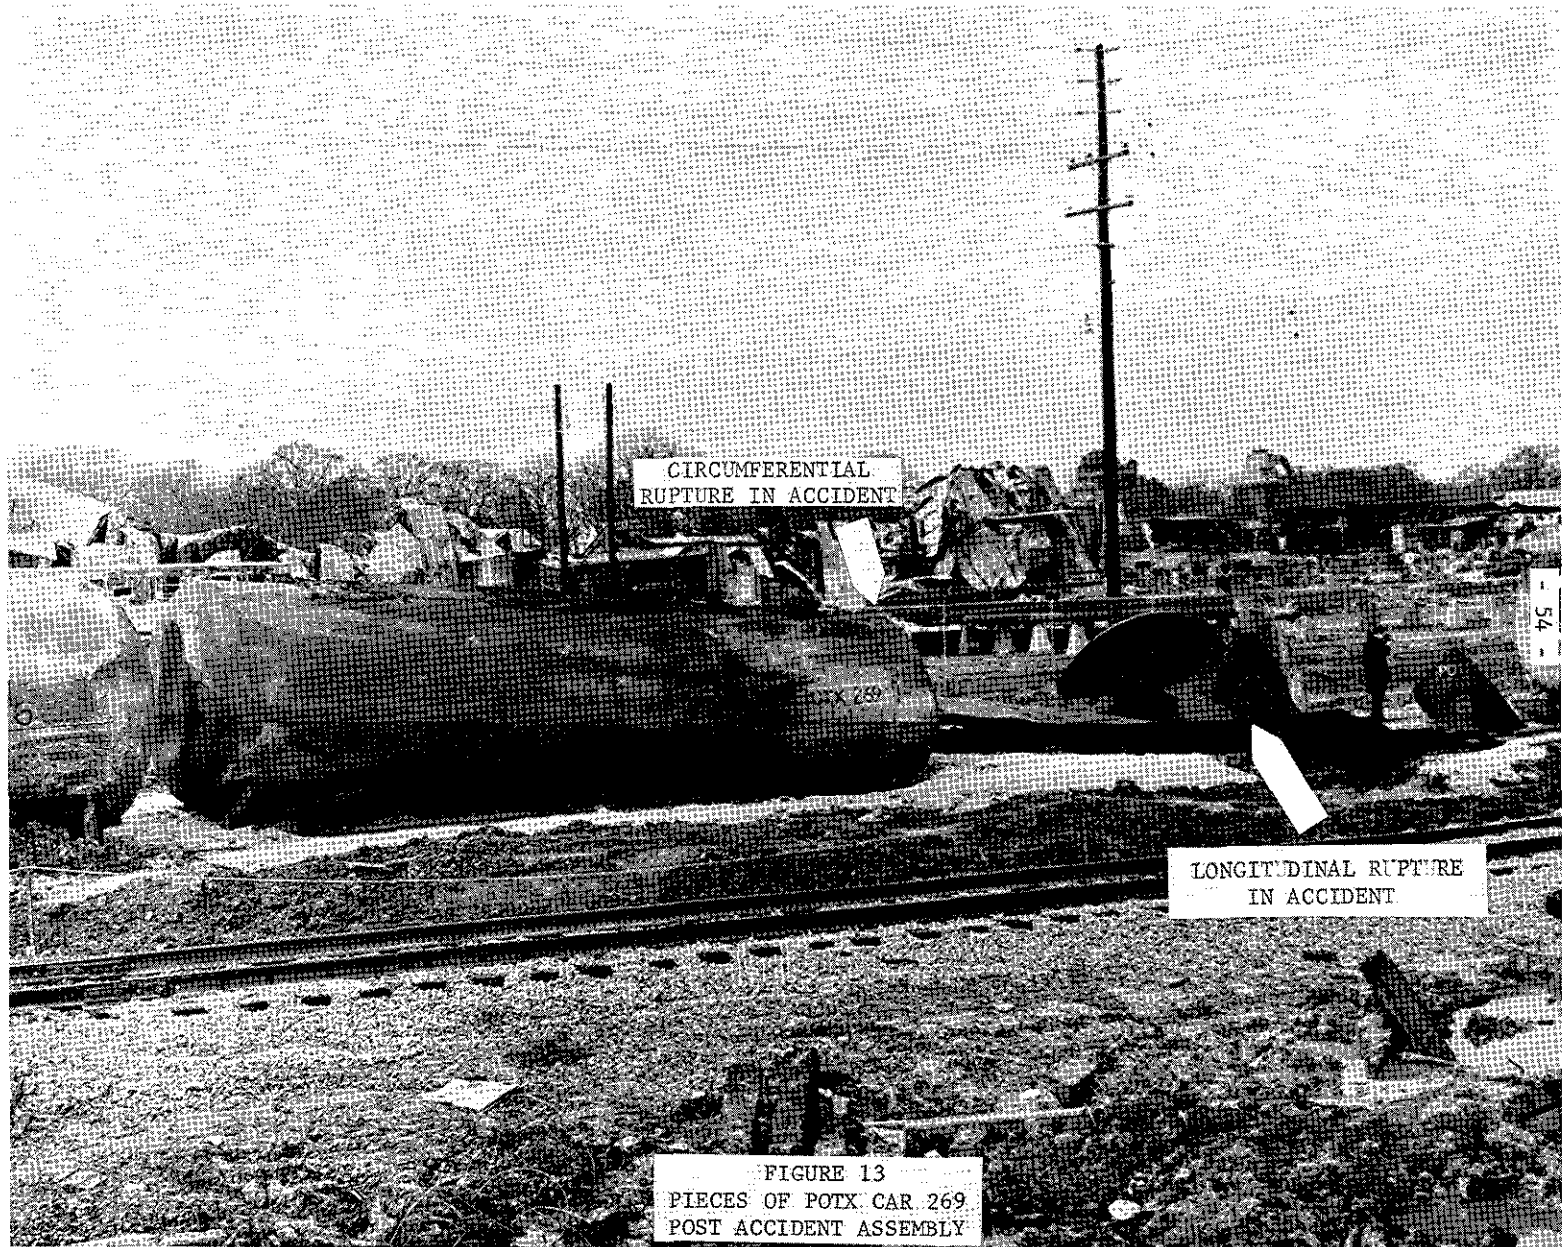
A similar condition is seen in the 37-foot section of POTX car 269, Figure 13. These tanks were not propelled to high velocity by any explosion-like external force.

CIRCUMFERENTIAL
RUPTURE IN ACCIDENT

LONGITUDINAL RUPTURE
IN ACCIDENT

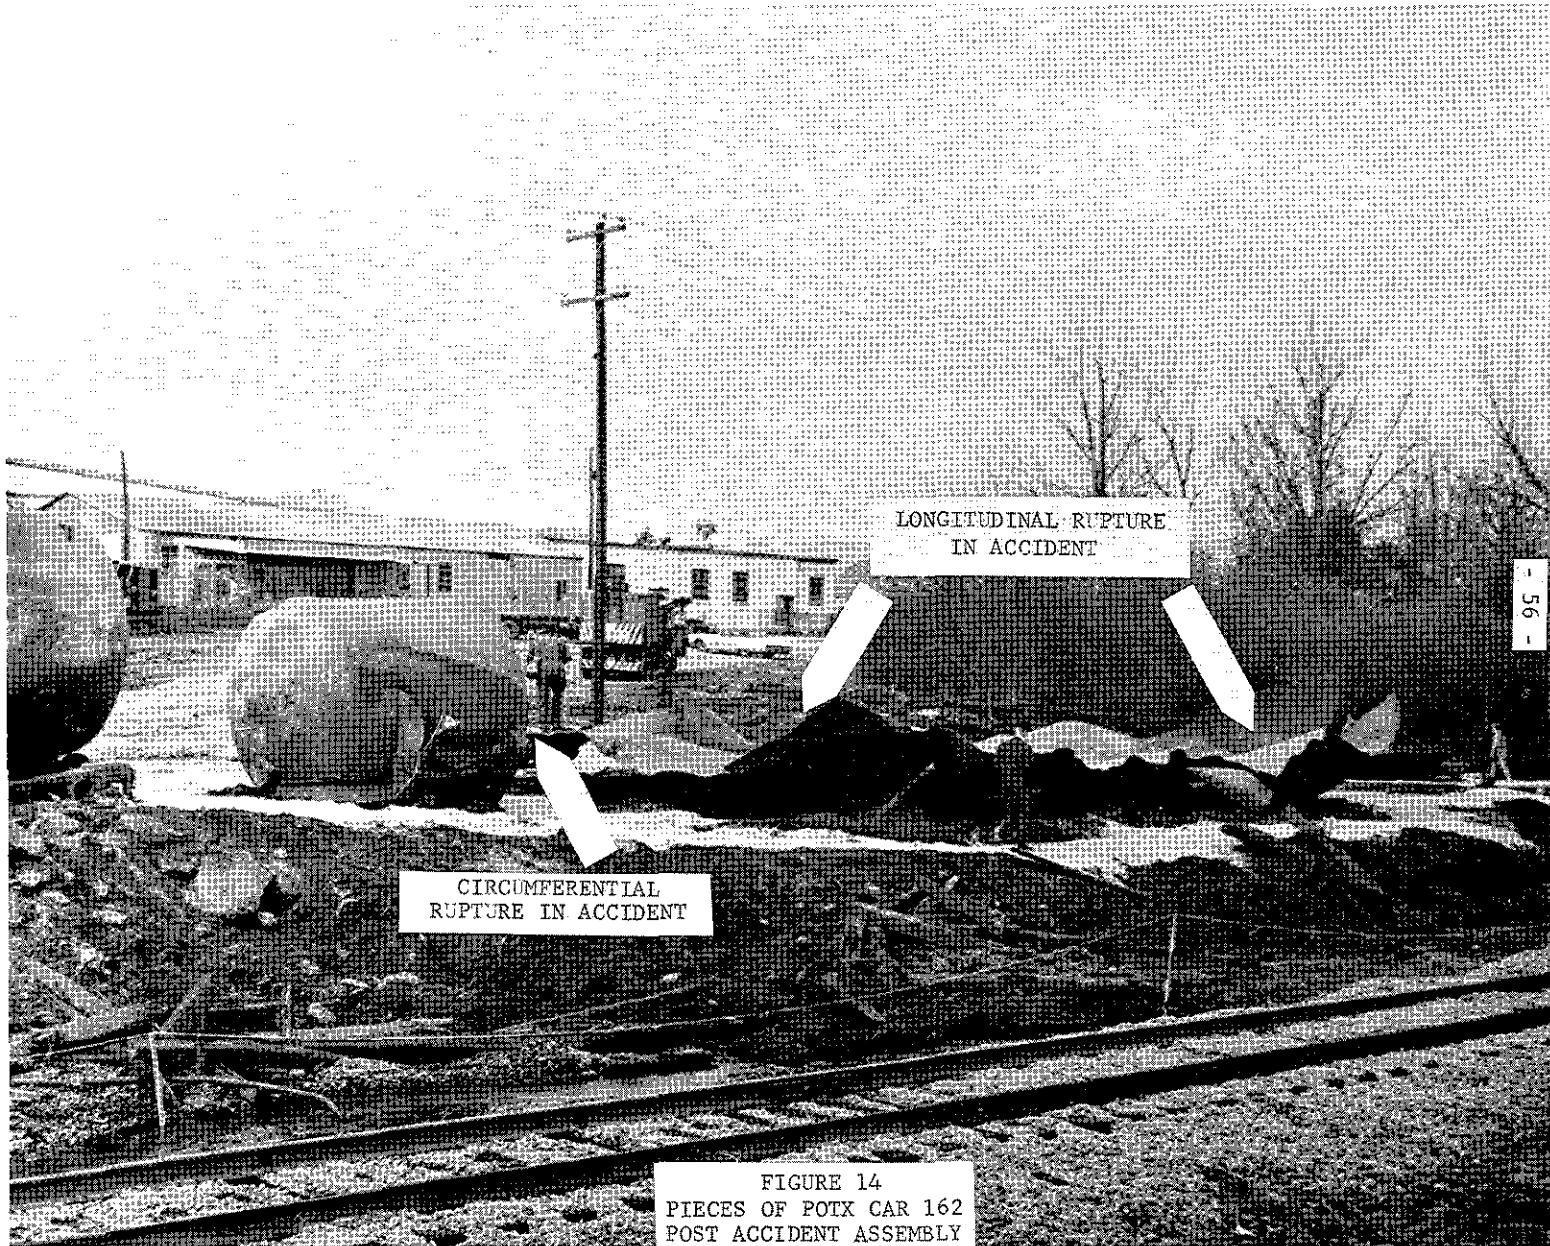
CIRCUMFERENTIAL
RUPTURE IN ACCIDENT

LONGITUDINAL RUPTURE
IN ACCIDENT
